International Organization for Migration (IOM)
The UN Migration Agency

Rapid Field assessment report Antananarivo:

Date: 15/03/2017

By: Joseph Ashmore (IOM Geneva), Giacomo Dei Rossi (IOM Madagascar)

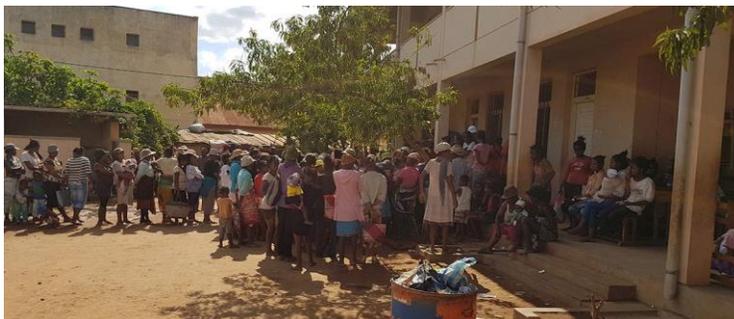
Location 1: EEP: Soavimasoandro

Displaced population: 128 families, or 545 persons at peak. This had now reduced to 62 families, although more were present for the distribution. The site was open and not overcrowded (pictured here during distribution).

Parts of the school were being used as an evacuation centre, and a food distribution was being conducted (WFP and MRC) during the site visit. People were staying there by night and returning to their accommodation by day. However it also appeared that men were staying by their houses by night to guard them. The distribution was primarily attended by women. More people attended the distribution than were actually staying in the collective centre, and many people were staying at the collective centre longer so as to receive the distribution.

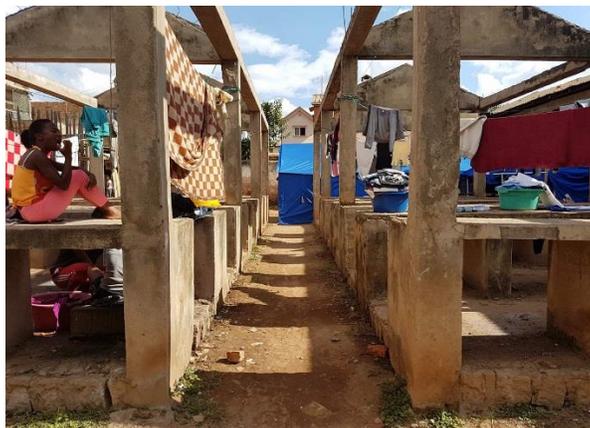
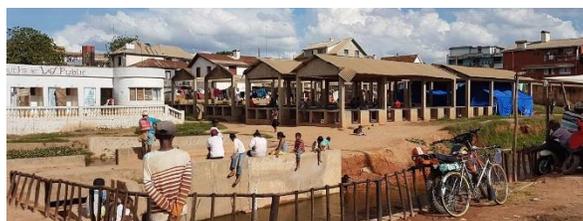
Location 2 : “camp” / Relocation centre: Amboditanimena

The “camp” was approximately 750m from the school. Three 8mx4m Tents were being erected under an existing corrugated iron roof over concrete stalls in an unfinished covered market. Wooden palettes were being used to make a raised floor (approximately 1m off the floor). The intention was for 62 families to relocate to this site. The space seemed woefully inadequate as this would mean approximately 100 people per tent. For the raised platforms there would be safety issues for small children, with risks of fall off.

There was an existing shower block but with no water and insufficient toilets for the intended caseload. Water was being sold in a nearby kiosk next to the bus stop.

If this site becomes populated as planned with the forced closure of the school there would be severe overcrowding and sanitation issues. If relocation proceeds, public health conditions at this site require careful monitoring.

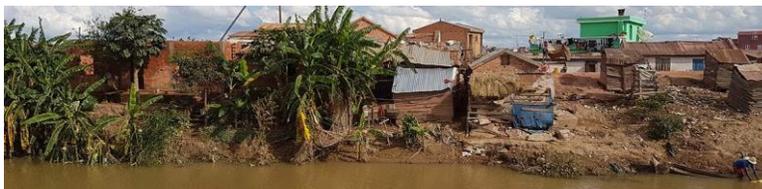
Location 3: An area of origin

The site visited was approximately 500m from the intended relocation site. Houses were built on marginal land on the sides of raised embankments. The location was semi rural – with livestock and rice paddies.

Flood waters had risen and flooded many of the houses, but now had receded and dried out causing minimal visible structural damage. Houses were primarily built of burnt brick with mud mortar, and were of low income households. This year the flood waters were higher than normal.

The risk of flooding had been increased in recent years by the development of recent roads infrastructure with insufficient culverts and drainage. This had reduced the ability of the land to drain during heavy rains.

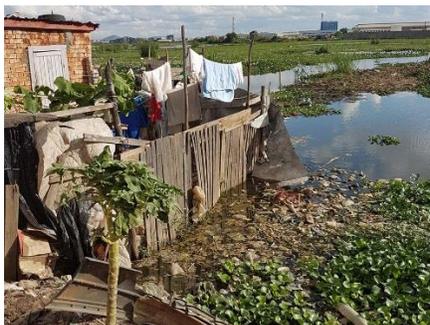
Location 4: Area of origin 2

The site is approximately 1.5km from the evacuation centre. It is an informal urban settlement on the edge of a large permanently flooded area. Houses were small as 2m x 3m and primarily built of burnt brick with mud mortar. Roofs were of a combination of corrugated iron and plastic.

Most of the houses visited were no longer flooded, but there was some evidence of structural cracking in the walls. The location had chronic sanitation issues, was built on marginal land and was highly overcrowded.
