Impact of the 2014 Conflict in the Gaza Strip

UNOSAT Satellite Derived
Geospatial Analysis

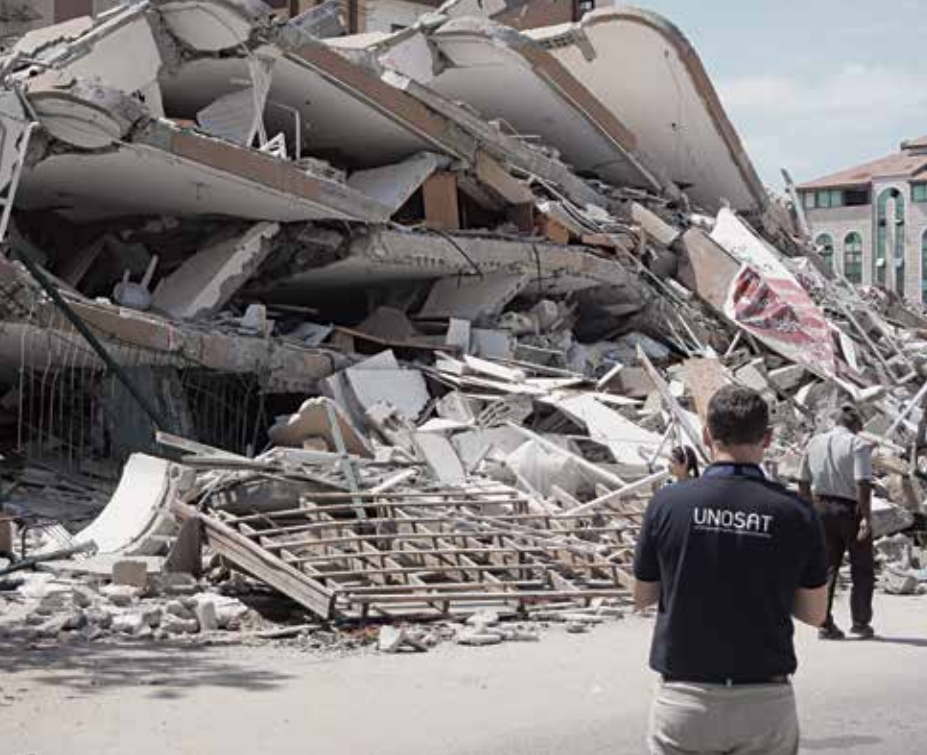
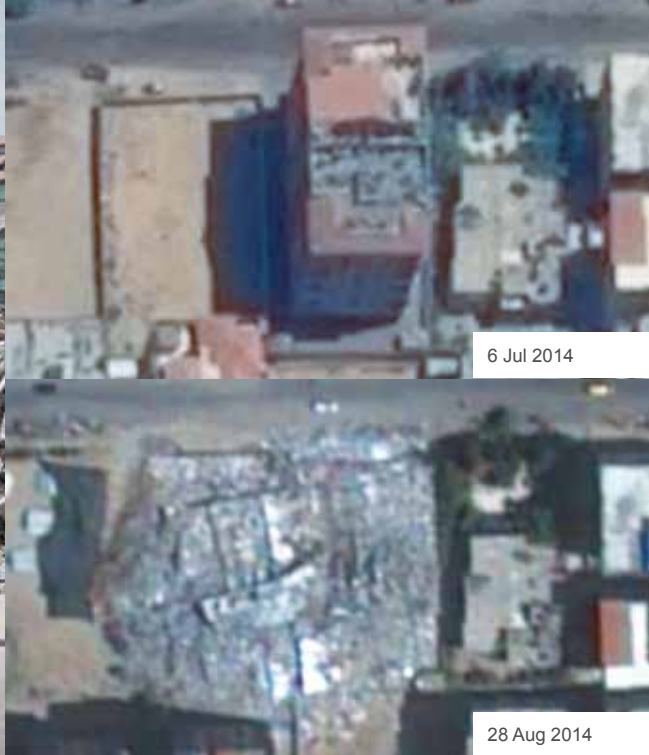
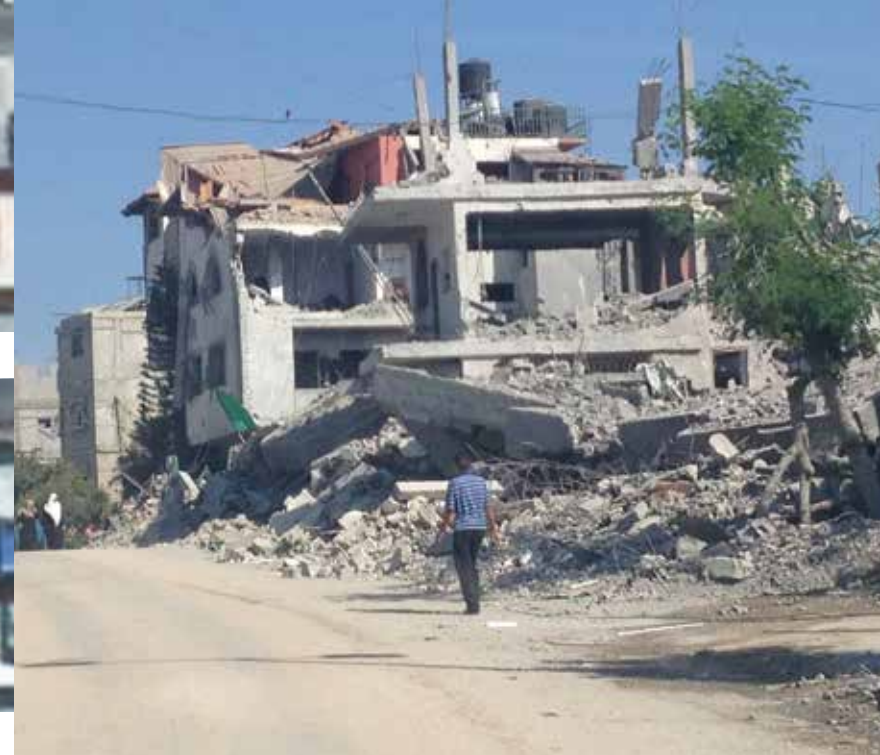
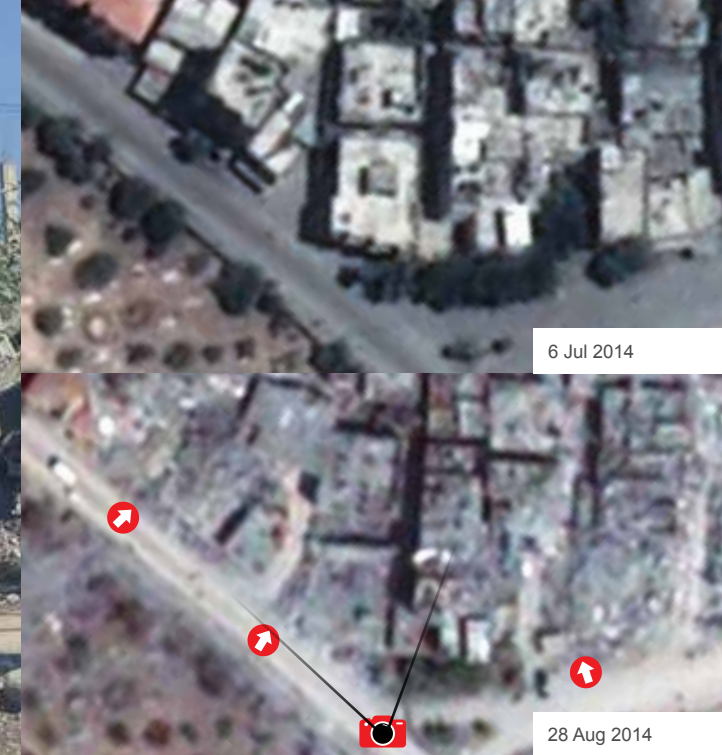
LEVEL OF DAMAGE

The image above shows a small part of the UNOSAT damage assessment using the 28 August 2014 imagery.

Buildings/structures that have suffered
Moderate Damage

Buildings/structures that have suffered
Severe Damage

Buildings/structures that have been
Destroyed

Crater

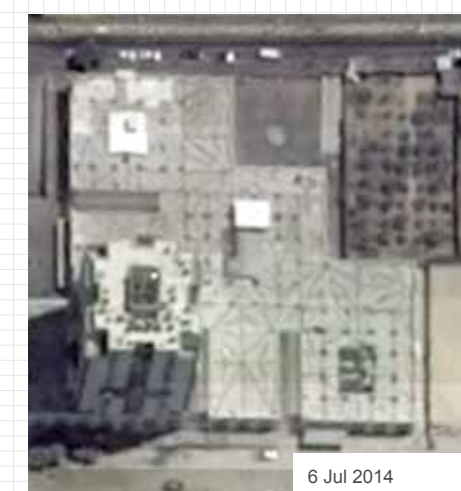
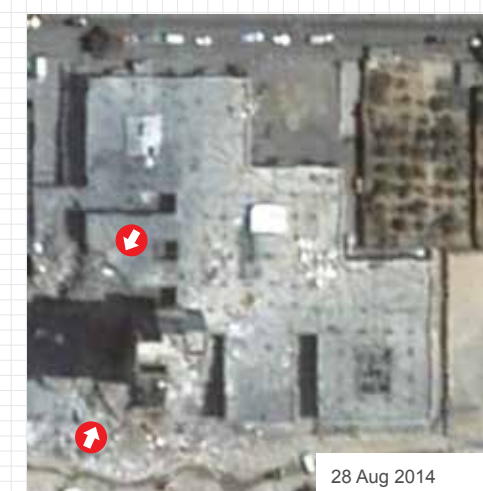
BEIT HANOUN

Beit Hanoun is a neighbourhood inside the North Gaza Governorate, in the northeast edge of the Gaza Strip. Imagery from 28 August 2014 as well as the UN-Assign photography show widespread damage to residential buildings across the Beit Hanoun neighbourhood. A total of 1,003 damage points were identified on imagery inside the neighbourhood boundary including 301 destroyed, 302 severely damaged and 350 moderately damaged buildings.

Visibly destroyed buildings

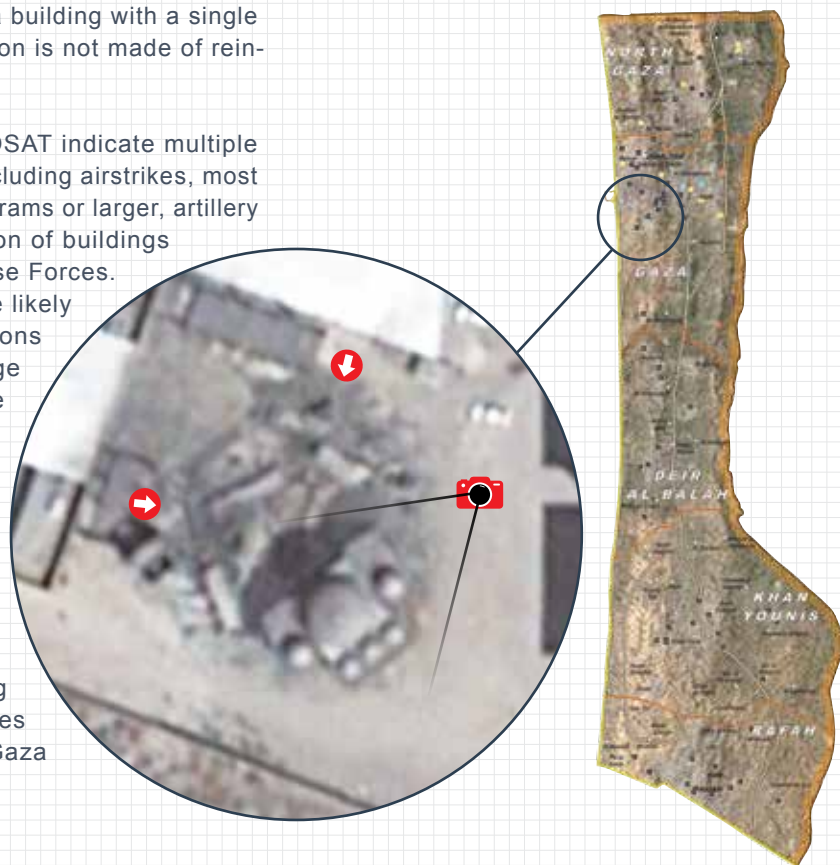
HAMZA MOSQUE, GAZA
Imagery from 28 August 2014 shows that the mosque has been severely damaged

➡ Severely damaged mosque

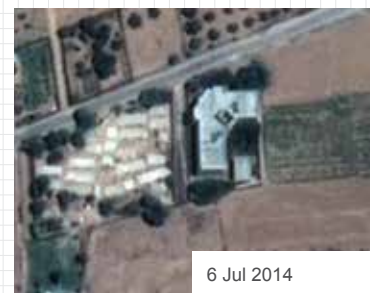
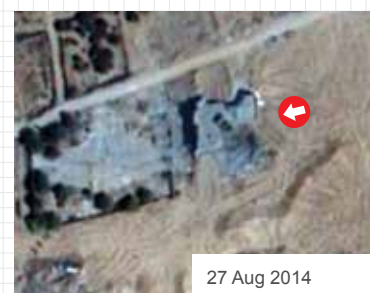
ABSSAN HEALTH CENTRE, KHAN YOUNIS

Imagery from 27 August 2014 shows severe damage to the main health center building. The southern wing of the building is completely destroyed and the remaining northern wing of the building is severely damaged.

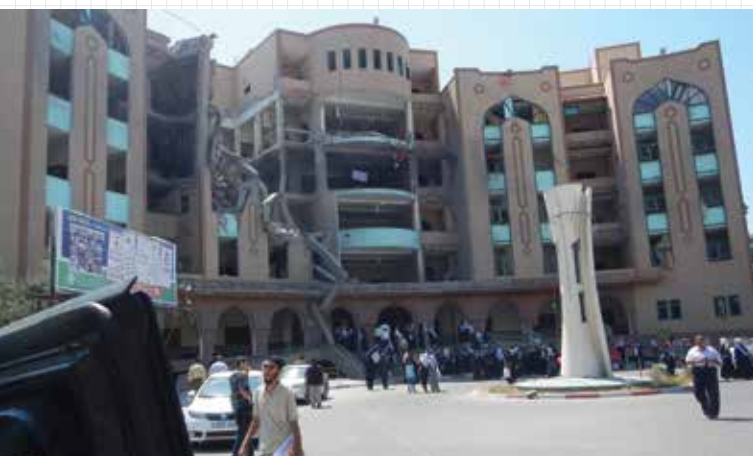
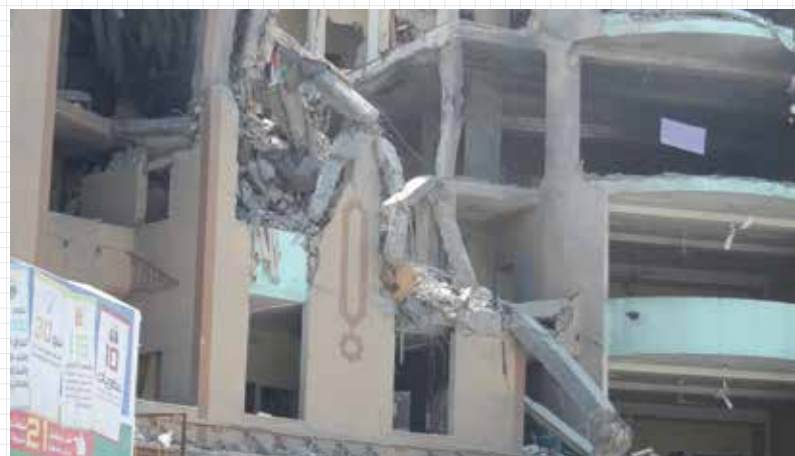
Imagery from 28 August 2014 shows severe damage to the main administration building of The Islamic University of Gaza, as highlighted on the image above and as seen on the UN-Assign pictures below, supporting reports from OCHA on 3 August 2014 stating that several buildings of the Islamic University in Gaza City sustained severe damage and are in need of repair.

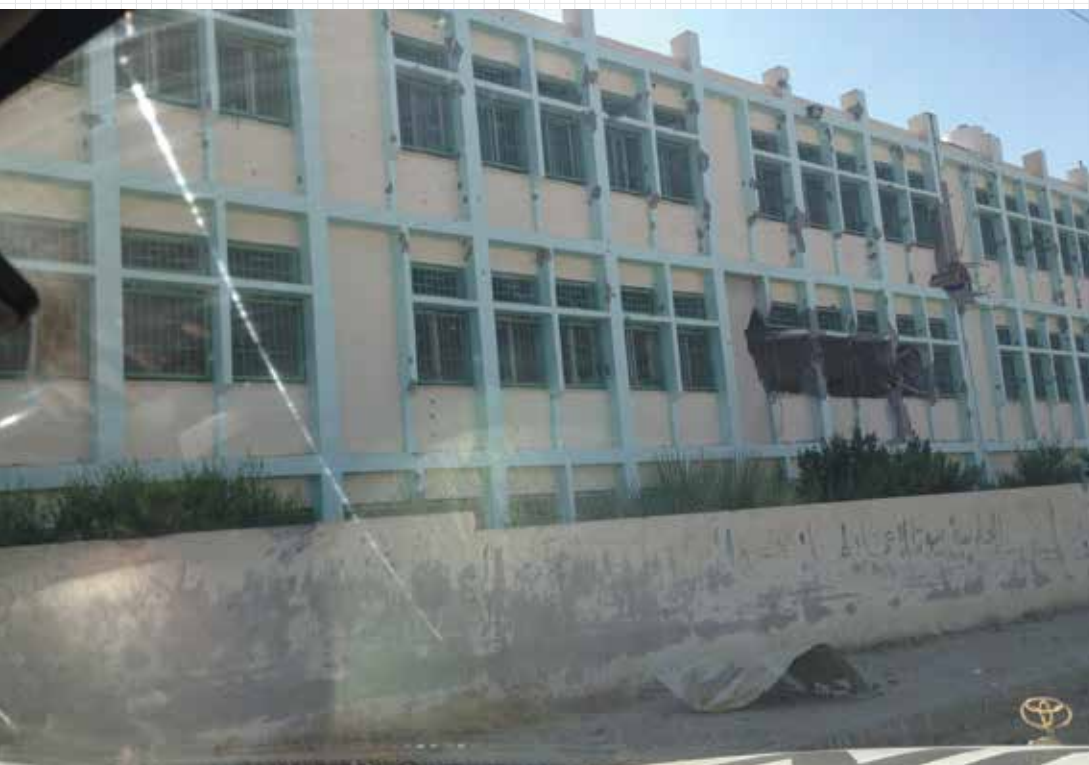
BEIT HANOUN SECONDARY SCHOOL FOR BOYS, NORTH GAZA

Sample images on these pages indicate significant combat activities in proximity to educational facilities. For example, the image showing the Beit Hanoun Secondary School for Boys indicates multiple debris areas around the school. Dirt spread across the road, and in piles in some areas, was likely one or more ad-hoc road blocks which were pushed aside by the IDF. Multiple buildings nearby are clearly destroyed, debris next to the school and some indentation of the school facade indicate damage. However, the Beit Hanoun school buildings are likely reparable and will not require complete reconstruction.

Imagery from 28 August 2014 shows possible moderate damage to the north section of the Beit Hanoun Secondary School for Boys building corroborated by UN-Assign ground photos taken 3 September 2014 and substantiated by an UNWRA report from 25 July 2014 stating that the attack on Beit Hanoun School followed three previous incidents in just the past four days of UNRWA shelters being hit by explosive projectiles.

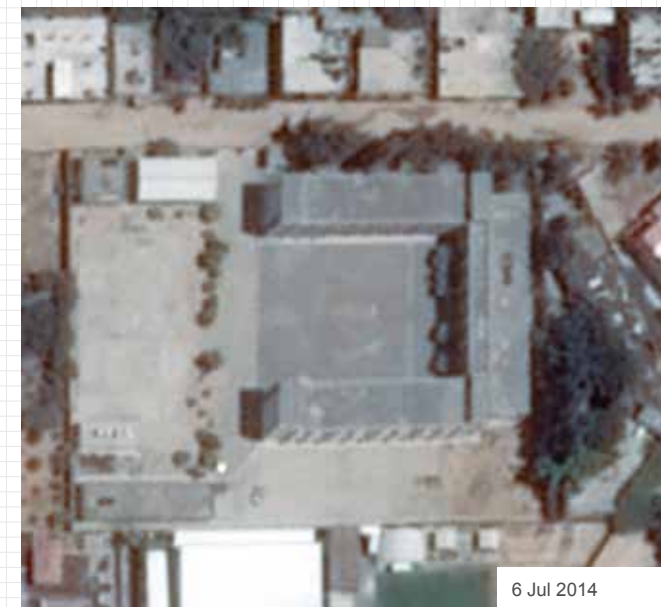
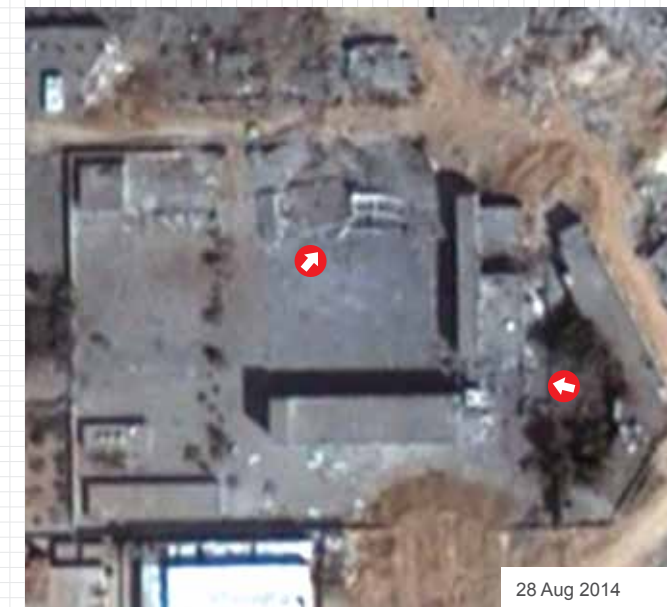
The Jamal Abd El-Nasser Secondary School was within an area razed by the IDF and thus likely experienced multiple munitions impacts from artillery, tank fire, and perhaps air strikes, completely destroying one building of the school and severely damaging others. These structures will need reconstruction after debris is cleared. Given the amount of damage in the area it is likely that even the structures remaining on the school grounds sustained significant damage and will need to be rebuilt.

Imagery from 28 August 2014 shows severe damage to the Jamal Abd El-Nasser Secondary School. Imagery shows the north wing of the school building completely destroyed and the east wing severely damaged. Additional damage to surrounding buildings and debris are visible as well.

Visibly destroyed buildings

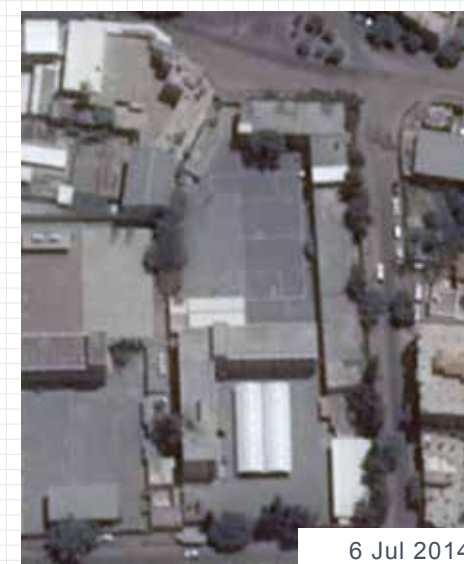
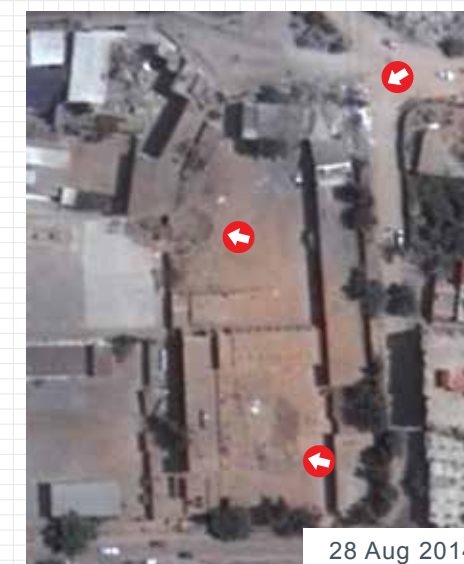
AL-SHEJAE'IA SCHOOL, GAZA

The Al-Shejae'ia School was almost certainly the target of air strikes as large craters are visible on the school grounds. The munitions impacts spread debris across the school grounds and visibly damaged the northeast building. Shock waves from such explosions would have certainly caused damage to the facades and interiors of surrounding buildings but may or may not have degraded their structural integrity. While some structures certainly require demolition and reconstruction, other structures may be repairable.

Imagery from 28 August 2014 shows extensive severe damage to the male and female schools. Impact craters are clearly visible inside the school grounds and the northeast section of the school is severely damaged.

Craters and visible severe damage

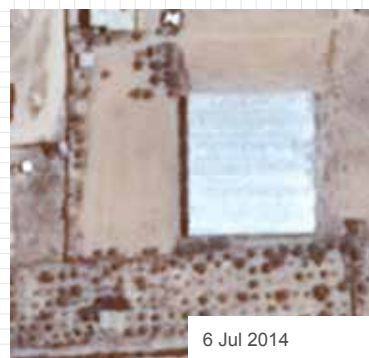
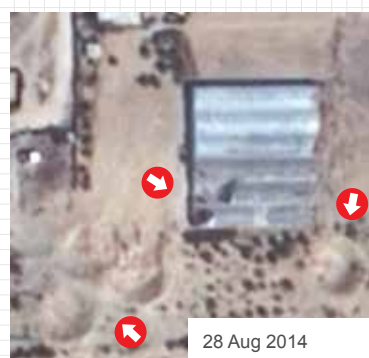
GREENHOUSES DESTROYED, NORTH GAZA

CRATER DAMAGE
Above is an example of moderate damage to a greenhouse with large craters in the close vicinity.

A total of 1,263 greenhouses were assessed to be damaged according to the most recent damage assessment using imagery from 27 and 28 August 2014. Imagery shows that 52 percent (or 657) of the total greenhouses found with some level of damage are completely destroyed (as seen on the image above), 17 percent (or 214) we found severely damaged and 31 percent (or 392) were seen with moderate damage (like the greenhouse on the left image).

Visibly destroyed greenhouse
