# JAPAN - Honshu Island Misawa Area

## Rapid Geographic Reference Map

# JAPAN - Honshu Island Hachinohe Area Rapid Geographic Reference Map

# JAPAN - Honshu Island Miyako Area Rapid Geographic Reference Map

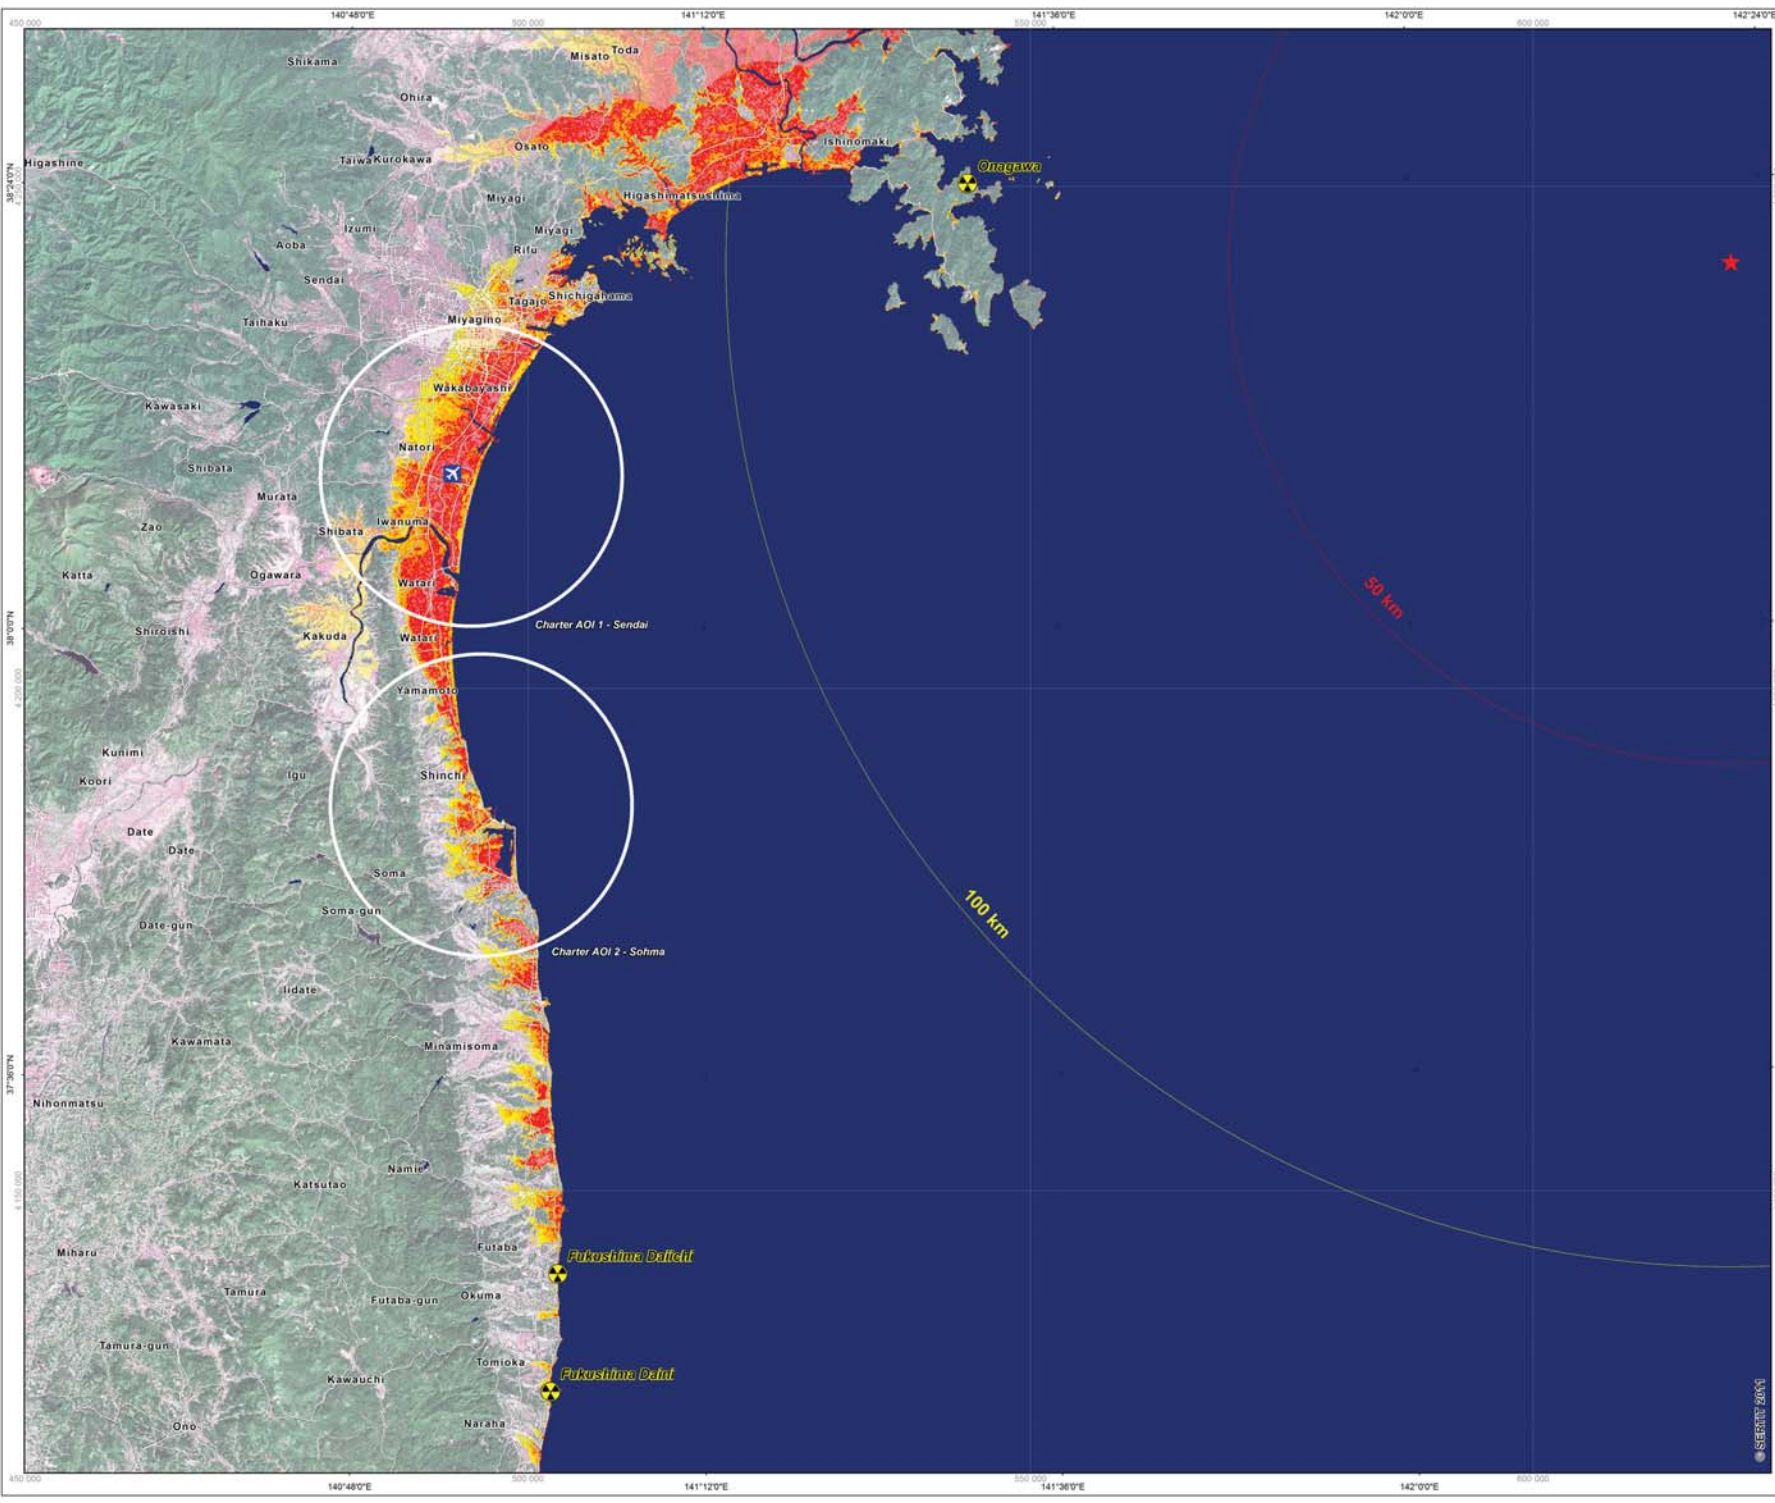
# JAPAN - Honshu Island Miyagino Area Rapid Geographic Reference Map

Potentially tsunami over-flooded areas from MNT SRTM (90m)  
© SERTIT 2011
