World Bank / GFDRR / ImageCat / RIT Remote Sensing and Damage Assessment Mission Haiti, January 2010

Summary

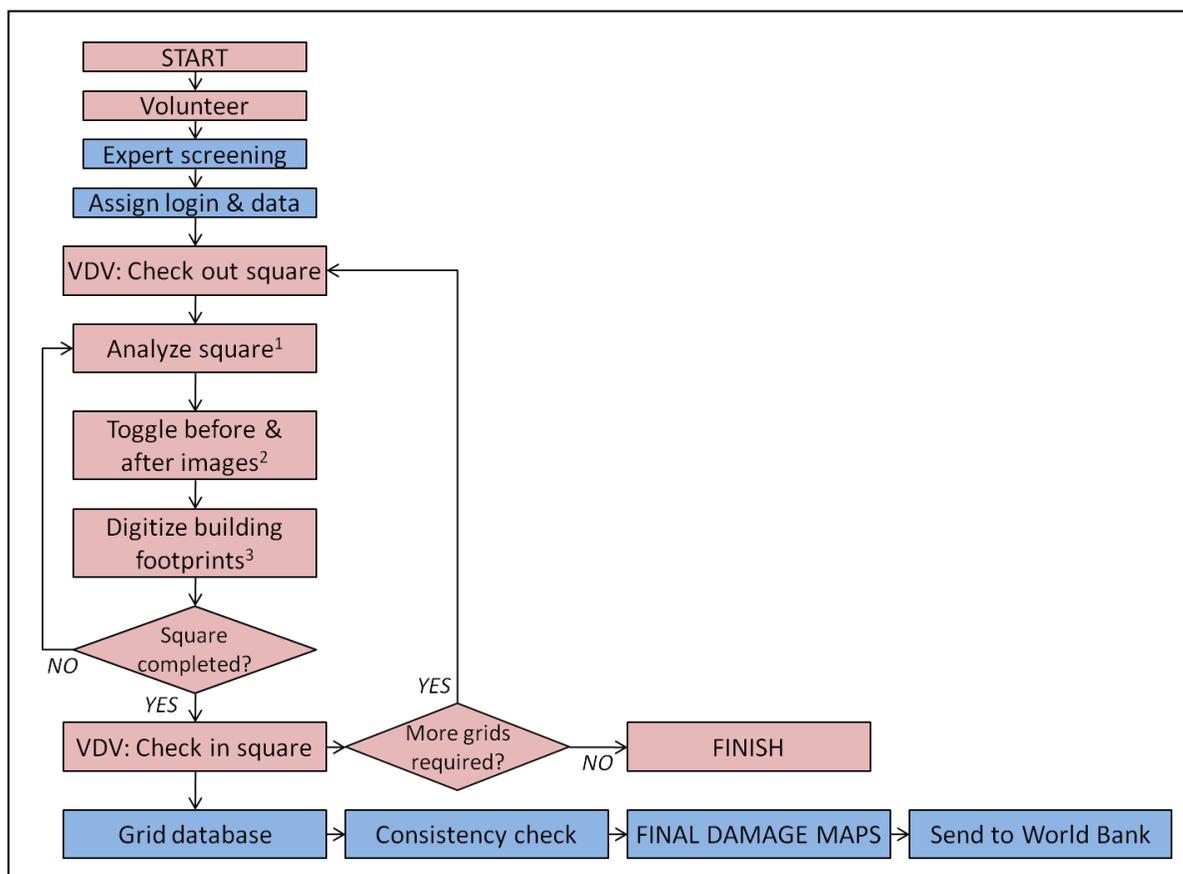
Figure 1. Workflow for each GEO-CAN volunteer (in pink)

The damage assessment utilized experts' experience in image analysis, earthquake engineering and other disciplines using the method described in figure 1. The study area was split into a grid of squares, with volunteers using the online virtual disaster viewer to *check-out* a square for analysis, and *check-in* the completed square, along with damage information for the building stock within the square

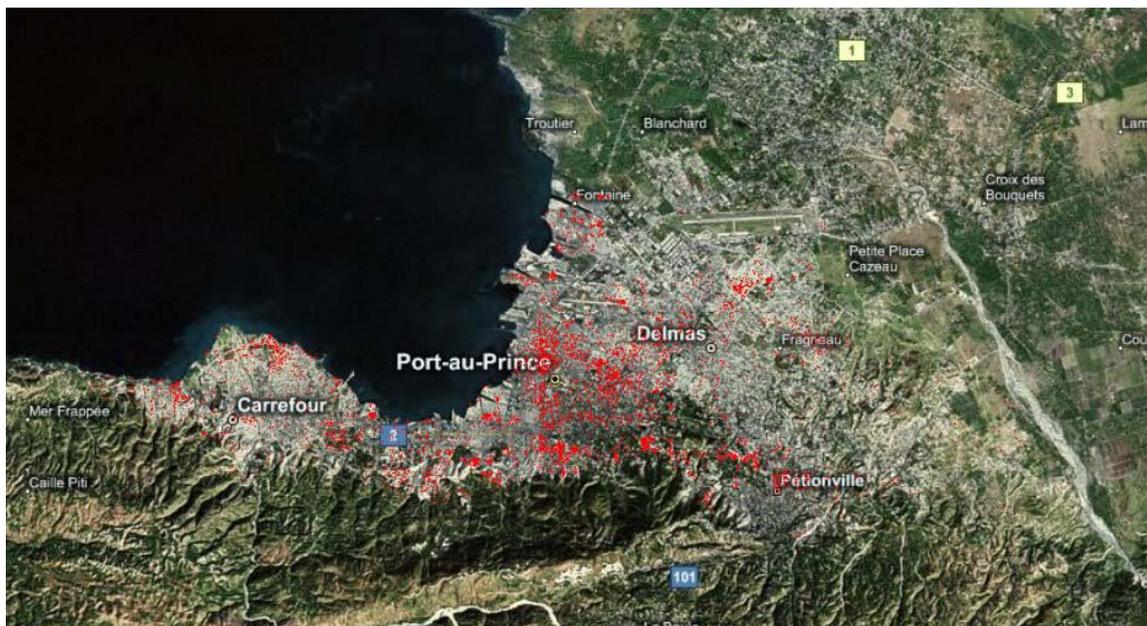
Figure 2: Point locations of collapsed structures (Phase 1)

The first set of damage maps for the city of Port-au-Prince was produced in 48 hours of the project commencing. The online Virtual Disaster Viewer system (VDV: www.virtualdisasterviewer.com) was customized by ImageCat to manage over 500 squares for distributed analysis by remote sensing professionals. A check-out/check-in system assigned each volunteer with squares to analyze and identify the collapsed buildings, using imagery captured by the GeoEye-1 satellite sensor on 13 January. All squares were rigorously validated by ImageCat scientists and the final maps sent to World Bank/GFDRR, and displayed in VDV.

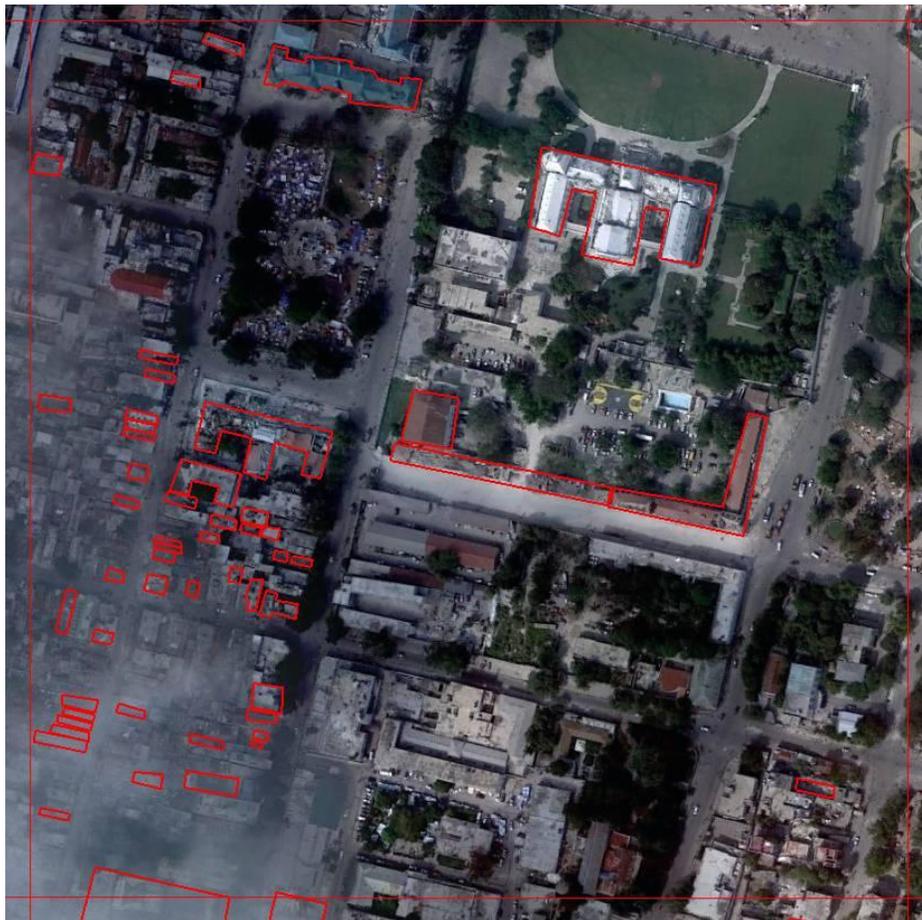
Figure 2: Building footprints for heavily damaged and collapsed structures

Phase 2 saw the study area extended to encompass areas to the north, east and southwest of Port-au-Prince. A total of 1384 500m squares were distributed to the newly-formed GEO-CAN community which grew throughout the phase to incorporate over 500 individuals. Volunteers gave their weekend for the analysis, and results were provided to WB-GFDRR within 96 hours of commencement, showing the building footprints of all collapsed or heavily damaged buildings (Figure 3). Newly acquired aerial imagery supplied by Google and the World Bank-ImageCat-RIT (WB-IC-RIT) remote sensing mission were used for this analysis, providing increased detail from phase 1 for the analysts. A total area of 346 km² was assessed for building damage.
