EERI Earthquake Reconnaissance Team Report: M7.8 Gorkha, Nepal Earthquake on April 25, 2015 and its Aftershocks

May 2016

A product of the EERI Learning From Earthquakes Program

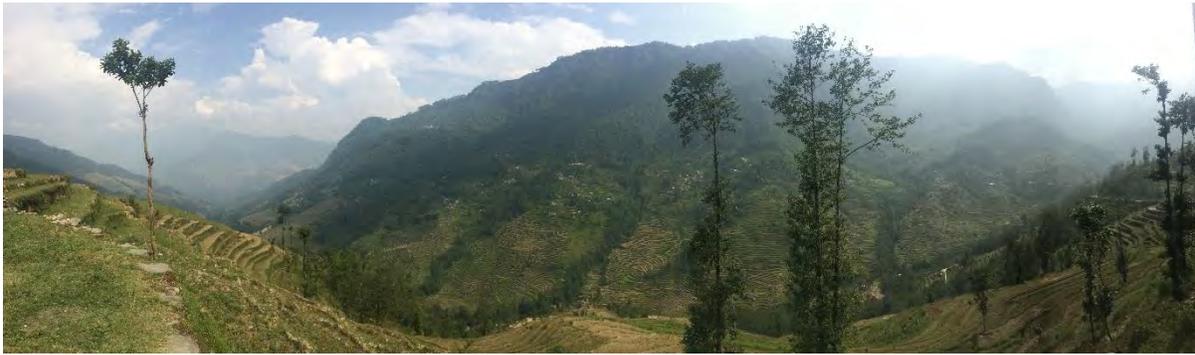
Figure 2-2. Typical view of terraced landscapes and deep riverine erosion in the Middle Mountain area, photo 27° 41' 56.559" 86° 3' 32.719' (photo: Jan Kupec)

Rapid uplift of Nepal's terrain due to seismic uplift (described more in Section 2.5), and corresponding rapid riverine erosion, created a very distinct landscape in the Middle Mountains. The terrain is dominated by steeply sloping terraced agricultural land and villages and townships along prominent mountain ridgelines, as shown in Figure 2-2. The area mainly affected by severe seismic shaking from the Gorkha Earthquake and its aftershocks is the Middle Mountain Range.

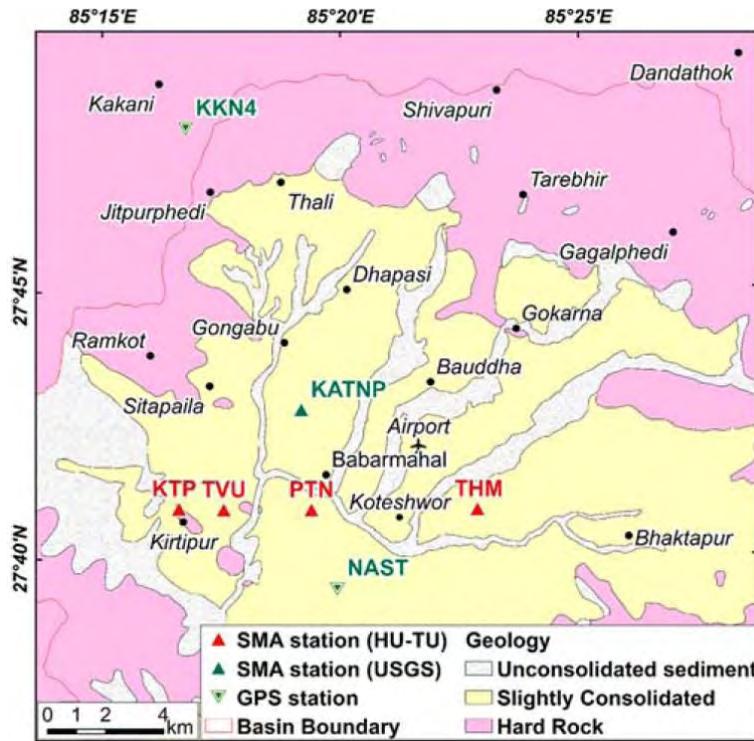
Figure 2-7. Locations of strong ground motion stations by site category within the Kathmandu Valley basin. Except KTP station (which was on a rock site), all the seismic stations shown on the map were located on soil sites (source: Takai et al., 2016).

Note that much of the building stock in Kathmandu Valley is composed of low and mid-rise reinforced concrete frames with infill masonry construction (with natural period < 1 sec). These buildings did not experience the peak spectral demands associated with the mainshock records in the 4.5 sec period range. Similarly, the peak ground accelerations and the spectral demands at shorter periods (less than 1 second) were relatively low when compared with standard ground motion prediction models (for example, Boore et al. 2014 as shown later in Section 2.9). The amplification at the long period range could have been caused due to deep basin response from strong shaking, which was further complicated due to the source rupture characteristics. However, such strong amplitude in the longer period range was not witnessed for the KTP station, which was located on a rock site.

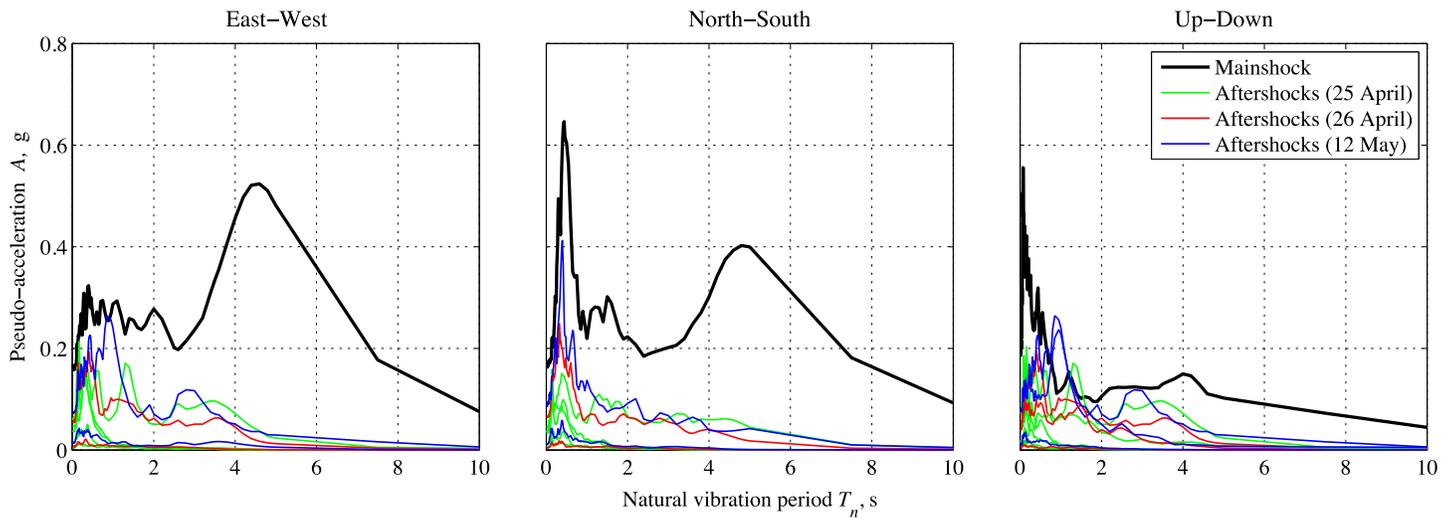
Figure 2-11. Response spectrum plots showing comparison of peak response accelerations of M_w 7.8 mainshock and the subsequent aftershocks at various period ranges for the three components of ground motions (source: Erol Kalkan, USGS).

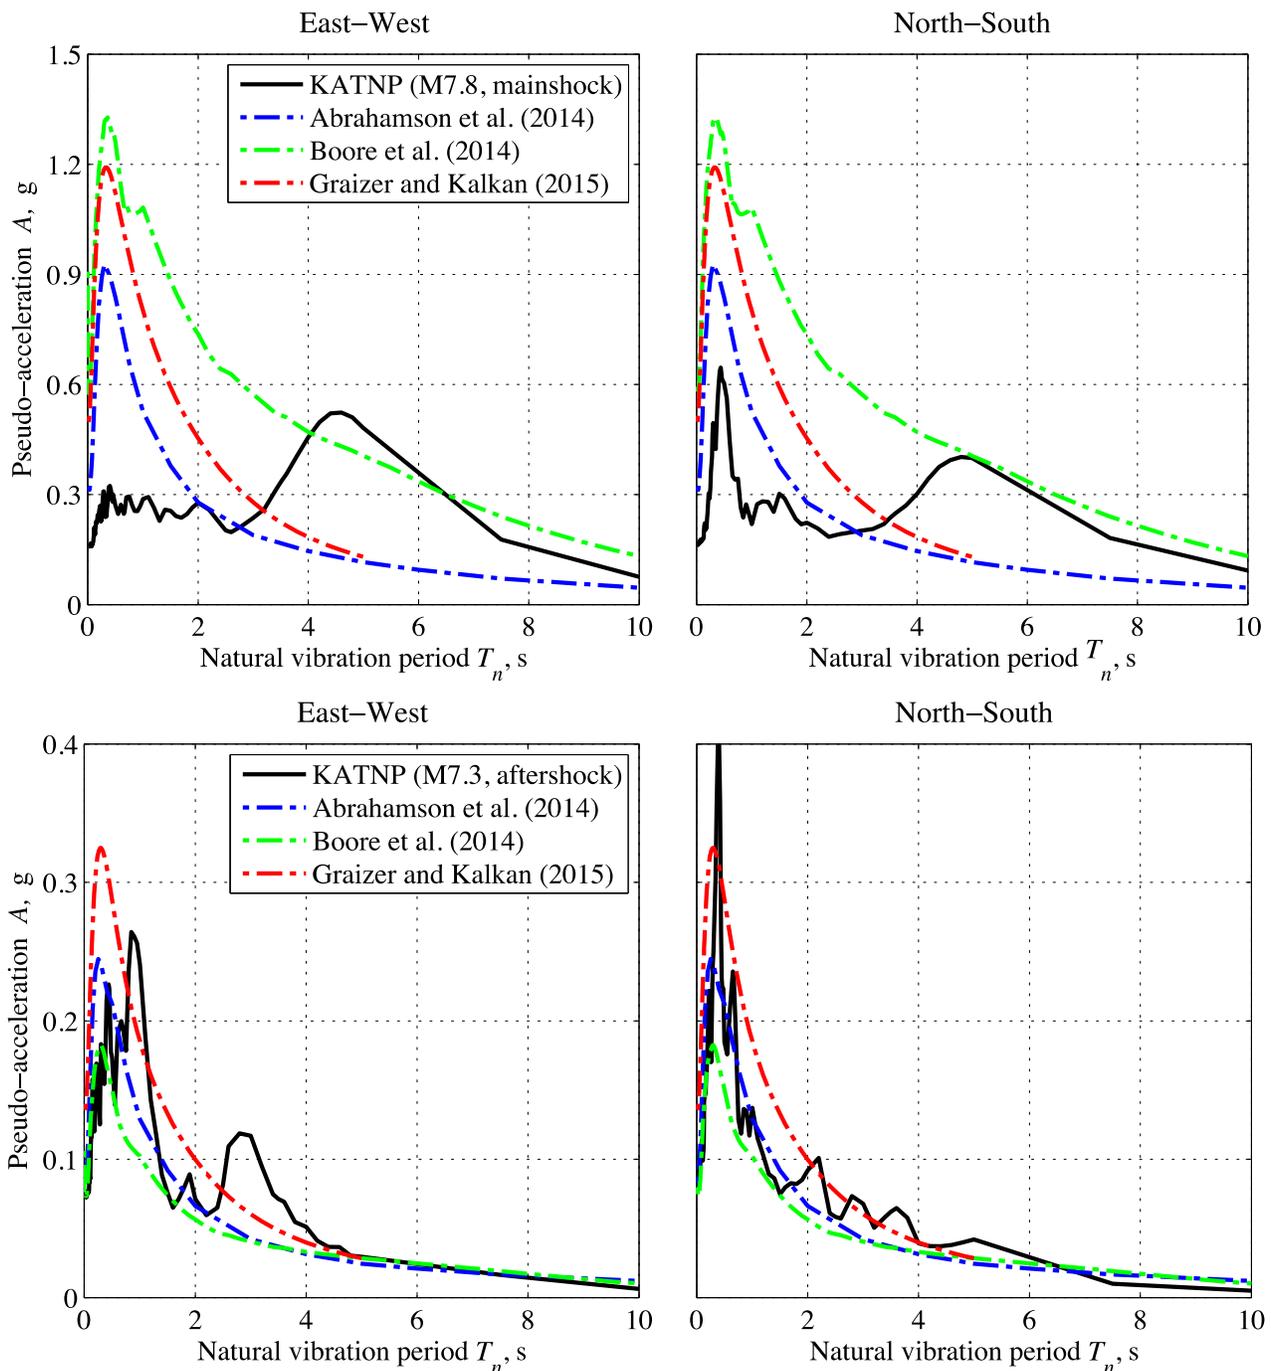
Figure 2-13. A comparison of observed ground motions during the mainshock (top panels) and aftershock (bottom panels) with respect to three ground motion prediction equations (Abrahamson et al., 2014; Boore et al., 2014; Graizer and Kalkan, 2015) (source: Erol Kalkan, USGS).

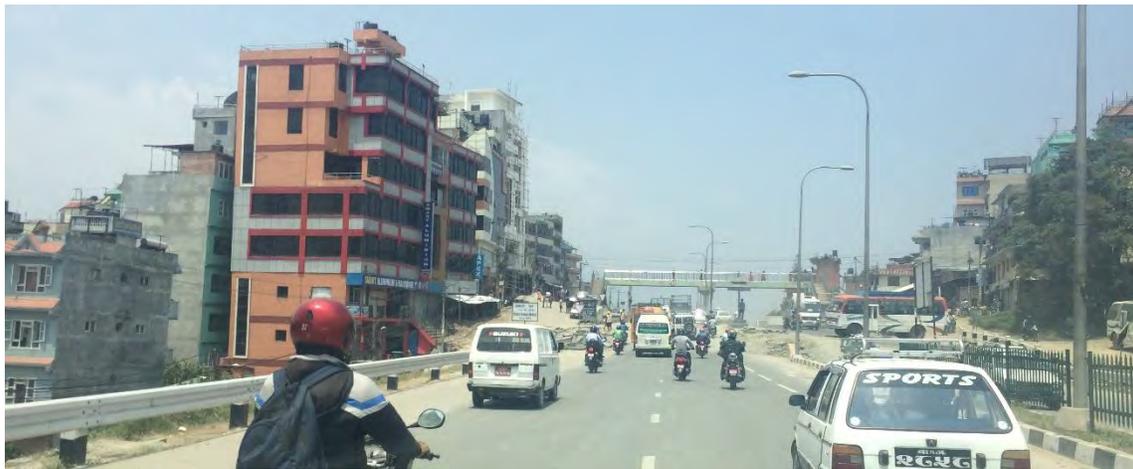
Figure 3-1. Araniko Highway damage, showing tilting building on the left-hand side and settlement center far, Lokanthali 27°40'28.71"N 85°21'42.54"E (photo: Jan Kupec).

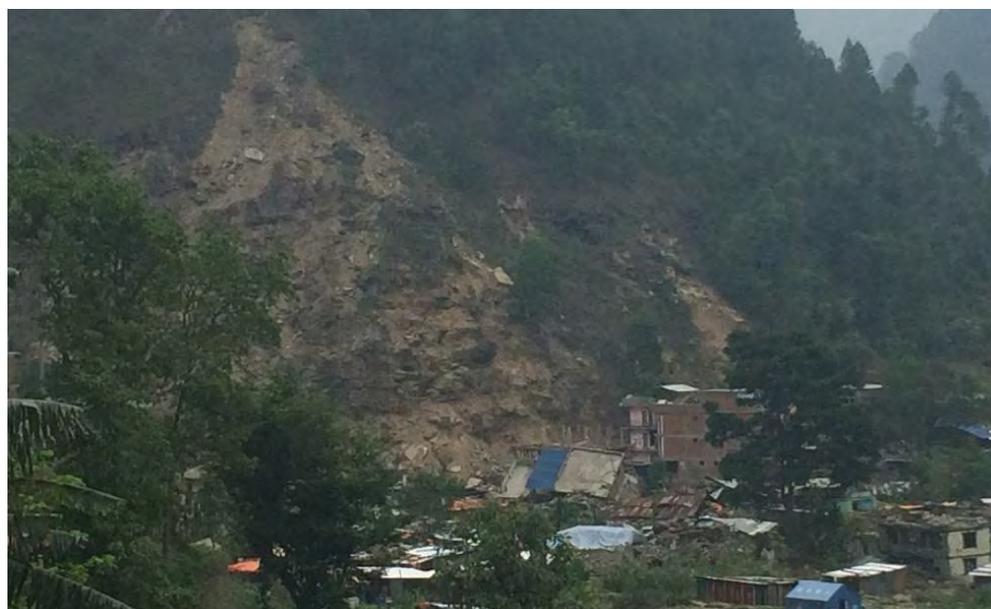
Figure 3-2. Singati Township, Dolakha District affected by cliff collapse and rock mass failures from an approximately 50 to 75m high near vertical slope, 27°44'15.49"N 86°9'50.16"E (photo: Jan Kupec).

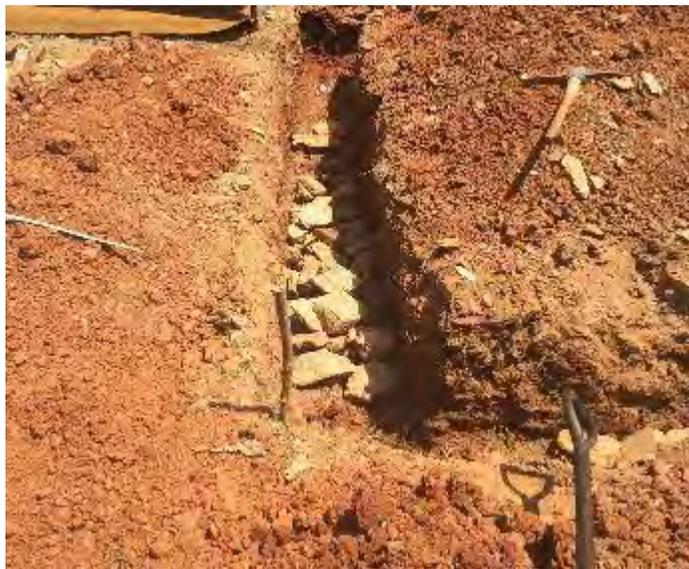
Figure 3-7. Example of a typical shallow footing (a) trench under construction in Chautara, (b) sketch of typical shallow footing detail, and (c) photo of typical building foundation (photos and sketch: Jan Kupec).

Rebuilding (where observed) used same shallow foundation systems, as shown in Figure 3-7.

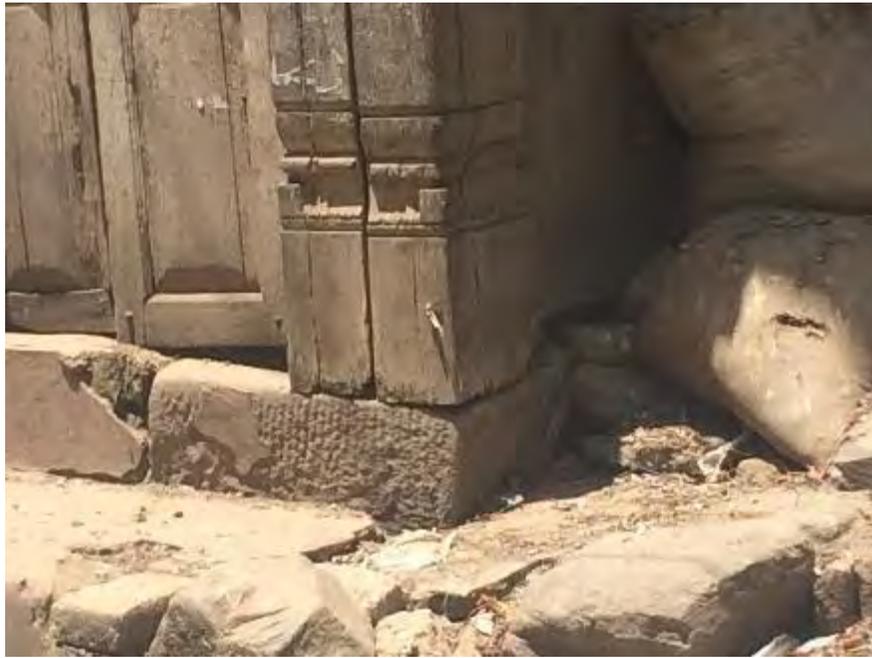
Figure 3-8. Example of a plinth and column connection for a traditional stone footing (photo: Jan Kupec).

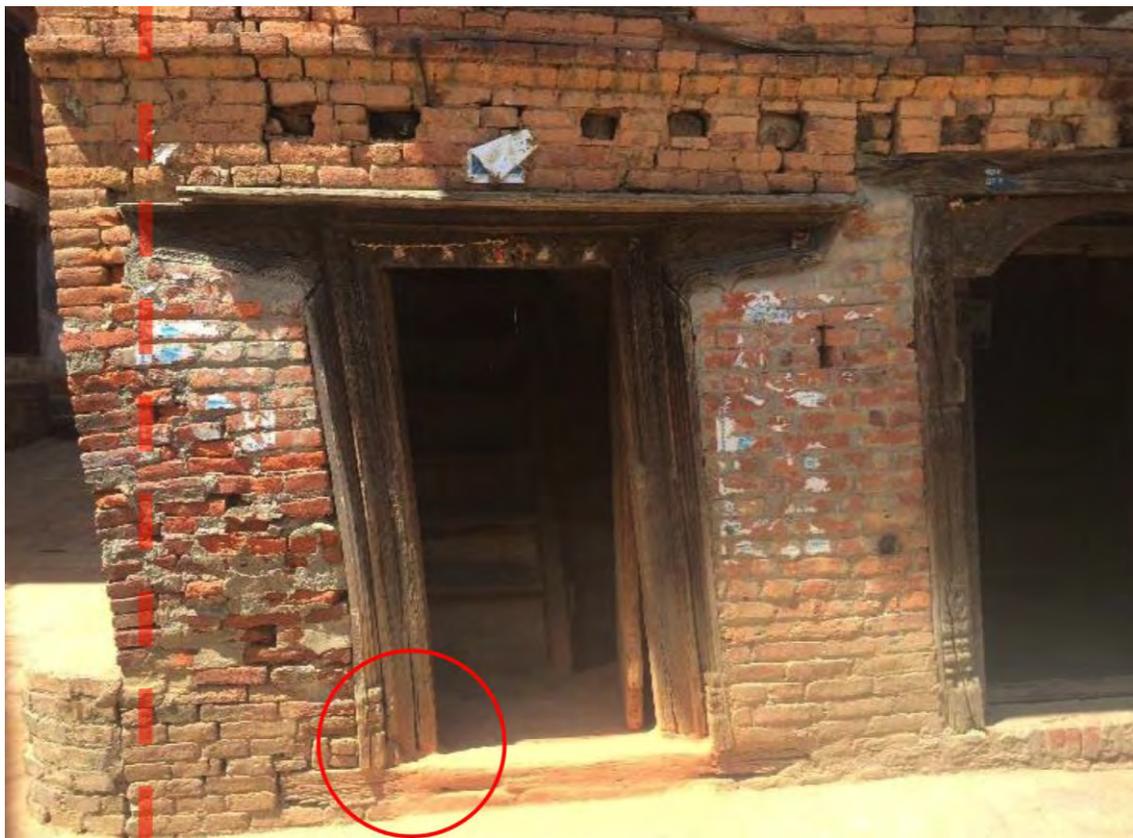
Figure 3-9. Timber column held in place by stone plinth protrusion despite URM superstructure with significant lean in Dhuliket (photo and annotations: Jan Kupec).

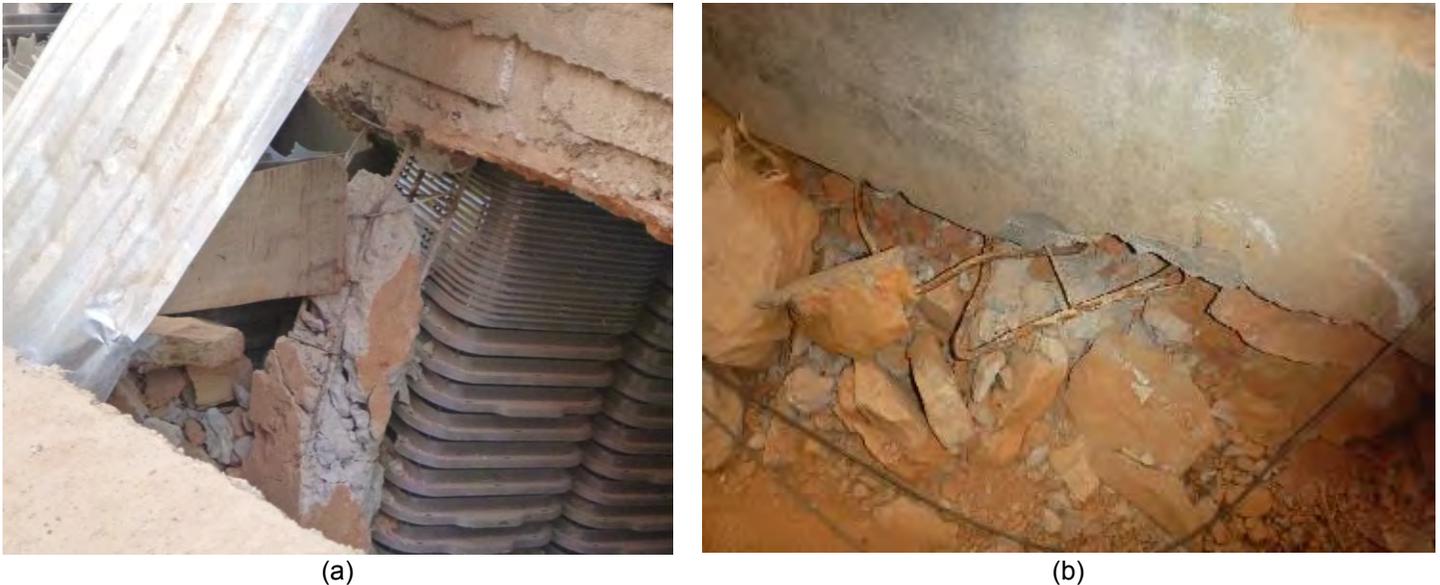
Figure 3-10. Examples of foundation damage in Chautara: (a) short column and infill damage between ground level and footing, and (b) crushing failure and out-of-plane masonry infill failure of building shown tilting in Figure 5-12a (photos: Jan Kupec).

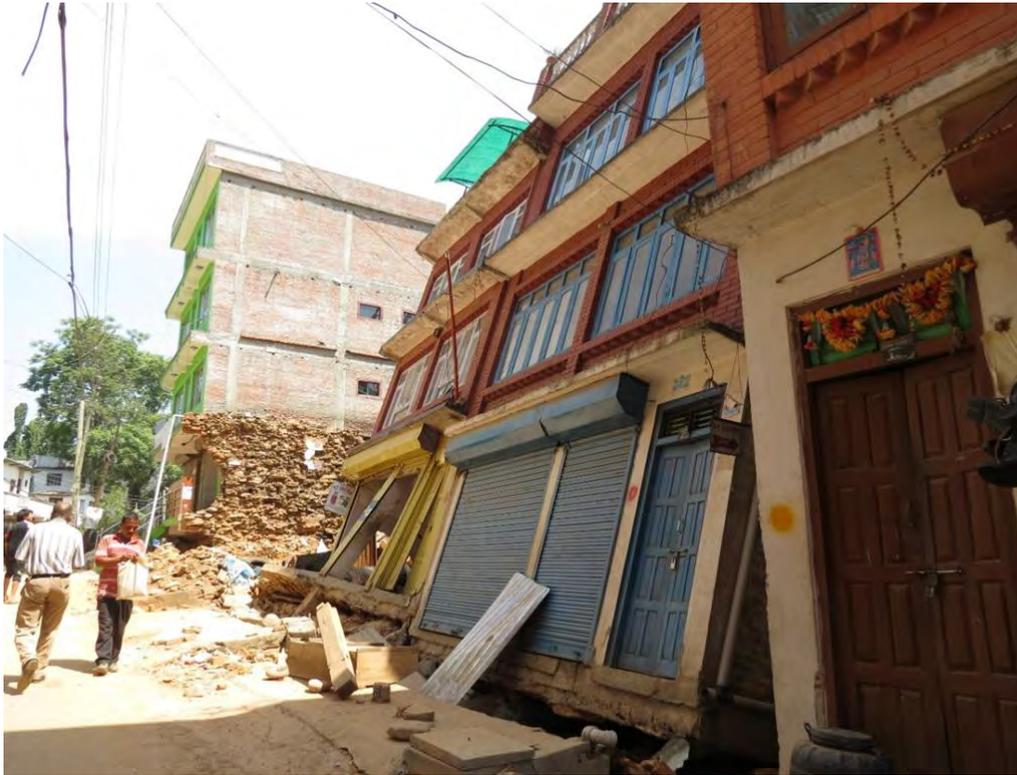
Figure 3-11. Example of significant building tilt in Chautara (photo: Hemant Kaushik).

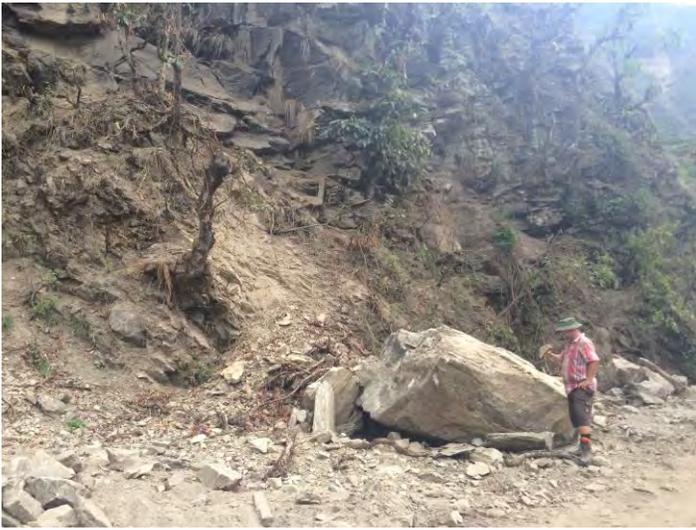
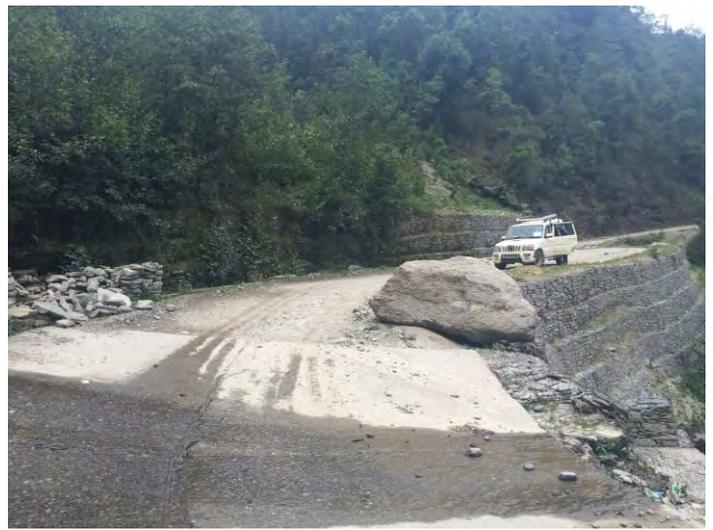
Figure 3-12. Examples of individual rock blocks along Charikot - Lamabagar Rd (photos: Jan Kupec).

Many landslides, in the form of individual rock blocks, were sitting on the carriageway. These blocks were often quickly cleared to allow traffic flow; but, some larger blocks, which needed to be broken down by machinery before moving, were noted during the EERI site inspections about one month following the trigger events, as shown in Figures 3-12 and 3-13.

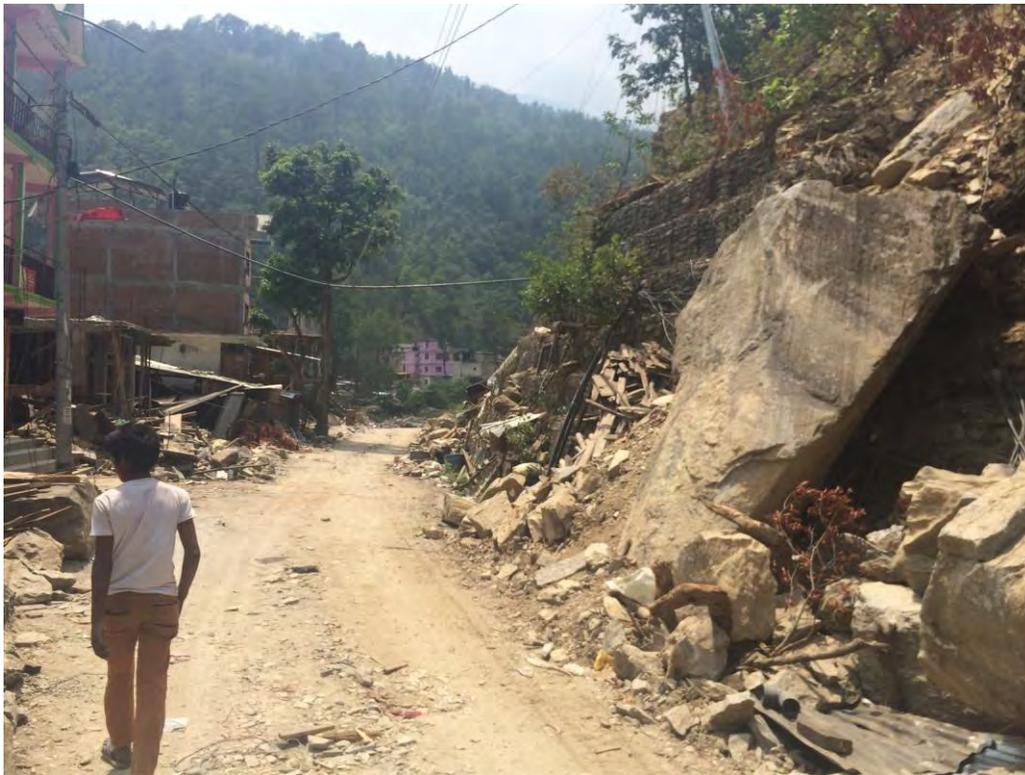
Figure 3-13. Structural damage and rock fall at gabion site in Singati Township (photo: Jan Kupec).

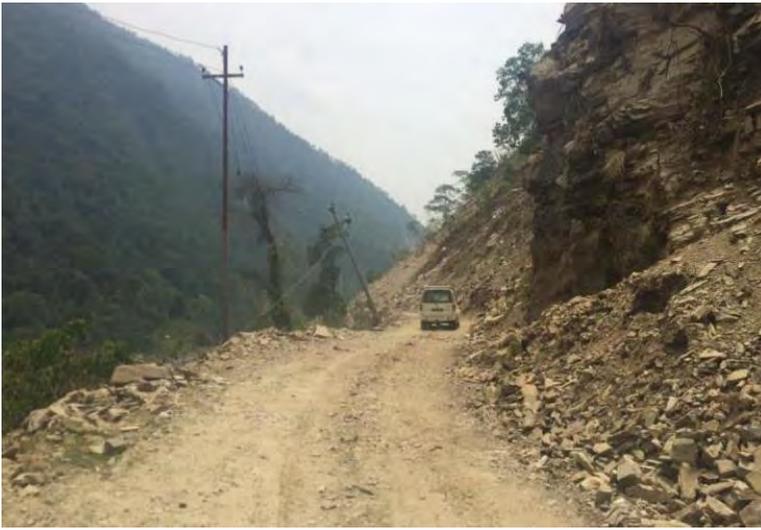
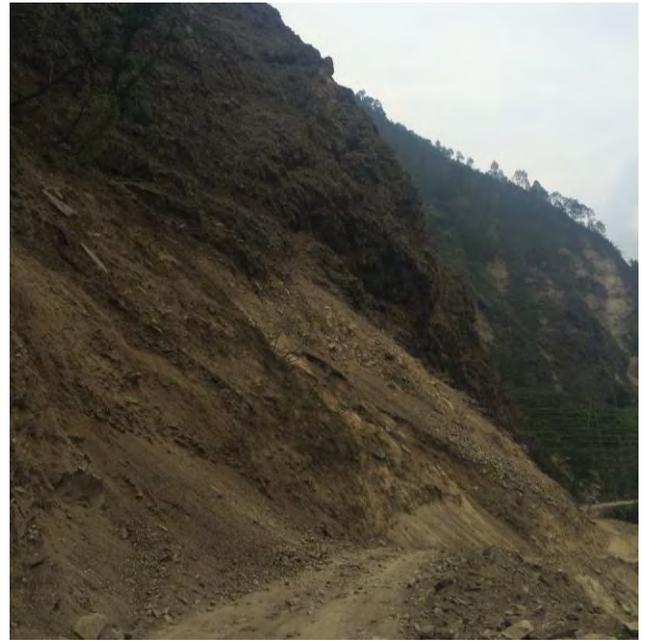
Figure 3-14. Examples of typical landslide debris blocking roads (a) along highway northeast from Singati Township along true right (the right-hand side of the river looking downstream) of Tama Koshi River and (b) along Charikot - Lamabagar Road (photos: Jan Kupec).

Landslides in the form of debris avalanches and mass movement were also noted on numerous occasions (Figure 3-14). Those were more pronounced in the northern Dolakha District and especially prevalent to the north of Singati Township in the Bhimeshwar Municipality along the Tama Koshi River towards the Chinese border.

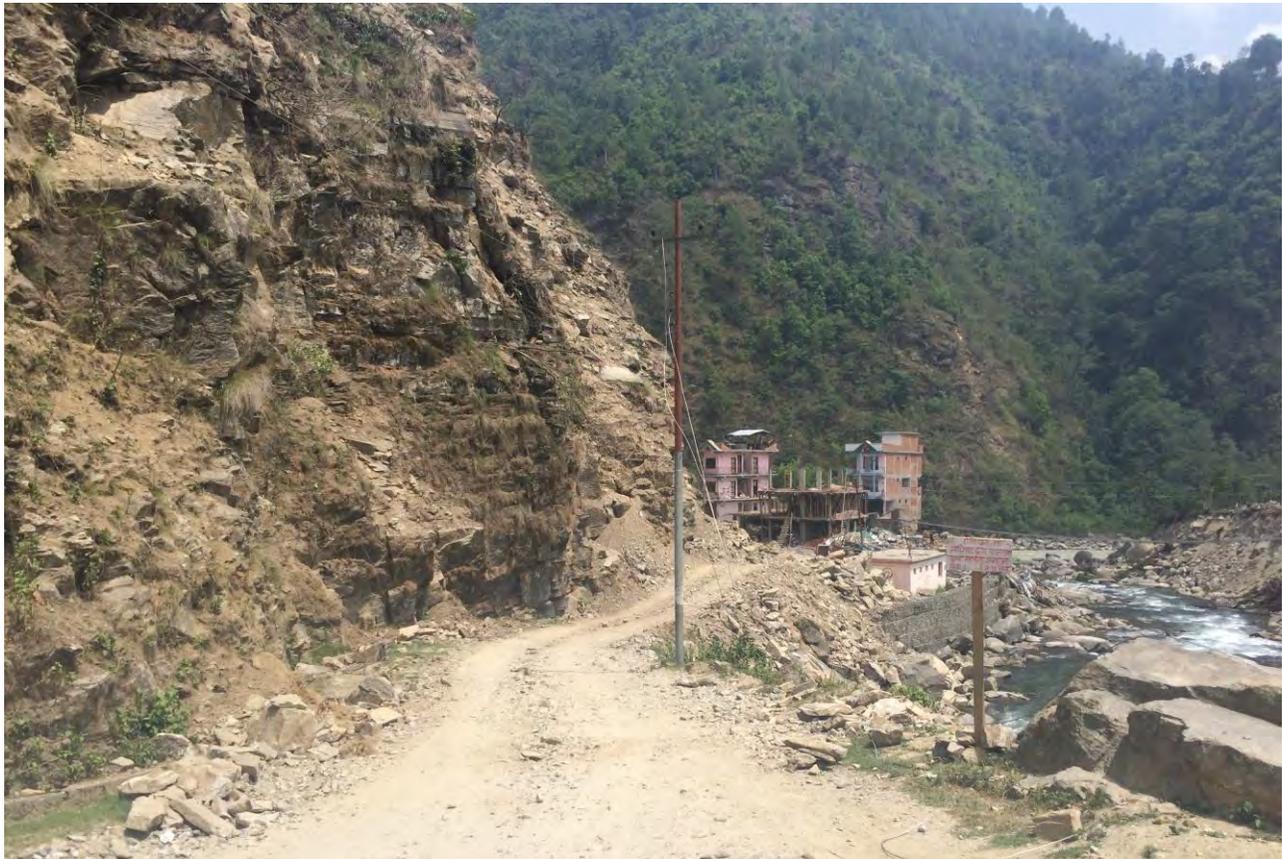
Figure 3-15. Singati Township landslide (photo: Jan Kupec).

The Singati Township was affected by a landslide in the form of a debris slide (Figures 3-15 and 3-16). Material detached from a very steep and up to 75 m high slope and inundated properties and the main road at the base of the slope. Fatalities were reported in Singati, but the actual number is unknown.

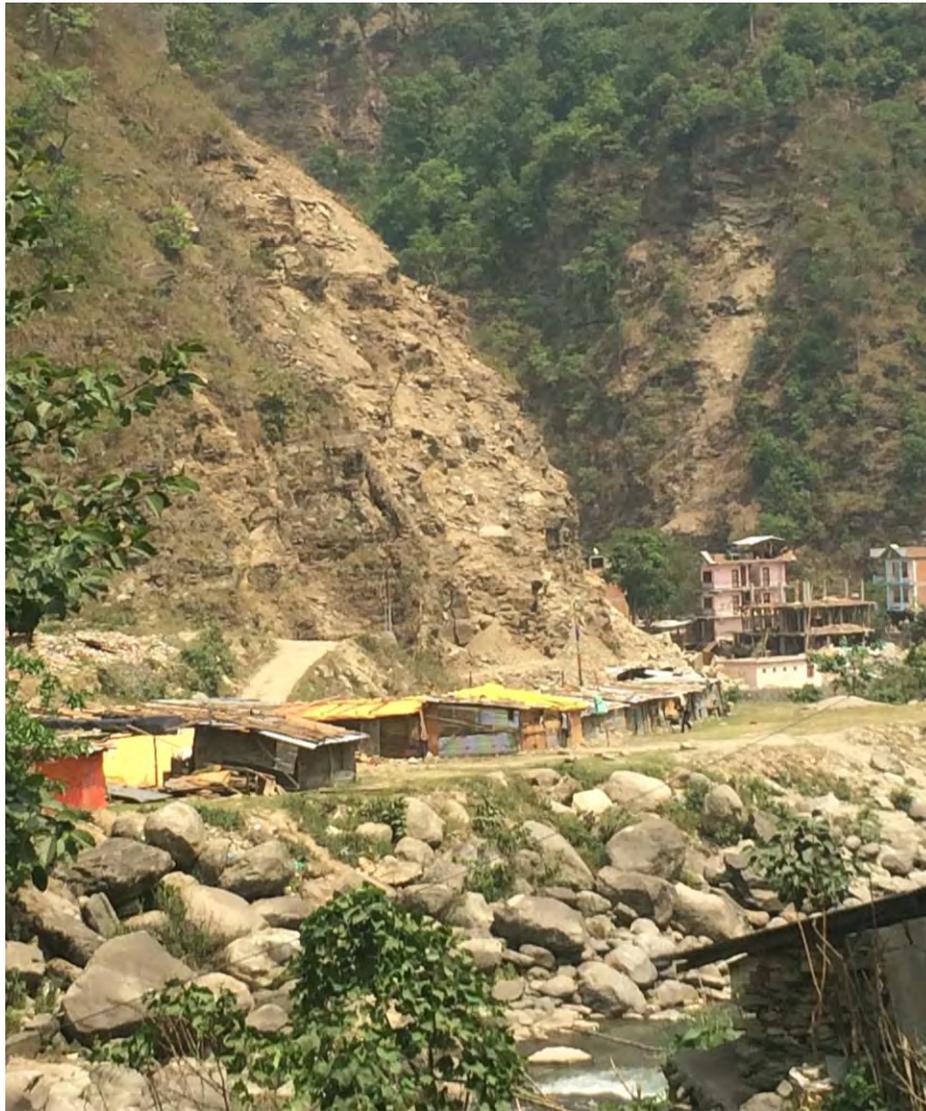
Figure 3-16. Singati Township landslide (photo: Jan Kupec).

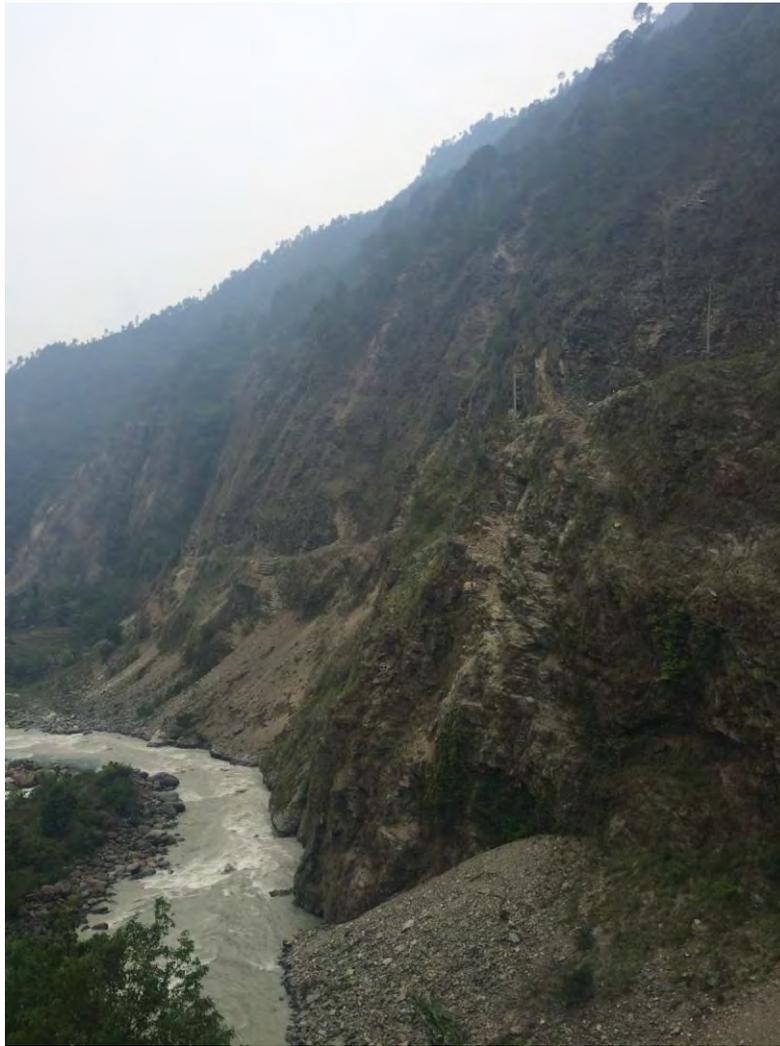
Figure 3-17. River cutting through landslide debris (photo: Jan Kupec).

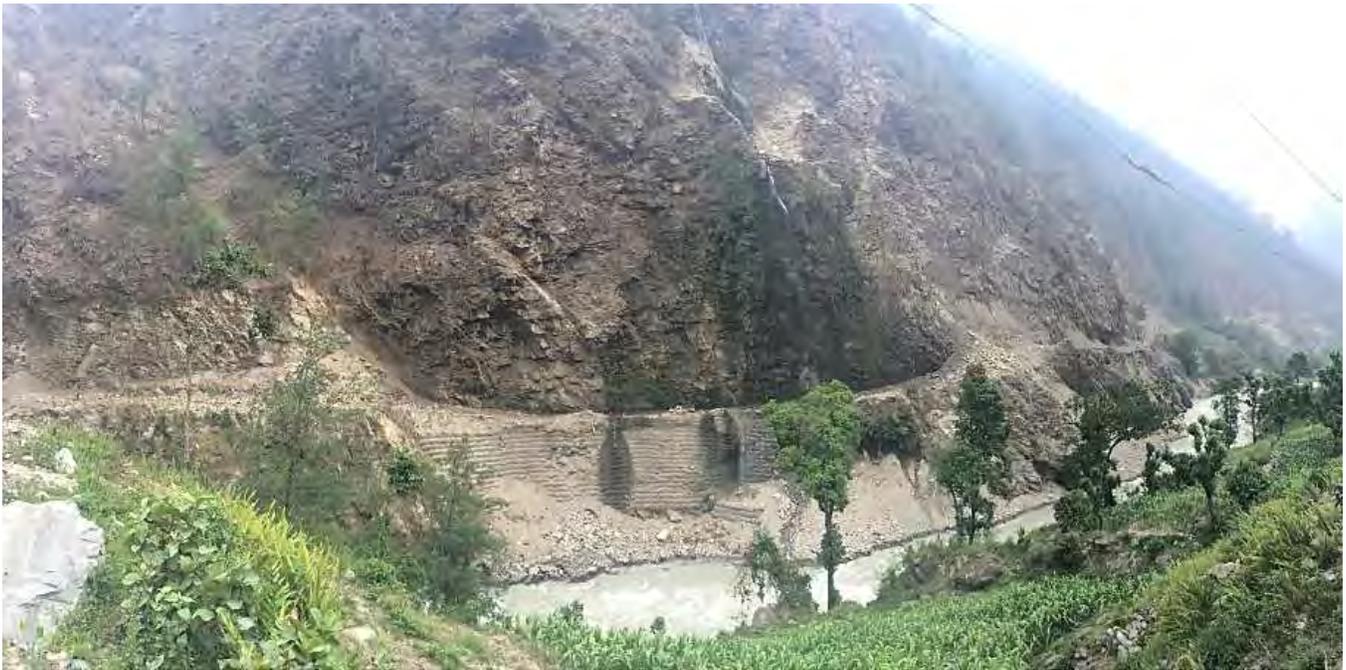
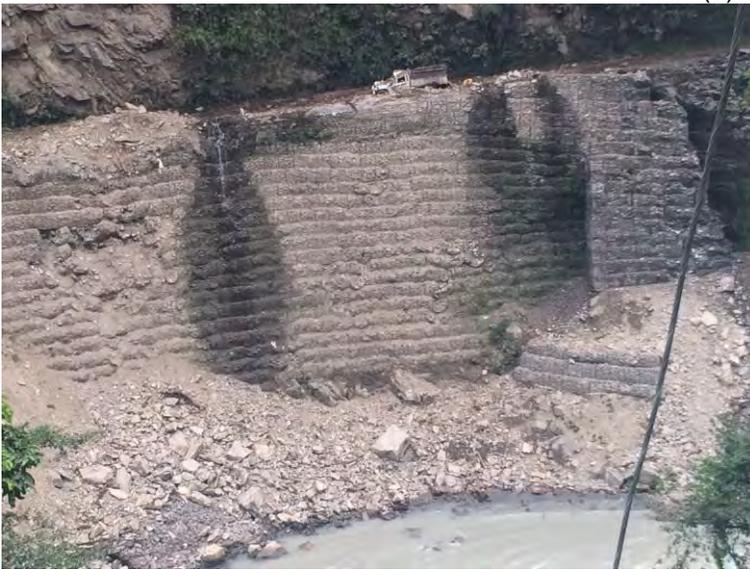
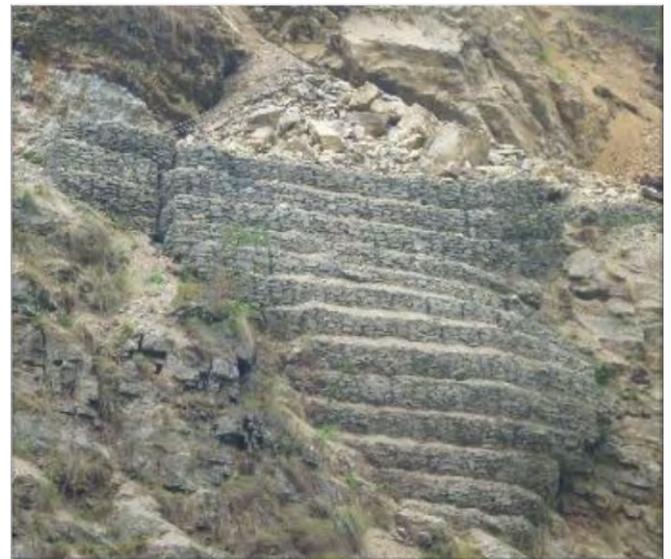
Figure 3-18. Landslide debris covering road above Tama Koshi River upstream of Singati (photos: Jan Kupec): (a & b) expanded and close-up views of damaged truck on road due to rock fall and land slippage, and (c) view of rock fall over road supported by a gabion wall that has overloaded it and caused the bottom to bulge.

Landslide debris affected (buried) more than 15% of the first 5 km of the Charikot to Lamabagar Road Highway to the north of Singati on true-river right as shown in Figures 3-18a and 3-18b. Further exploration by the EERI team was not possible as the road became impassable. Observations from true-river left some further 3 km upstream indicated that the landslide density remained constant. Anecdotal evidence suggested that the majority of the landslide debris was deposited in a strong aftershock rather than the main earthquake event. Interestingly, while the team was on site, individual rock falls were ongoing with numerous boulders originating high up in the unstable slopes and travelling at great velocity into the river. Villagers interviewed mentioned that the frequency of rock fall significantly increases after a significant aftershock.

Landslide debris also affected road infrastructure including drains, culverts, and especially retaining walls. Rock filled gabion retaining walls are prevalent in Nepal, presumably due to their ease of transportation and construction in steep terrain and ability to use locally available rock fill. Many retaining walls were impacted (directly hit) by large boulders causing significant damage, or in landslide areas the walls retained a large volume of debris which overloaded them. Bulging and severe displacement were apparent causing structural distress (Figure 3-18c). Even removal of landslide debris, where observed to the south of Singati, often resulted in partial collapse of the wall or significant damage, which affected its functionality.

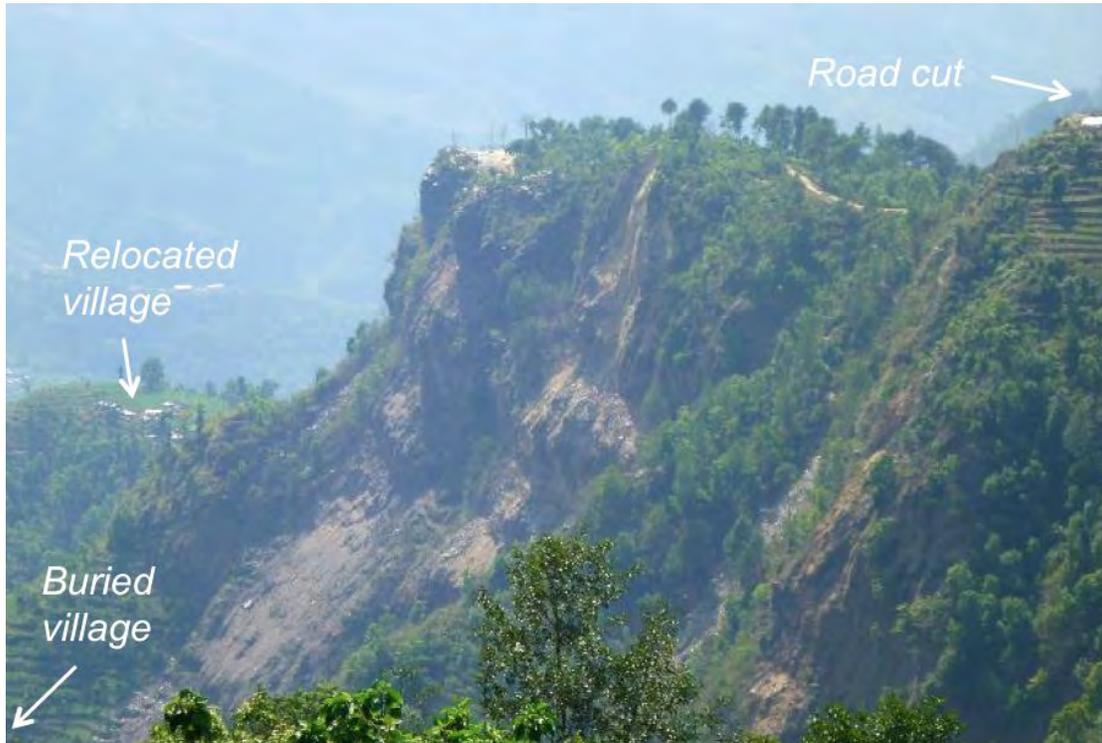
Figure 3-19. View of landslide from across the valley on the Chautara side about 4.5 km northwest from Chautara township center (photo: Jan Kupec, annotations: Bret Lizundia).

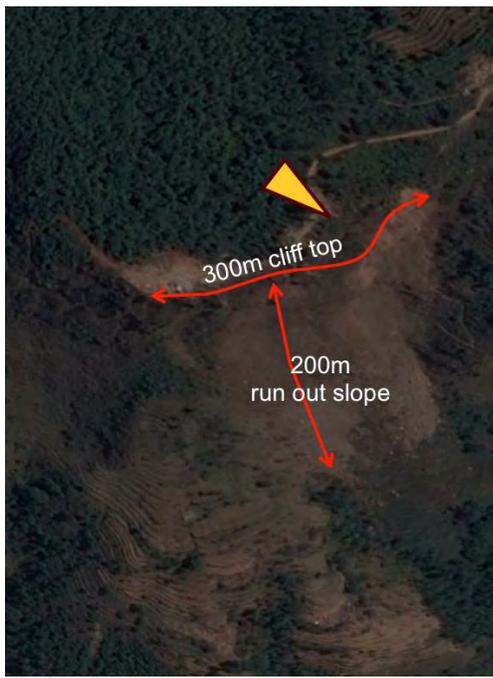
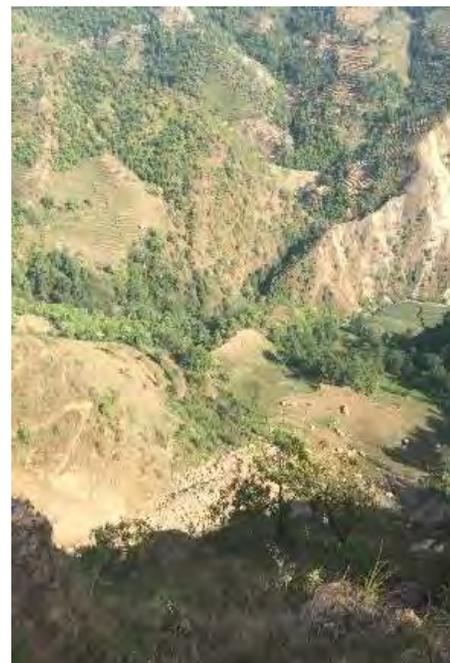
Figure 3-20. (a) Birdseye view of Herlang Berlang cliff collapse (source: Google Earth Pro with annotations by Jan Kupec), and (b) view from cliff top with photo location and orientation indicated by triangular mark on image a (photo: Jan Kupec).

The observed main failure mode was the retreat of a near vertical escarpment or cliff edge. The cliff top edge failed along approximately 300 m of length, and the rocks travelled as a debris avalanche some 200 to 250 m downslope, although individual large boulders travelled as far as 300 m (Figure 3-20). Historic (paleo) landslide debris was observed amongst

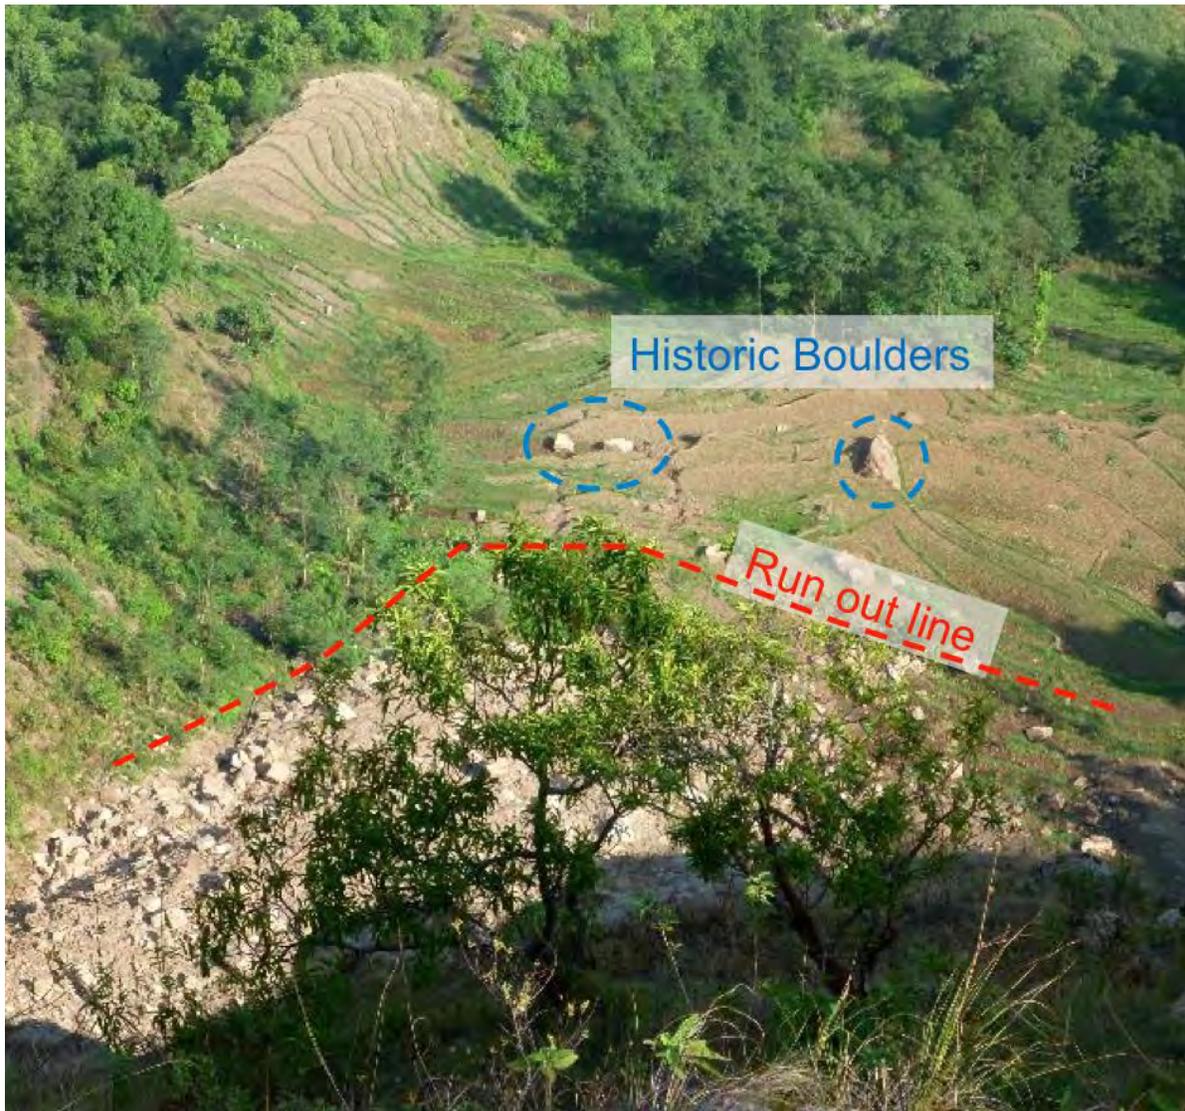
Figure 3-21. Debris avalanche and historic (paleo) downslope talus (photo and annotations: Jan Kupec).

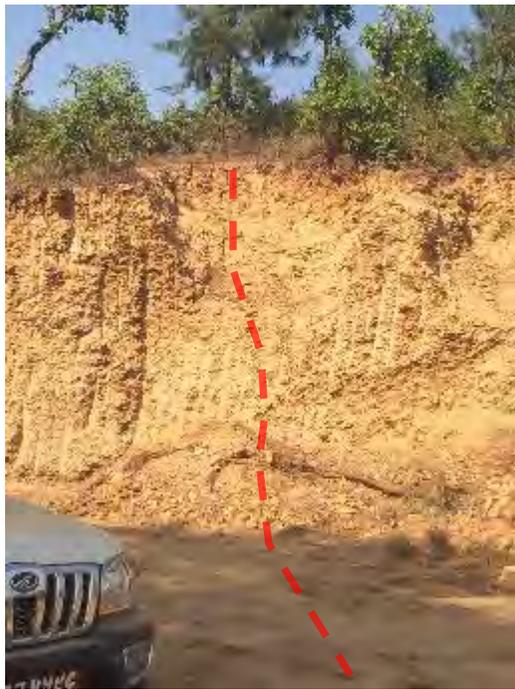
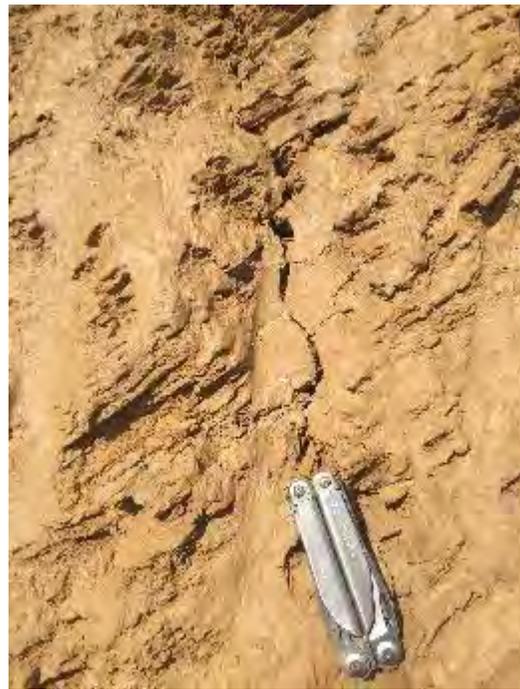
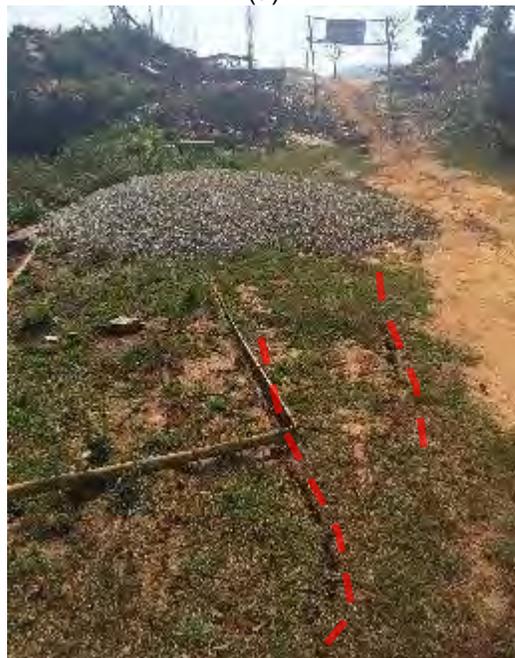
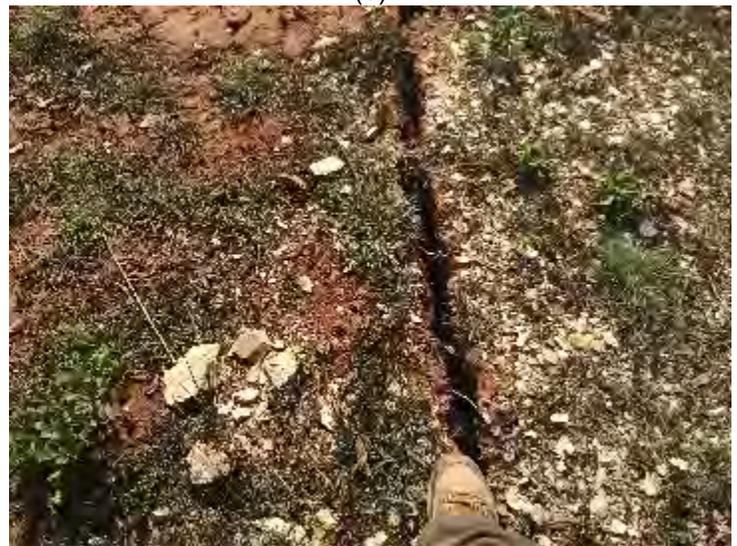
At the top of the cliff, there was significant cracking with crack widths in excess of 75 to 100 mm, some 10 to 15 m setback from the cliff edge, indicating that the rock mass was greatly disturbed by seismic shaking (Figure 3-22). The cracking exhibited both horizontal movement as well as some vertical deformations. Vertical deformations were most notable within the first 10 m from the cliff edge and included up to 75 mm of settlement. Fine cracking (smaller than 5 mm) was noted up to 30 m distant from the edge. A road cut near the northeastern edge of the landslide showed that cracking continued vertically into the rock mass. A crack (5 to 10 mm in wide) was traced through the entire 5 m high road cut and then continued for another 100 m as a semi-continuous crack along the cliff top, some 15 to 20 m away from the cliff edge. The crack pattern is indicative of rock mass damage due to severe shaking.

Figure 3-22. Expanded and close-up views of (a & b) typical cliff edge cracking approximately 15m back from the cliff edge and (c & d) typical ground cracking near cliff edge (photos and annotations: Jan Kupec).

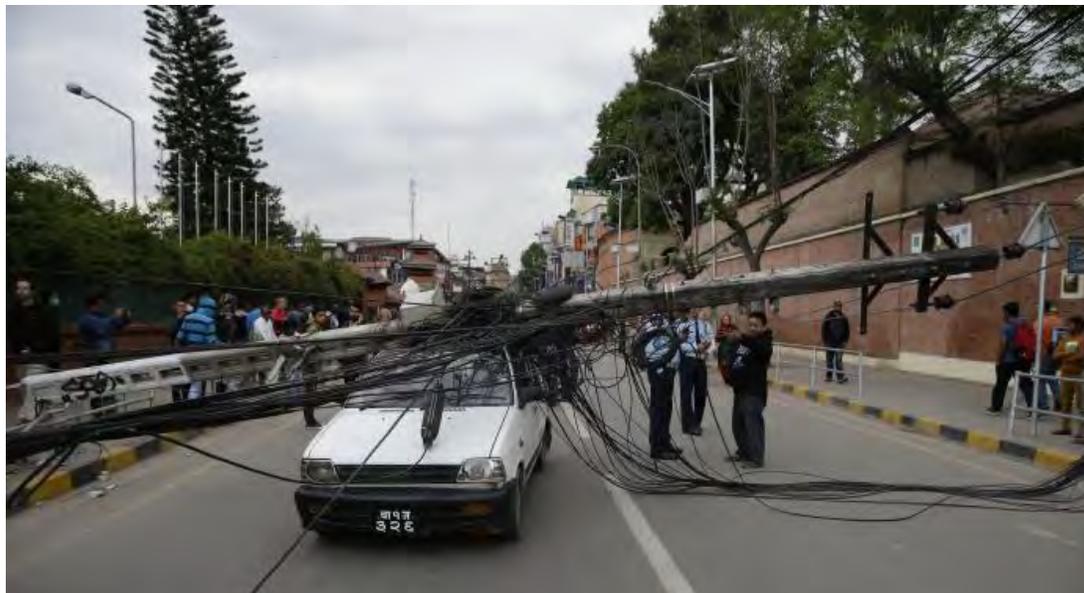
Figure 4-1. Electric pole damage that impacted roadways and vehicles (source: EPA, 2015)
