EERI Earthquake Reconnaissance Team Report: M7.8 Gorkha, Nepal Earthquake on April 25, 2015 and its Aftershocks

May 2016

A product of the EERI Learning From Earthquakes Program

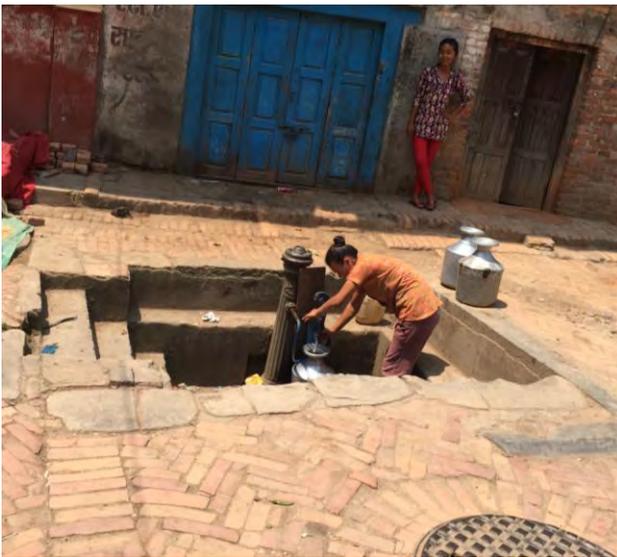
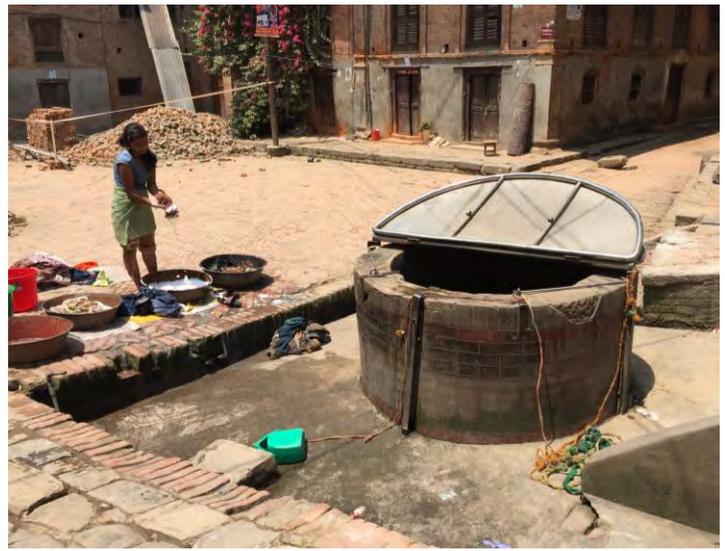
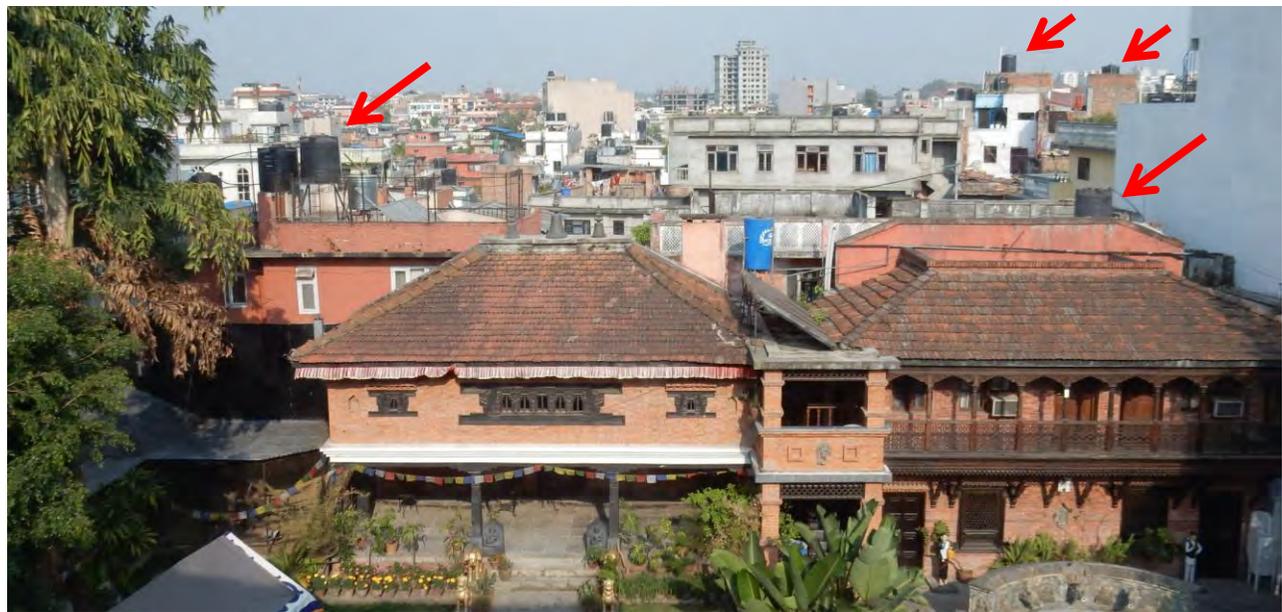
Figure 4-3. Common water sources: (a & b) Community spigots and wells in Bhaktapur, and (c) Rooftop water tanks in Kathmandu (photos: Rachel Davidson)

Kathmandu Upatyaka Khanepani Limited (KUKL) operates and maintains the water supply and sewerage systems in most of Kathmandu Valley. There are 2.7 million people and 200,000 connections in its service area (Bhandari, 2015). The system is comprised of eight subsystems (Figure 4-2), each with a different source and treatment plant. The system also includes 70 tube wells that provide about 30% of KUKL's water. There are 300 km of transmission main and 1300 km of distribution mains, mostly cast iron, ductile iron, and galvanized iron (for distribution), with some newer lines of PVC and HDPE (KUKL, 2015a). Not all homes have private water connections; many use communal wells or taps (Figure 4-3a and 4-3b), especially in more rural areas.

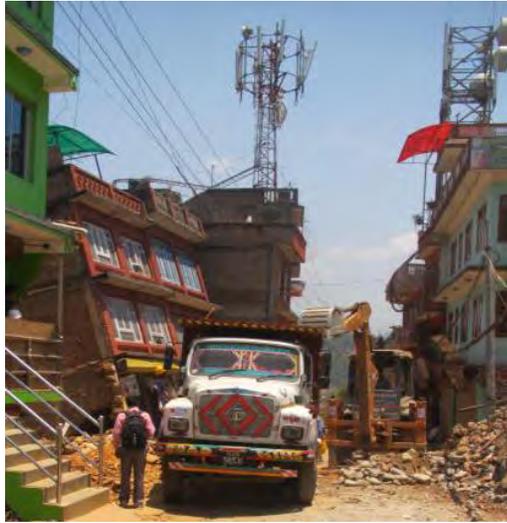
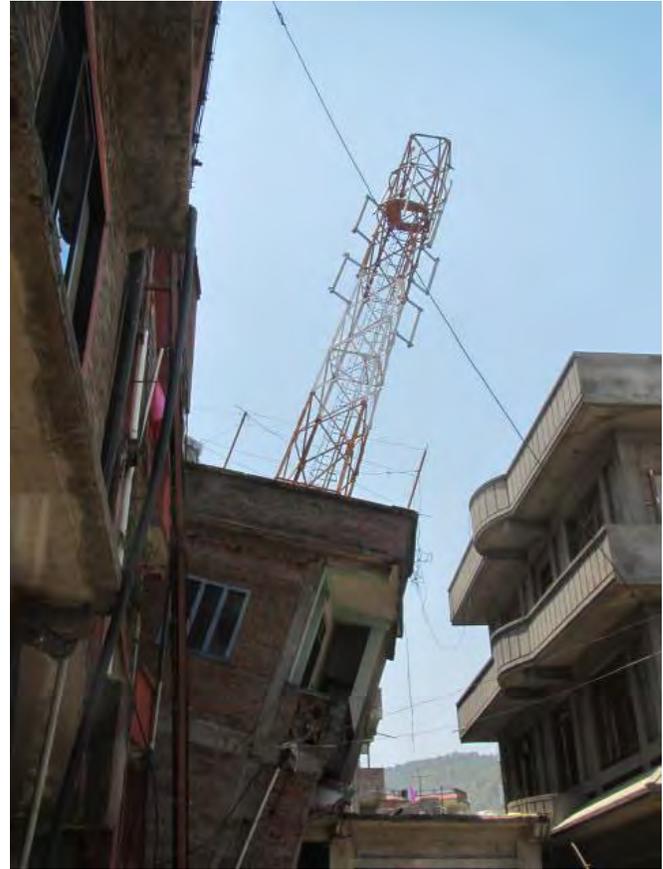
Figure 4-5. (a) Typical installation of mobile towers on building roofs in Chautara (photo: Chris Poland), (b) Number of mobile towers down vs. days post-earthquake (adapted from: NTA 2015c), (c) Mobile tower anchored to roof of a building that was severely tilted in Chautara (photo: Chris Poland).

In the earthquake, approximately 250 (20%) of the 1,240 mobile towers in the eleven most affected districts were down, and that number was reduced to 100 after two weeks by which time about 90% of service was restored (Figure 4-5b). Many overhead optical fiber lines were down, as well as some microwave links. The international link to India remained in service. Many mobile towers had several hours of battery backup to address normal load shedding in the electric system (some had generators as well), but they lost service when the batteries ran out. The internet was down in the Kathmandu Valley for about 24 hours because of power outages, but it was able to serve as an important part of the response. Operators had some spare parts and imported additional ones, which happened quickly. There were some delays getting access to remote damage locations. In all, the telecommunications sector loss is estimated at NPR 8.7 billion (NPC, 2015).

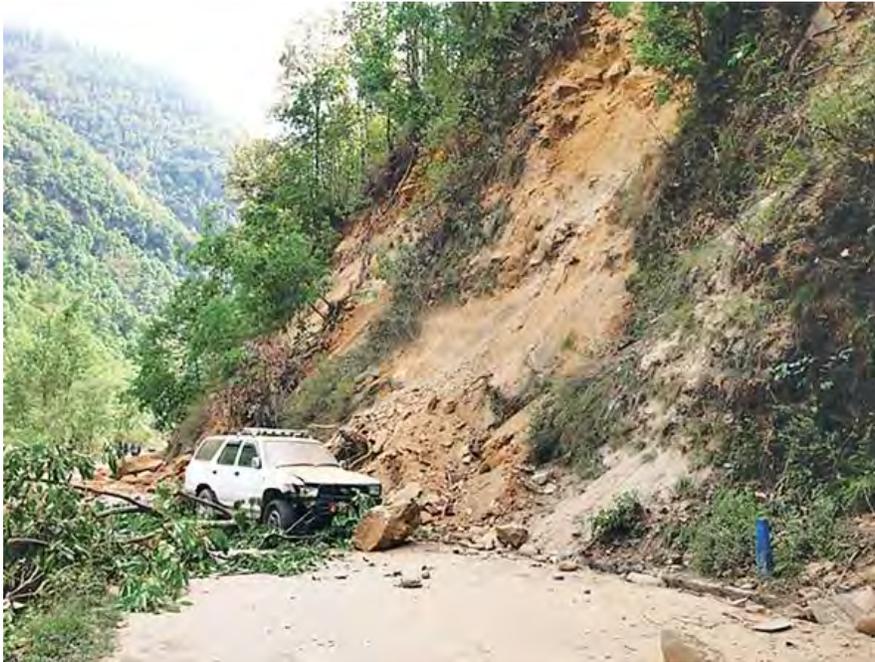
Figure 4-6. Araniko highway in Sindhupalchowk District obstructed by landslide (Source: Paudel, 2015)

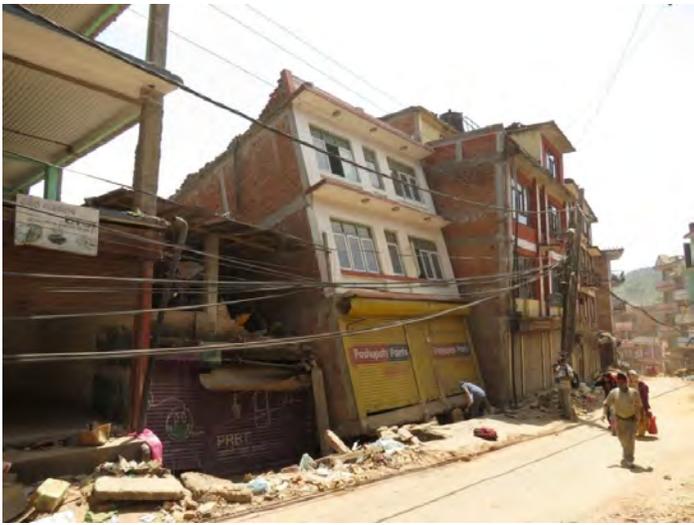
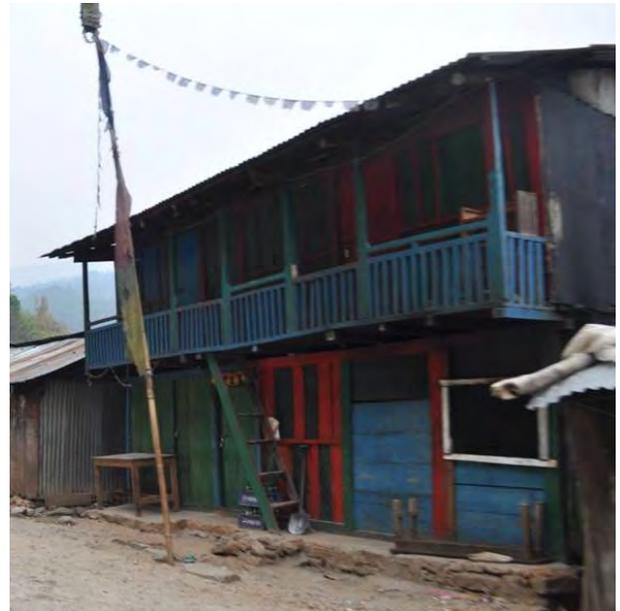
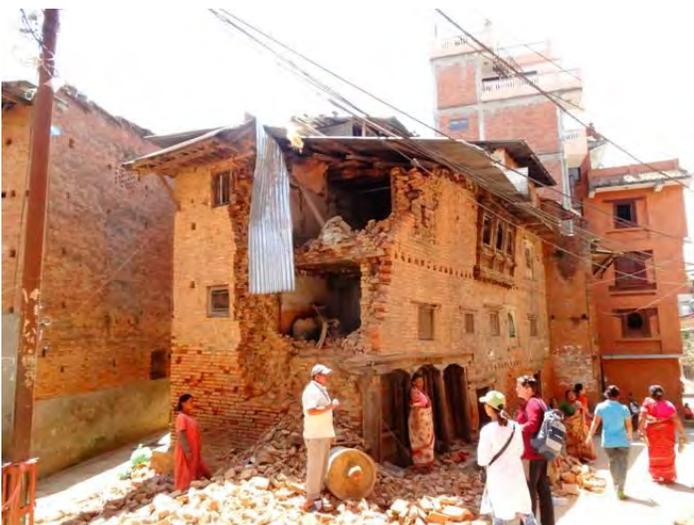
Figure 5-1. Common building typologies in Nepal: (a) masonry infilled RC frame buildings (photo: Hemant Kaushik), (b) URM bearing wall buildings (photo: Bret Lizundia), and (c) wood frame buildings (photo: John Bevington).

The most common building typologies in Nepal are reinforced concrete (RC) frame buildings with masonry infill walls, unreinforced masonry (URM) bearing wall buildings, and wood frame buildings (Figure 5-1). The RC frames with masonry infills are commonly constructed in urban and semi-urban areas. Most of these buildings are three to five stories high, and most privately owned buildings are non-engineered. High rise buildings (up to 17 stories high) are also found in Kathmandu, but their number is limited. Burnt clay bricks are widely used as masonry infill walls; external walls are generally one full brick thick (~ 230 mm), and internal walls are one half brick thick. URM bearing wall buildings are an obvious choice for the population in rural areas and the outskirts of cities, primarily to limit the material expenses. Such buildings are generally two to four stories high and constructed using burnt clay brick masonry or stone masonry with cement, lime, or mud mortar. In some of the older constructions, a different mortar known as *Vajra* (a mix of lime and brick dust) is also observed. These buildings have either wooden or reinforced concrete flooring. A hybrid type of construction also prevails in semi-urban and rural areas, where wood frames are used in the ground story front façade, and rest of the house is made of unreinforced masonry bearing walls. Wood frame houses (generally two to three stories high) are also observed in rural areas where the material for such construction is easily available.

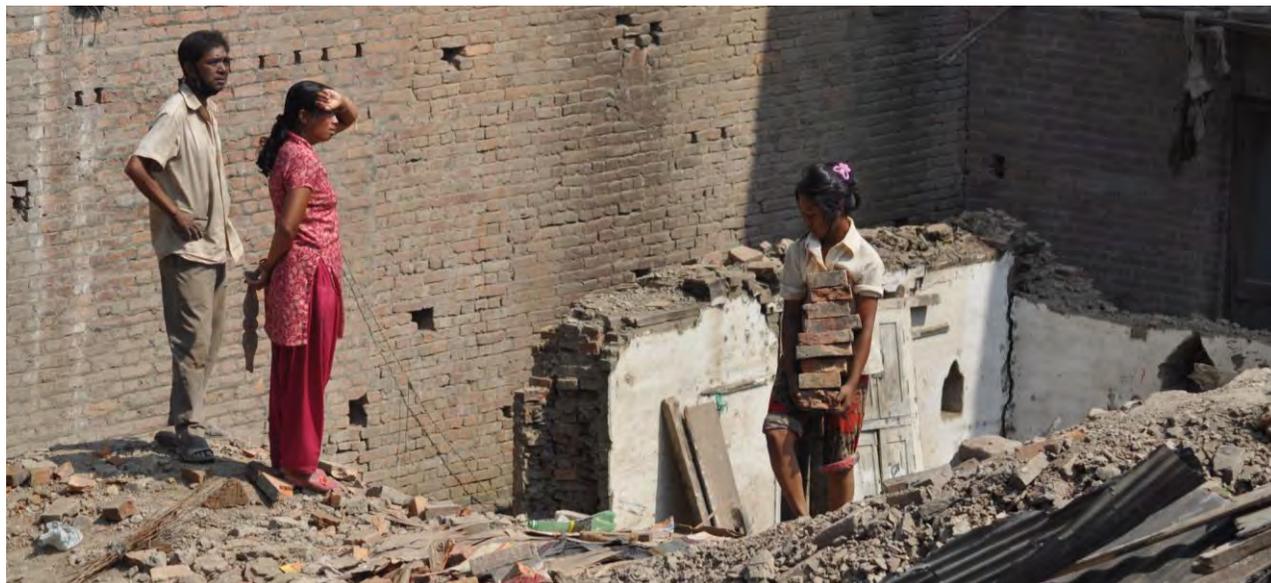
Figure 5-3. Salvaging bricks from damaged and destroyed buildings in Bhaktapur (photo: John Bevington).

any formal supervision, and mostly by salvaging the clay and mud bricks from the damaged buildings (Figure 5-3). Although many of these were officially classed as “temporary” shelters, it is clear that many of these structures will be occupied for a long time and will eventually become part of the permanent built stock. Several news reports published one year after the earthquake have identified a lack of rebuilding since the earthquakes, particularly in the worst-affected rural areas, forcing communities to face a second monsoon in non-engineered, makeshift shelters (BBC, 2016). These reports were backed up by an inter-agency community perception survey in 14 districts, which found that 82 percent of respondents did not believe their main reconstruction needs have been addressed (Inter-agency Common Feedback Project, 2016). Provision of adequate technical supervision alongside financial assistance for affected communities is recommended.

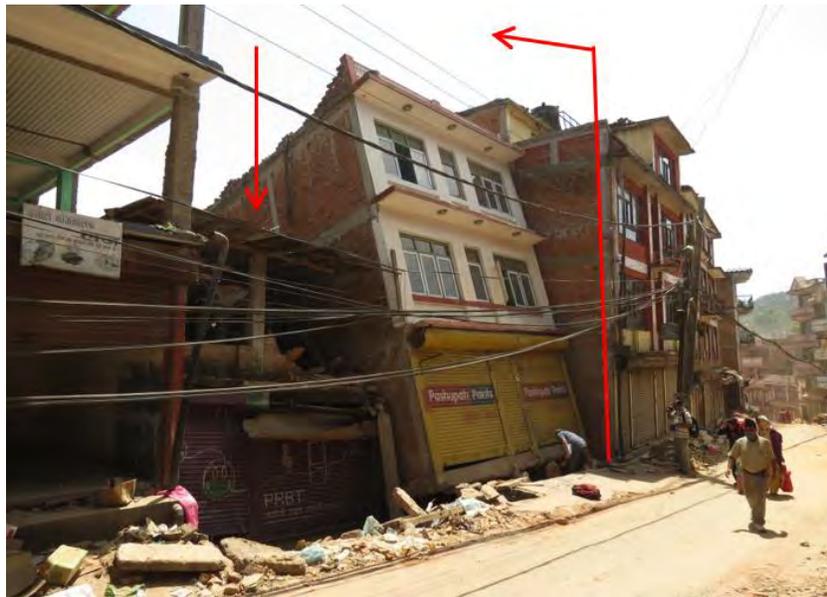
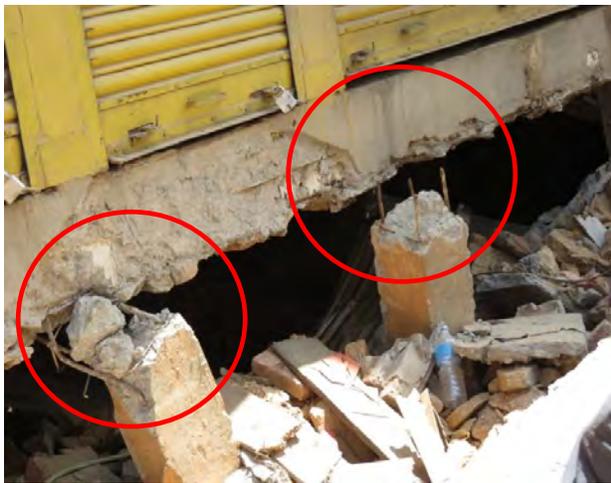
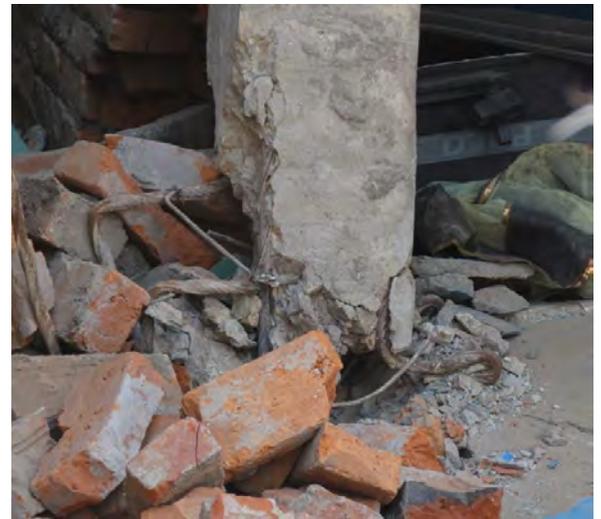
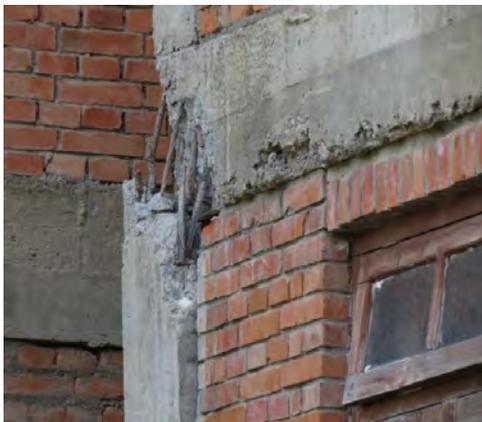
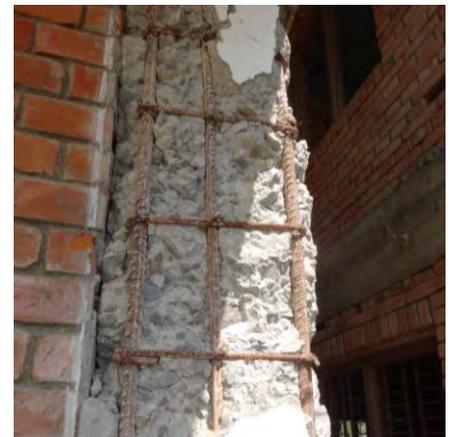
Lack of compliance with available Mandatory Rules of Thumb (MRT) and other codes has led to extremely poor performance of large number of buildings in different regions of Nepal. For example, Figure 5-4 shows several cases of RC buildings damaged severely due to poor reinforcement detailing in RC members. Shear reinforcement provided in critical regions of columns of most of these buildings was in the form of 6 mm diameter bars at a spacing of 200 mm center-to-center with 90° hooks. By contrast, the requirement in the MRT is to provide 8 mm diameter bars in critical regions of columns at a spacing of 75-100 mm center-to-center with 135° hooks.

Figure 5-4. Poor reinforcement detailing led to collapse or severe damage to several RC buildings in Nepal (photos, annotations, and illustrations: Hemant Kaushik, unless noted otherwise): (a & b) Collapse of a three-story building at Chautara due to column failure, (c) buckling of longitudinal bars of columns in a four-story building at Balaju, and a four-story school building at Sankhu with (d) severe damage to beam-column joint, (e) rebar configuration and cross-sectional characteristics of the column observed on site, and (f) damage to column exposing rebar spacing (photo: Bret Lizundia).

Non-seismic reinforcement detailing in RC members was another important reason of poor performance for RC frame buildings. Poor design and detailing in combination with poor configuration resulted in 'pancake' style collapses, failure of beam-column joints, and shear failure of columns near door or window openings due to short column effects (Figure 5-4, 5-8, and 5-9).

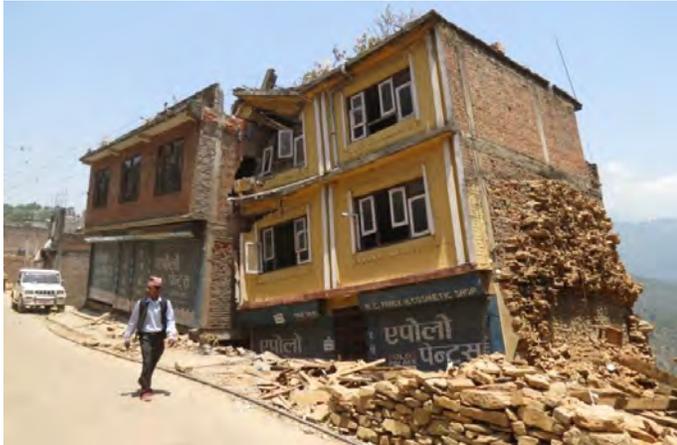
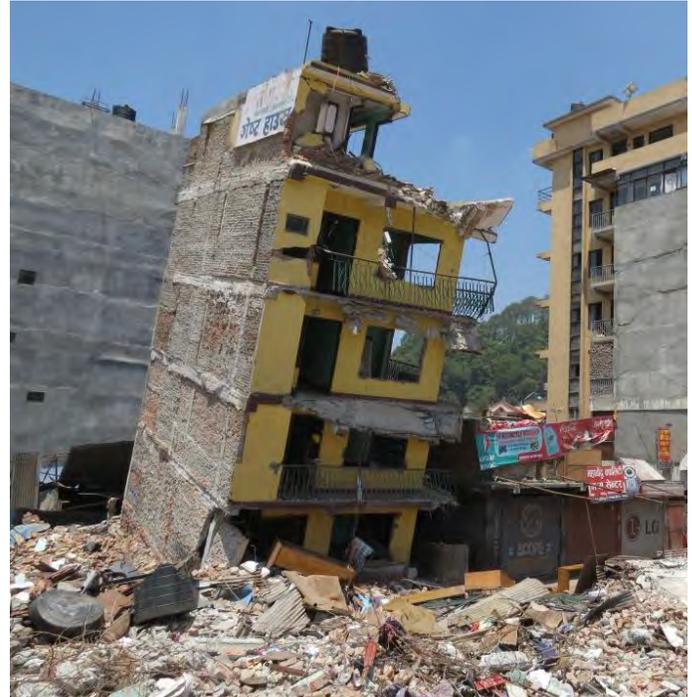
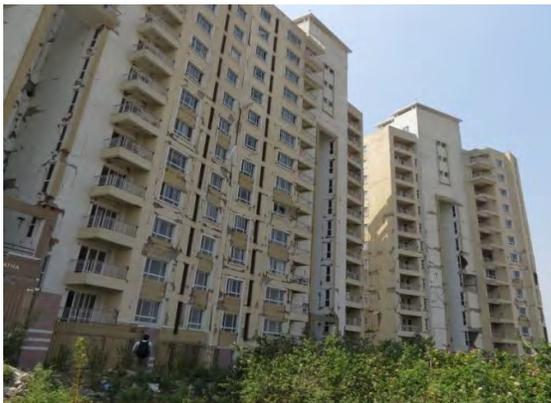
Figure 5-5. Damage sustained by RC frame buildings with masonry infills with different heights: (a) three-story building in Chautara, (b) six-story building in Balaju, and (c) 17-story building in Dhapasi (photos: Hemant Kaushik).

Damage was more prominent in buildings constructed on ridge tops perhaps due to ridge-top shatter amplification of ground motion. Interestingly, masonry infill walls were found to be more or less intact in large number of buildings that had permanent displacement, implying a foundation failure (Figure 5-5a, 5-5b). Generally, a geotechnical investigation for the project site is not carried out in Nepal, except for some important projects, which often results in inappropriate foundations on slopes. A large number of buildings constructed on slopes collapsed or suffered permanent displacement/tilt due to foundation or slope failure (Figure 5-6).

Severe in-plane and out-of-plane damage was observed in masonry infill walls of RC frame buildings constructed on proper foundations (Figure 5-5c). These buildings dissipated a large amount of energy by cracking along both the in-plane and out-of-plane directions (Figure 5-7a). Similarly, severe damage was observed in long infill walls due to diagonal and shear sliding crack at mid-height in a school building at Sankhu (Figure 5-7b). As observed in several past earthquakes, such long walls are also quite susceptible to out-of-plane failure.

RC frame buildings with masonry infill walls are commonly constructed in urban and semi-urban areas throughout Nepal. Most of the new government buildings and a large number of privately constructed new buildings fall into this category as there is a general perception that such buildings are much safer than the URM buildings. However, most privately built buildings are non-engineered and lack basic earthquake resistant features. Depending on functional requirements, low-rise, medium-rise, and high-rise buildings are all constructed as RC frame structures. RC frame buildings of all heights suffered damage ranging from minor to severe, and even to collapse, depending on their location and configuration (Figure 5-5).

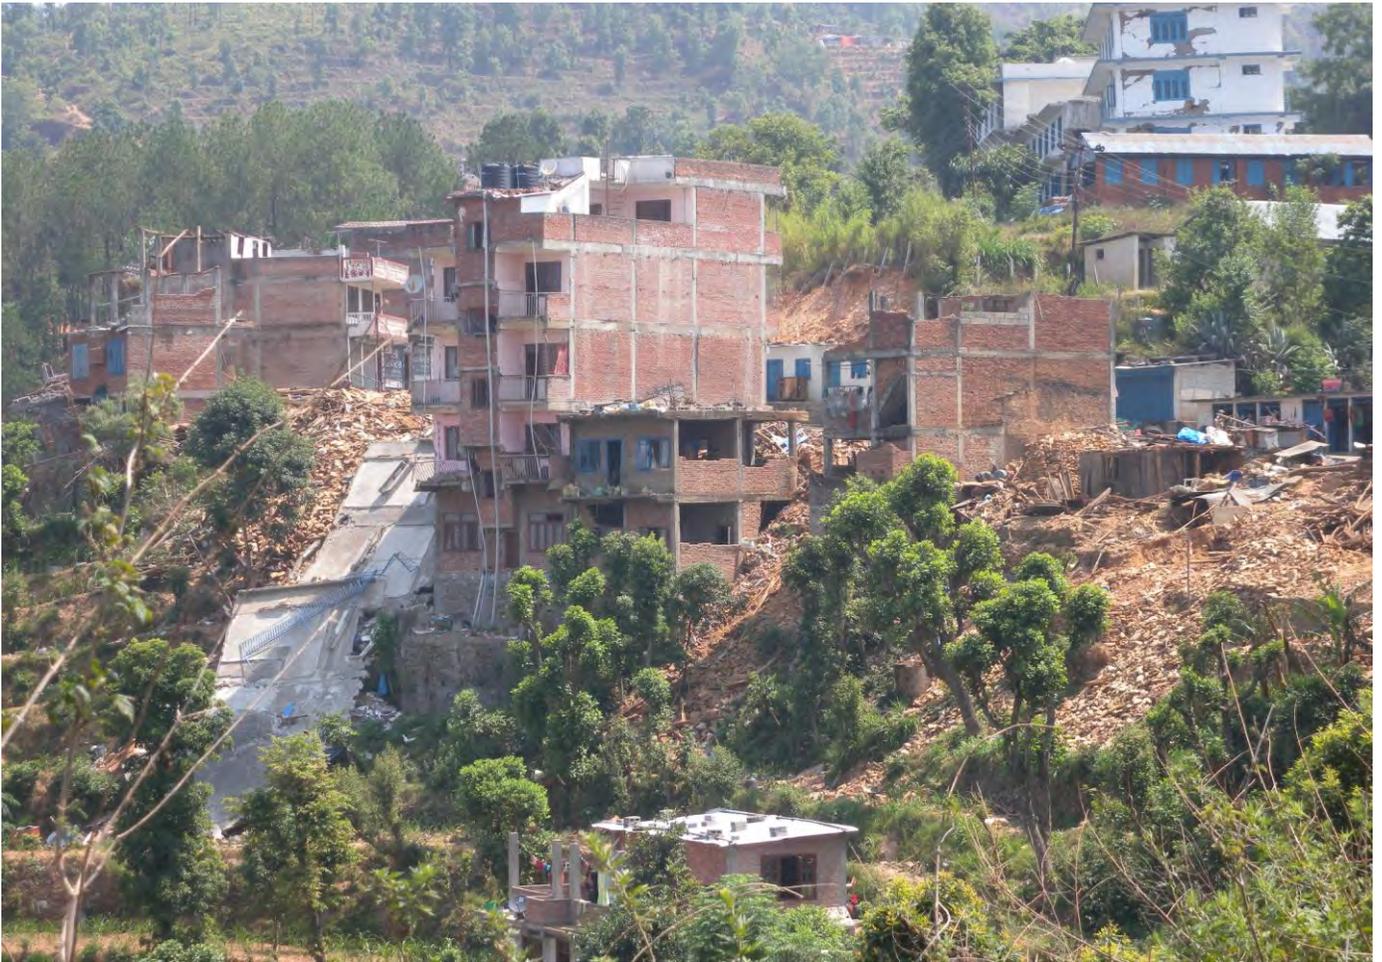
Figure 5-6. Example of common hillside construction on precipitous slopes near Chautara showing use of weak rubble stone infill on the bottom base story of the building in the center of the image. The cause of failure of the collapsed building on the left is not known, but issues such as infill or lack of geotechnical input may have contributed to the failure of this building (photo: John Bevington).

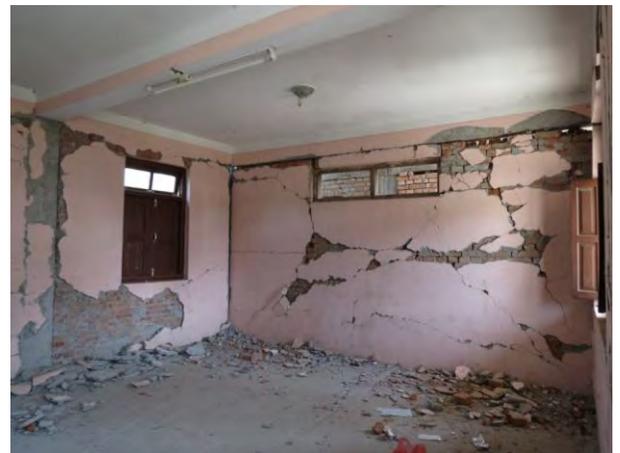
Figure 5-7. (a) Severe damage to infill walls along both in-plane and out-of-plane directions in the high-rise apartment building at Dhapasi, and (b) severe damage to infill walls due to diagonal and shear sliding crack at mid-height of walls in a school building at Sankhu (photos and annotations: Hemant Kaushik).

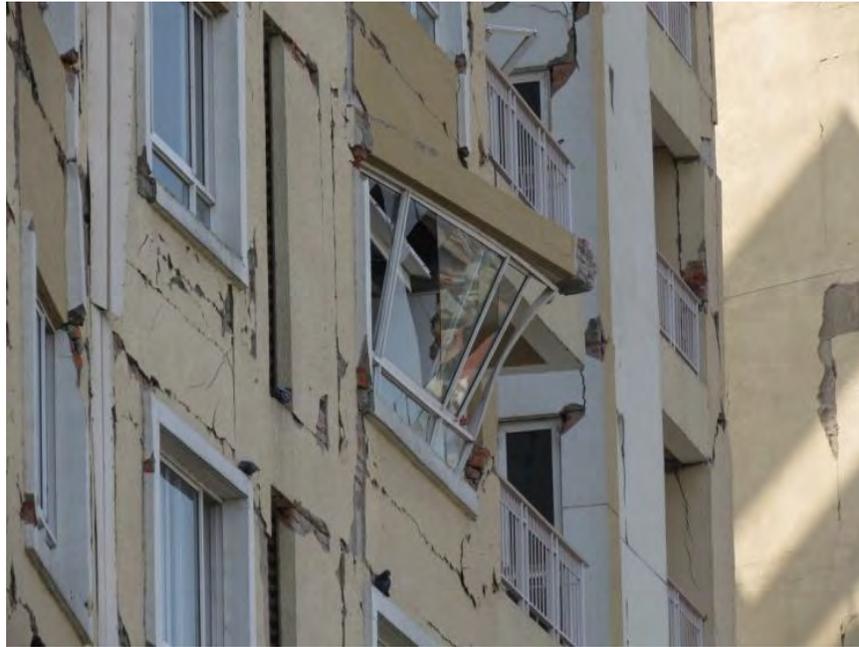
Figure 5-8. Poor seismic design and detailing in combination with poor geometric configuration resulted in severe damage in RC frame buildings with masonry infill walls, including the connection failure shown in the lintel of the 17-story Park View Horizon Apartments in Dhapasi (photo: Hemant Kaushik). Additional types of design and detailing failures are shown in Figure 5-4.

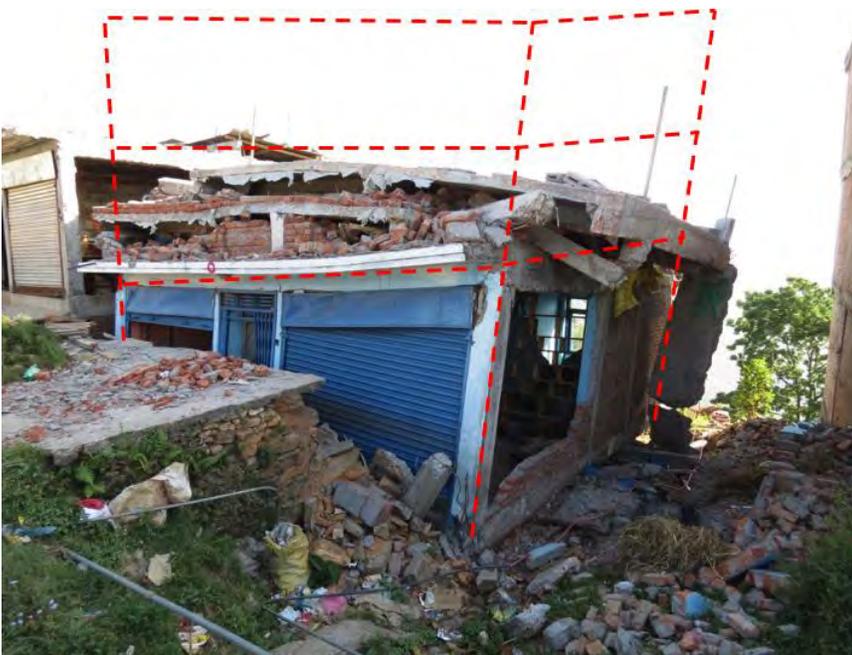
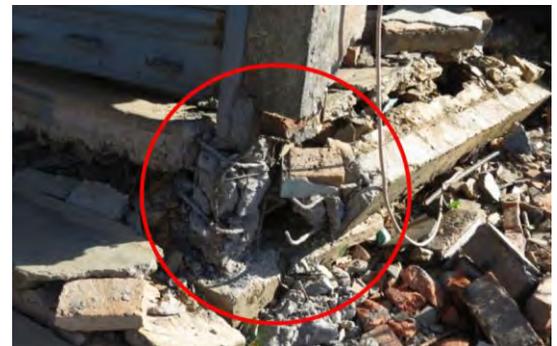
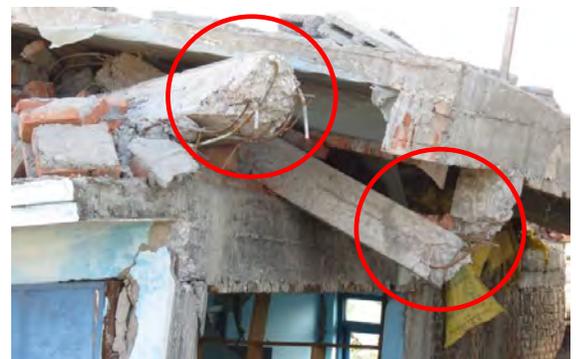
Figure 5-9. Poor seismic design and detailing in combination with poor geometric configuration resulted in severe damage in RC frame buildings with masonry infill walls: (a) collapse of a four-story building at Irkhu, (b), failure of beam-column joints in the same building, (c) rupture of reinforcing bars in first-story columns of the same building (photos and annotations: Hemant Kaushik).

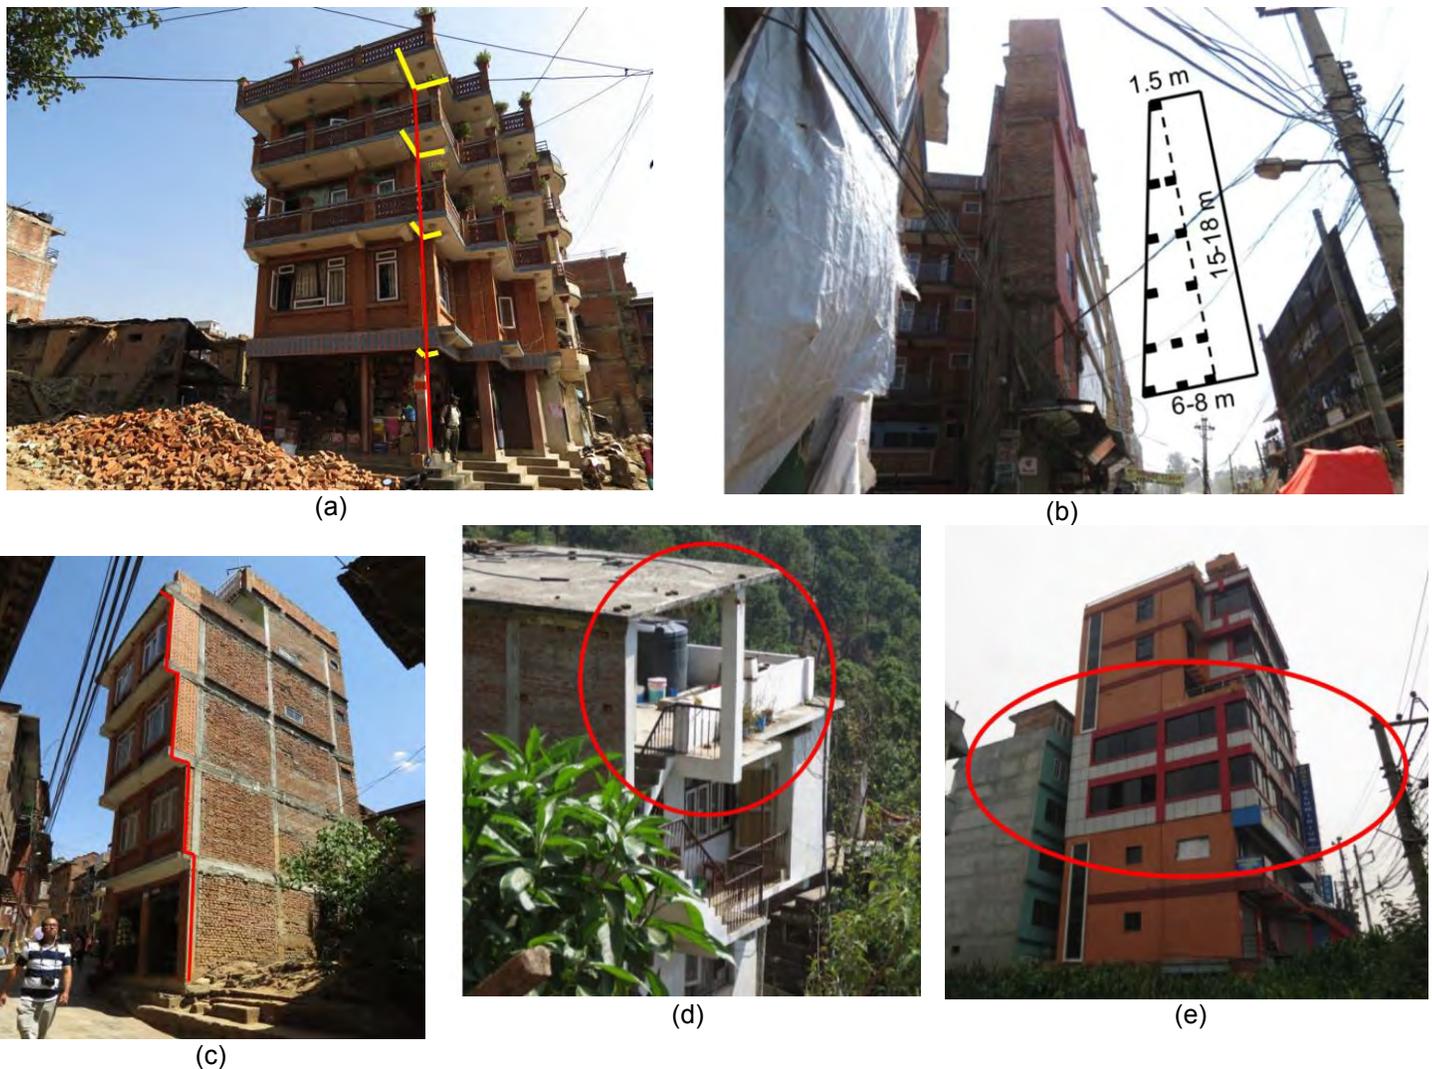
Figure 5-10. Different types of geometric irregularities observed in RC frame buildings with masonry infills: (a) large overhangs in both directions at building in Sankhu, (b) trapezoidal plan building in Balaju, (c) large overhangs in one direction at building in Dhulikhel, (d) floating columns at a building in Chautara, and (e) soft story buildings in Lokanthali (photos and annotations: Hemant Kaushik).

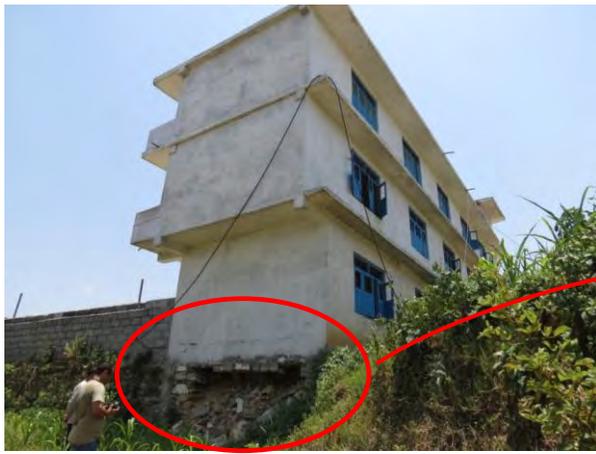
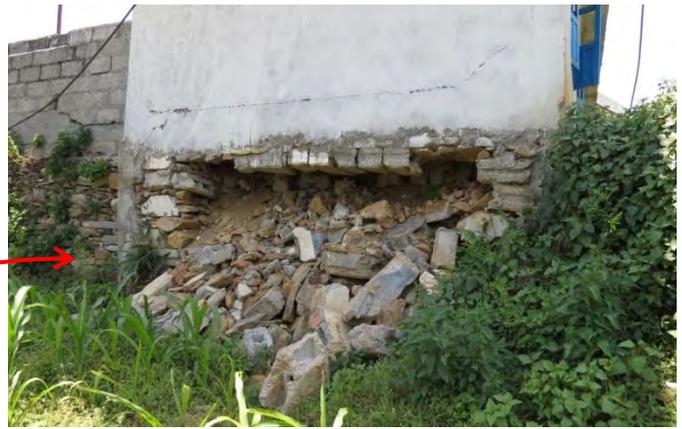
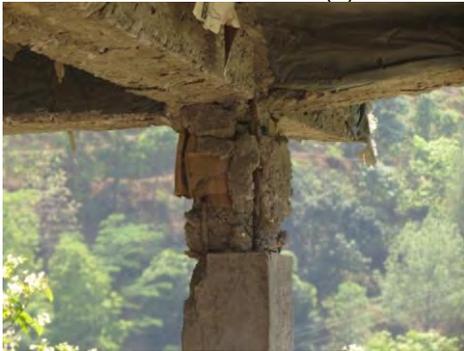
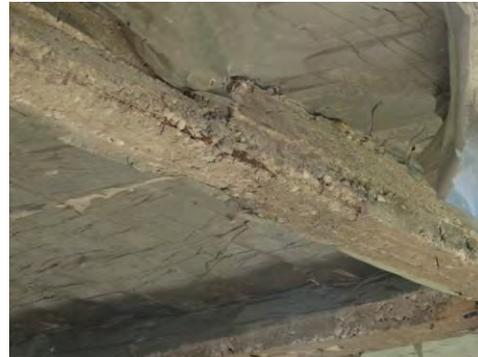
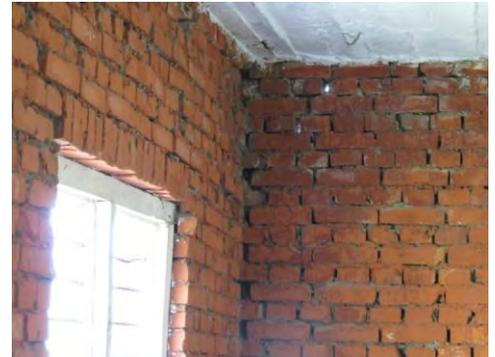
Figure 5-11. Poor quality of construction and workmanship further aggravated the problem: (a & b) poor quality of brickwork below plinth beam in a three-story building at Irkhu, (c) poor concrete quality in RC column and (d) RC beam in a two-story building at Dolalghat, and (e) poor masonry joints with absence of lintels over window opening in a school building at Dolalghat (photos and annotations: Hemant Kaushik).

Poor quality of materials and workmanship are other considerations that reduced capacity and exacerbated damage to RC frame buildings, particularly in non-engineered RC construction. At various locations, it was observed that damage was a result of low-quality, non-engineered construction by laborers with insufficient skill, supervision, or both (Figure 5-11). Unplanned and unsupervised construction practice has also resulted in haphazard construction without sufficient gaps between buildings. Several buildings that were otherwise undamaged by earthquake shaking suffered severe damage due to pounding with adjacent buildings (Figure 5-12).

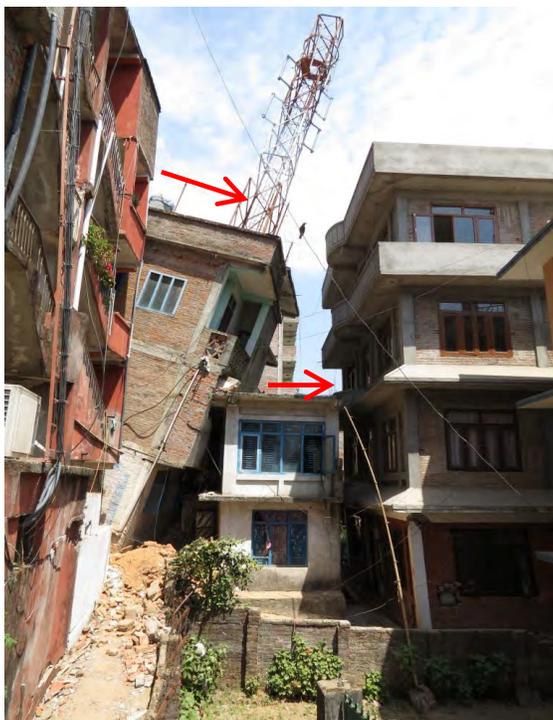
Figure 5-12. Pounding between adjacent buildings damaged buildings, which otherwise performed reasonably well: (a) a two-story house between two tilted buildings at Chautara, and (b) a six-story building suffered severe damage to tilting of an adjacent five-story building at Balaju (photos and annotations: Hemant Kaushik).

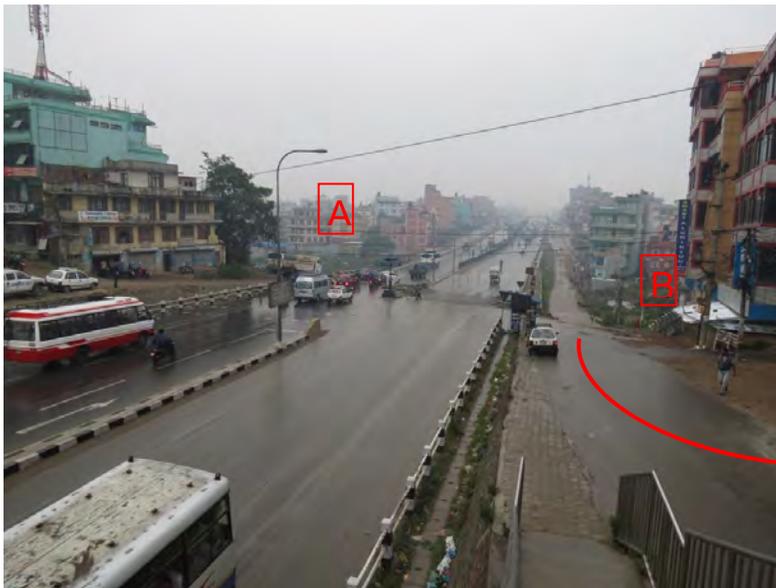
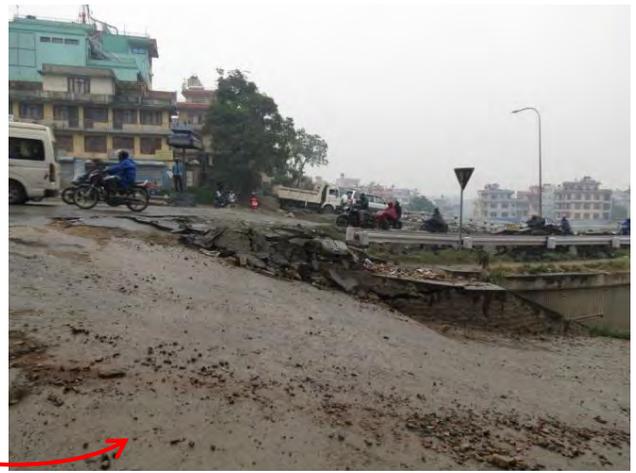
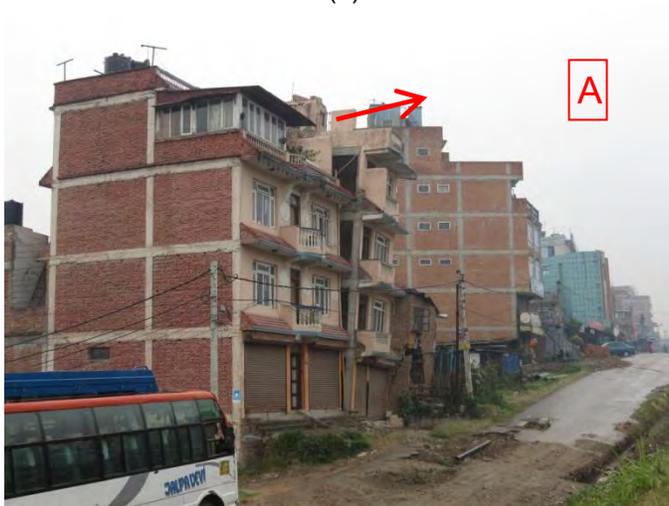
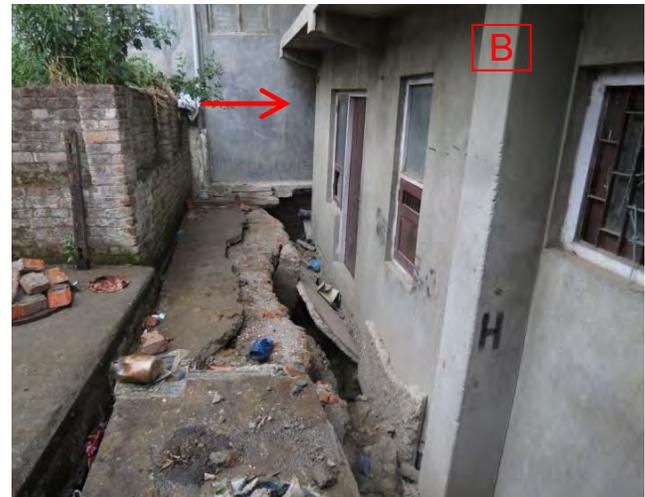
Figure 5-13. Several buildings on both sides of the Araniko Highway at Lokanthali near Kathmandu tilted due to foundation failure because of severe ground cracks and settlement (photos and annotations: Hemant Kaushik).

Severe ground failure and cracking in various areas also resulted in damage and failure of several buildings. For example, severe ground cracking and settlement was observed along the Araniko Highway at Lokanthali near Kathmandu. Several buildings sustained severe damage (mostly tilting of buildings due to foundation failure) on both sides of the highway (Figure 5-13).

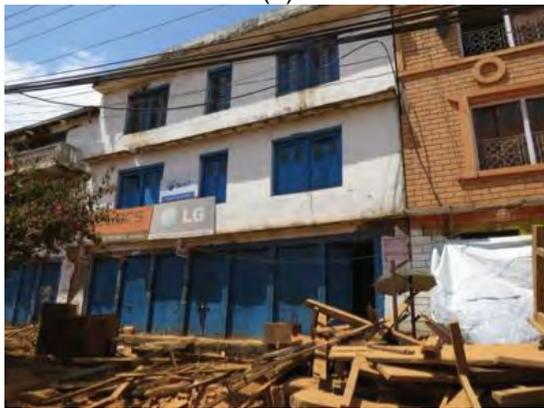
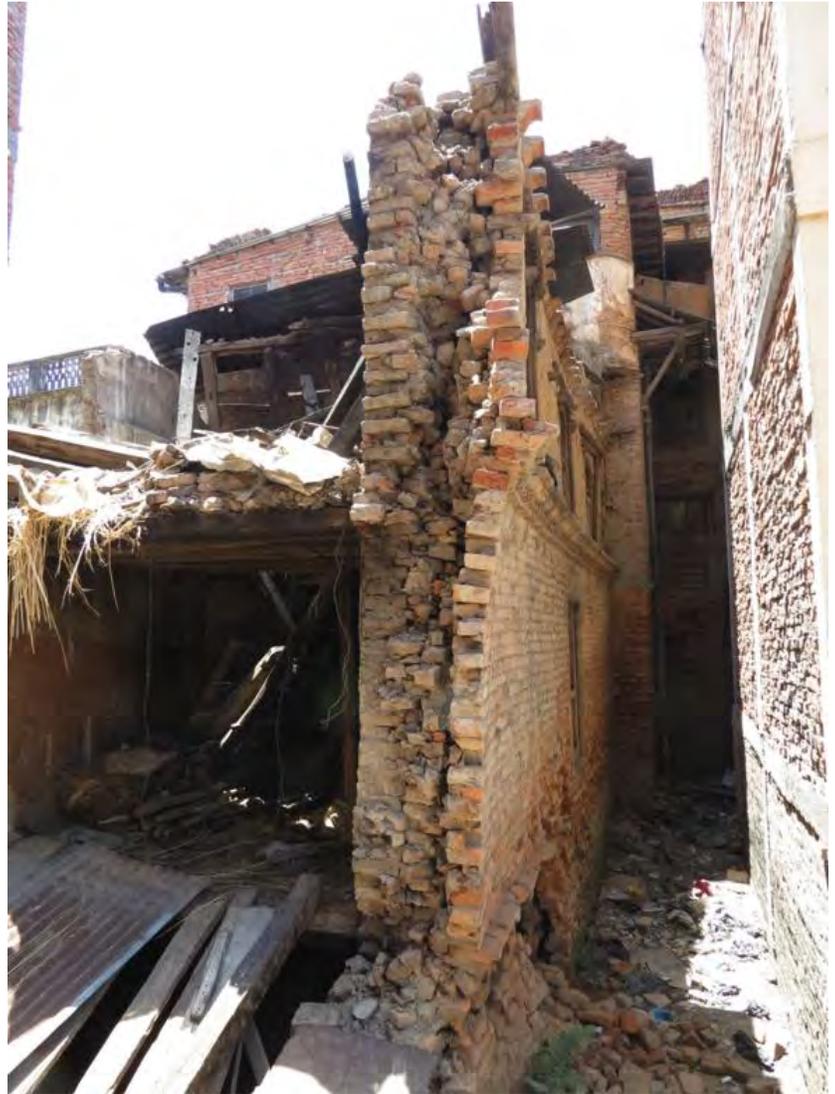
Figure 5-14. (a & b) Typical URM bearing wall buildings in Nepal with wood frame store front in the ground story, and (c) brick wall and floor details in a typical URM bearing wall building at Banepa (photos: Hemant Kaushik).

Walls in URM bearing wall buildings are typically made from brick masonry, stone masonry, or adobe using mud, lime, or cement mortar. Walls typically rest on either a brick or stone foundation. Roofing in these buildings primarily consists of corrugated galvanized iron sheets (CGI) or clay tiles (in valley areas) on wood joists, and the flooring is made by mud filling over wood sheathing supported on wood joists. In most cases, masonry wythes are poorly connected (Figure 5-14c) and the seismic features recommended for URM walls in seismic-prone regions (i.e. corner reinforcement, through stones, corner stones, intermediate bands, etc.) are missing (Bothara, 2011, Blondet et al., 2011). During the Gorkha

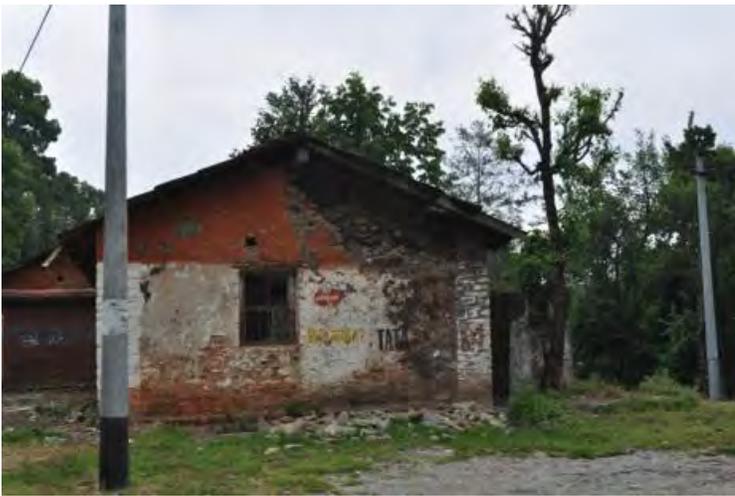
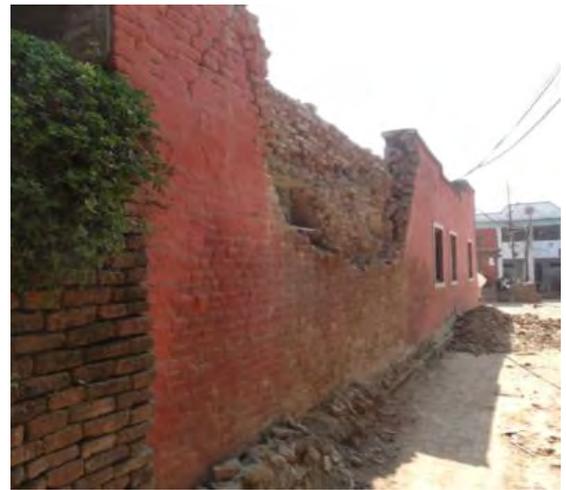
Earthquake, wythe delamination was observed in large number of URM buildings due to poor connection between wythes (Figure 5-15a). Figure 5-15b shows a parapet that collapsed, but in general relatively few parapets or masonry chimneys were observed by the reconnaissance team.

Figure 5-15. (a) Delamination of wythes and partial collapse of exterior brick and mud mortar wall in Sankhu (photo: John Bevington) and (b) collapse of unsupported stone and mud mortar parapet wall in Dolakha (photo: Bret Lizundia).

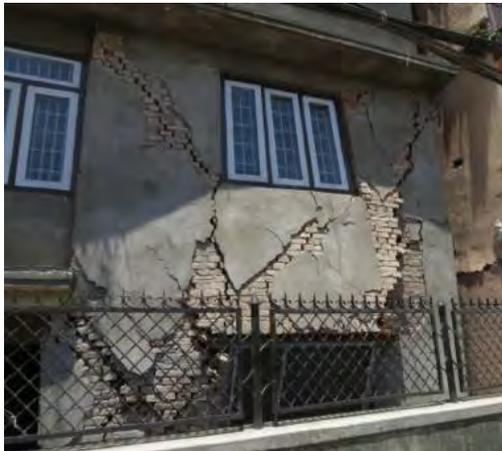
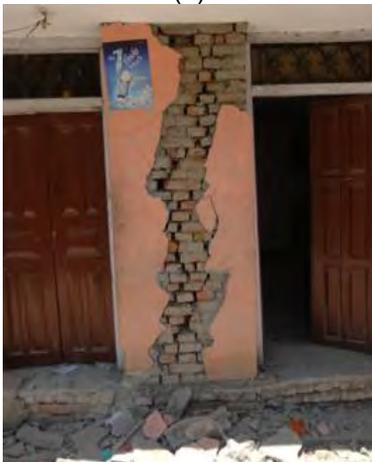
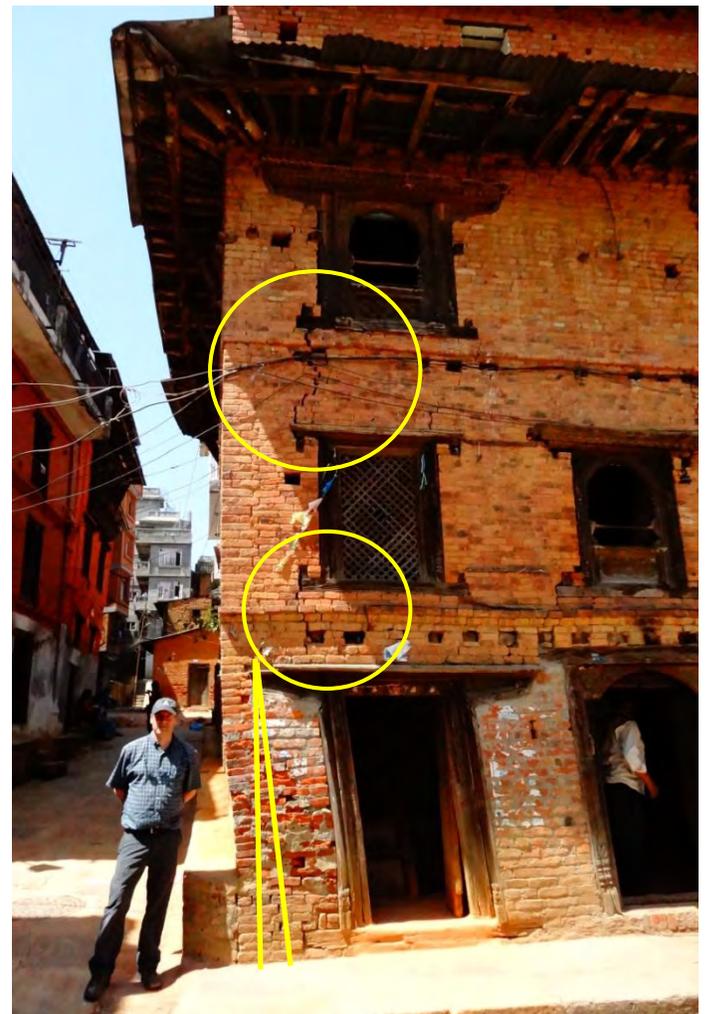
Damage observed in walls of URM buildings can be classified into two types: in-plane wall damage and out-of-plane wall damage. The in-plane wall damage was generally observed in the form of cracks in wall piers near openings as shown in Figure 5-16a and 5-16b. In some cases spandrel cracking and leaning were observed as shown in Figure 5-16c. As already discussed, seismic features (i.e. stone or concrete bands around openings) that are well known to reduce these types of damage in URM walls were not included.

Figure 5-16. (a) In-plane wall damage in Gangabu (photo: Hemant Kaushik), (b) in-plane damage to wall pier in Gangabu (photo: Bret Lizundia), and (c) in-plane spandrel cracking and ground story leaning in Dhulikhel (photo: Hemant Kaushik with annotations by Bret Lizundia).
