EERI Earthquake Reconnaissance Team Report: M7.8 Gorkha, Nepal Earthquake on April 25, 2015 and its Aftershocks

May 2016

A product of the EERI Learning From Earthquakes Program

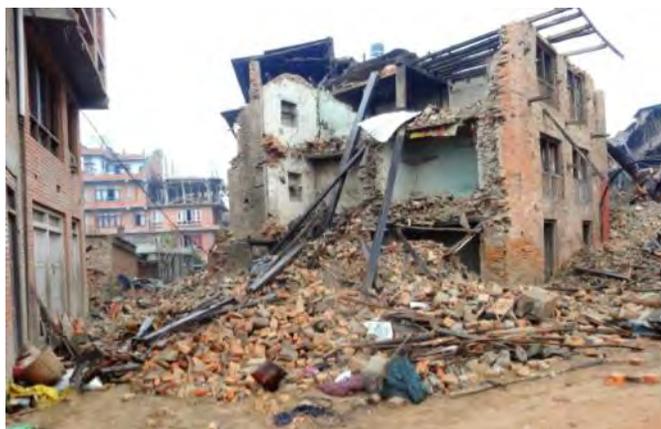
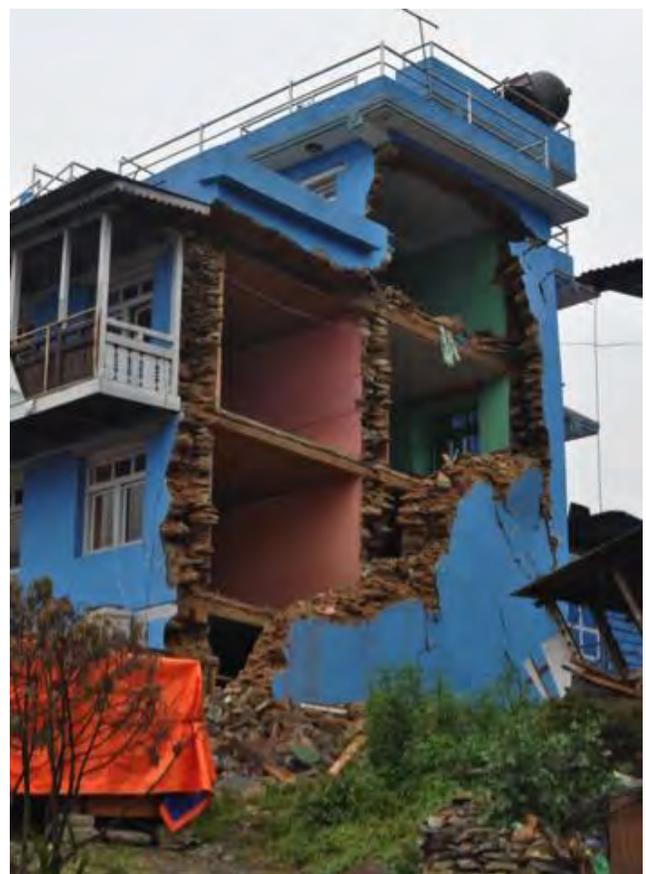
Out-of-plane damage was observed in large number of URM bearing wall buildings primarily due to poor diaphragm-to-wall ties, inadequate out-of-plane wall capacity, and initial in-plane damage (Figure 5-17). Collapse of such walls in the out-of-plane direction resulted in large loss to life and property during the Gorkha Earthquake. People also reported that smaller adjacent buildings suffered heavy damage due to out-of-plane collapse of walls in adjacent taller buildings. People were seen collecting the bricks and stones from the fallen walls and cleaning them for future construction (Figure 5-3). Although, some government and non-government organizations were providing suggestions on better construction practices, urgency to reconstruct houses before the approaching monsoon season was resulting in construction by many people using the same traditional practices without incorporating any seismic strengthening features.

Figure 5-17. Out-of-plane collapse of (a & b) brick masonry walls at Bhaktapur (photos: Bret Lizundia) and (c) stone masonry walls in Dolakha district (photo: John Bevington).

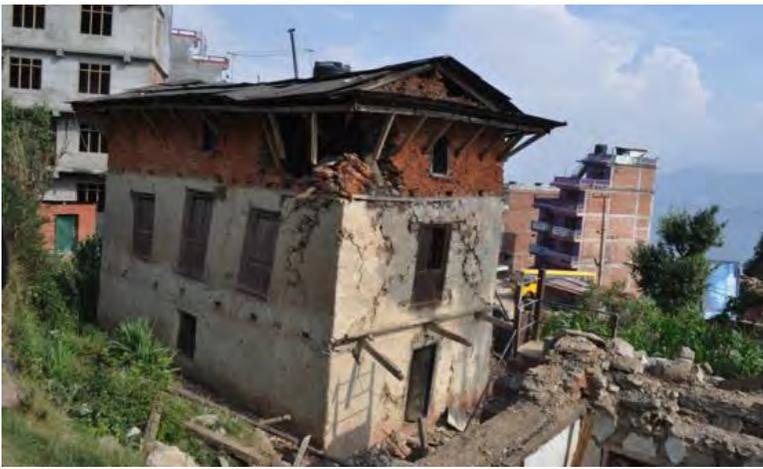
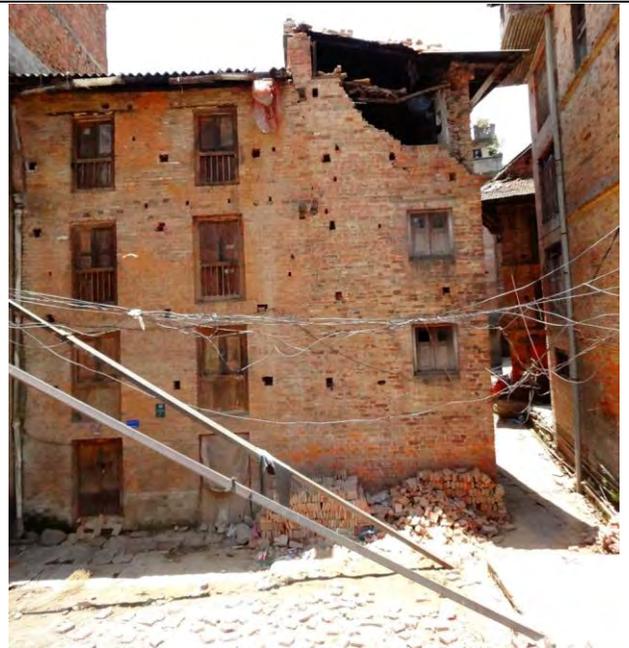
Corner damage was also quite commonly observed at the intersection of roof and walls subjected to in-plane and out-of-plane demands (Figure 5-18). Corner damage and subsequent collapse of the walls often took place due to poor connection between the floor or roof diaphragms and the walls, and between perpendicular walls. Subsequent to failure and collapse of walls in the top story of URM buildings, severe damage to roof or attic framing was also observed, as shown in Figure 5-19.

Figure 5-18. Corner damage in brick masonry walls at (a) Dolakha district (photo: John Bevington), and (b) Banepa (photo: Bret Lizundia).

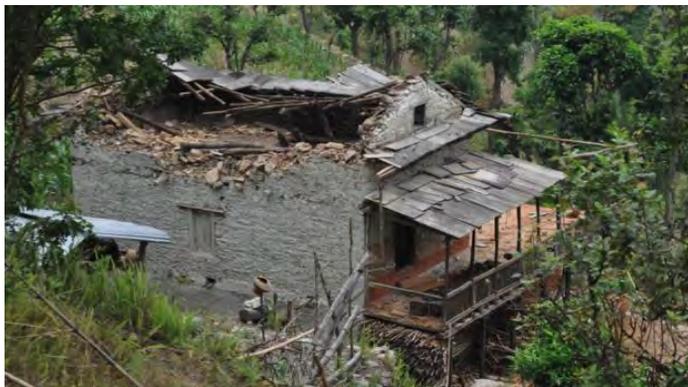
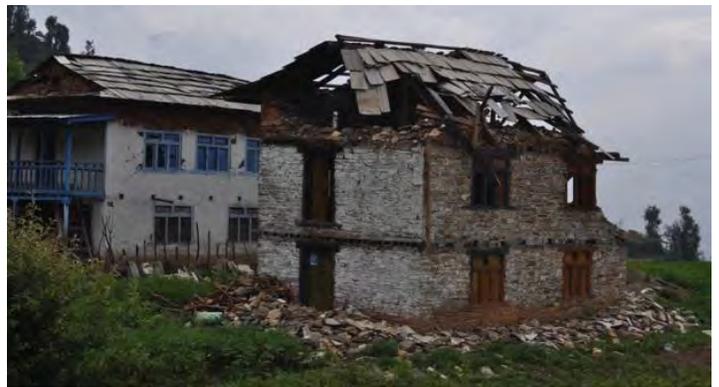
Figure 5-19. Roof or attic damage in stone masonry buildings in Dolakha district (photos: John Bevington).

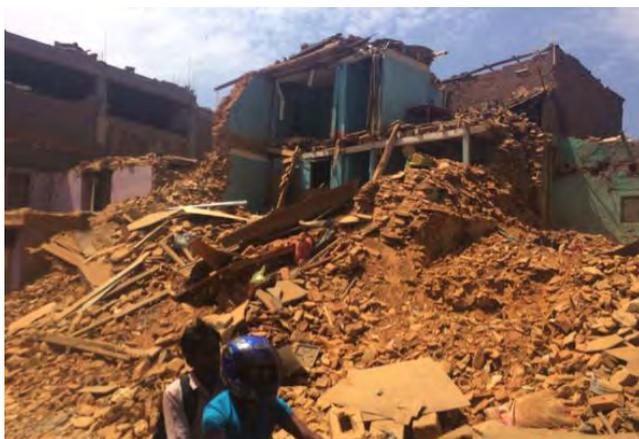
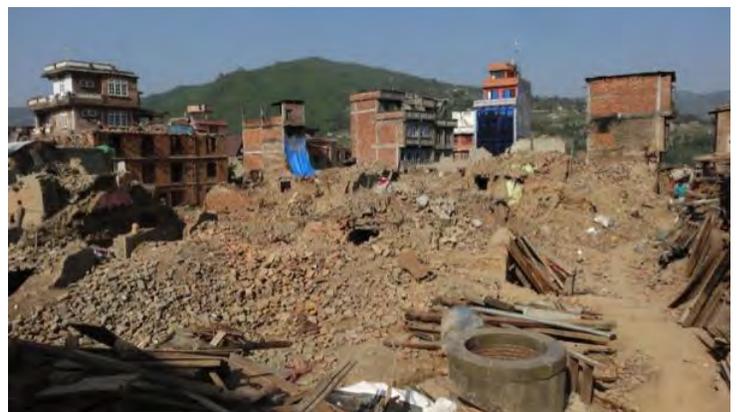
A combination of in-plane and out-of-plane damage in URM bearing wall buildings contributed to the complete collapse of many buildings in Nepal both in urban as well as rural areas (Figure 5-20). Though statistical data are not available, the reconnaissance team observed that the buildings constructed with mud mortar suffered more significant damage than those constructed using cement or lime mortar.

Figure 5-20. Partial and complete collapse of stone masonry buildings in (a) Chautara (photo: Jan Kupec) and (b) Sankhu (photo: Bret Lizundia).

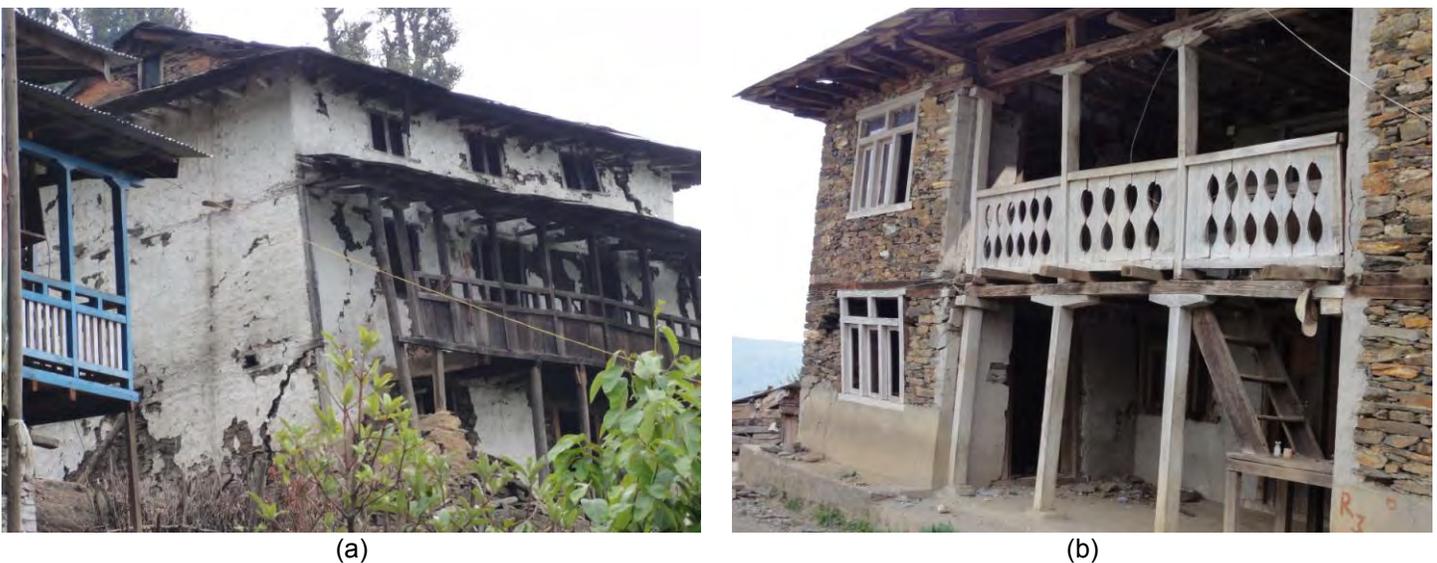
Figure 5-21. Traditional heavy post-and-beam timber frame buildings with infill masonry walls showing damage to masonry and timber elements (photos: Kishor Jaiswal).

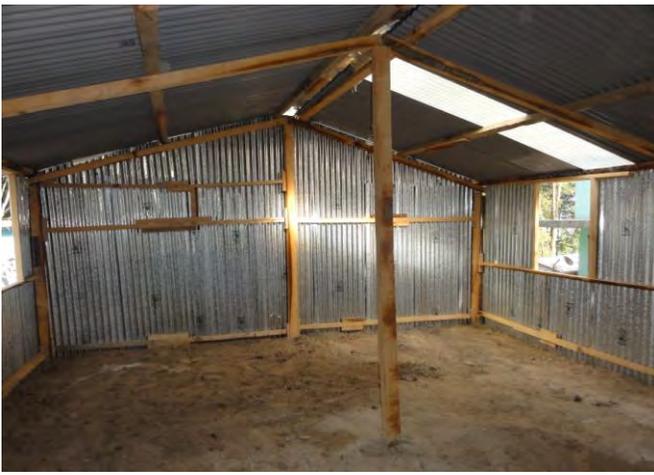
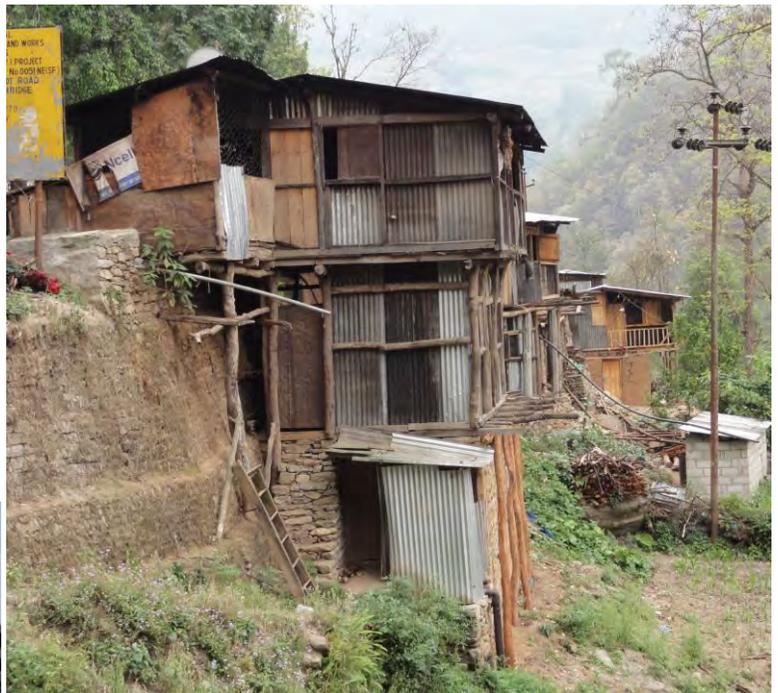
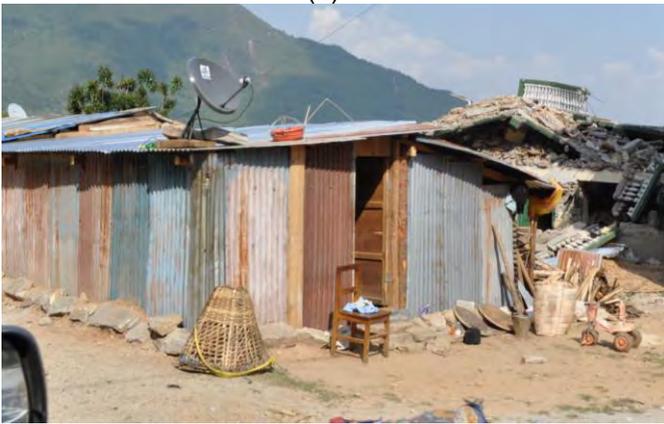
Figure 5-22. Examples of post-and-beam timber frames with light metal sheathing for roof and wall in (a) urban areas and (b) rural areas (photos: Kishor Jaiswal), and (c) when used for temporary housing (photo: John Bevington).

Due to the lightweight construction and inherent ductility in the framing system, timber frame houses performed reasonably well during the earthquake and aftershocks when compared with the URM bearing wall and RC frame dwellings. Despite the fact that this construction type represented only a small fraction of total housing stock, many local community members in regions visited by the reconnaissance team noted its good performance. Given the strong aftershocks, the EERI team observed that many local masons and homeowners had started building temporary shelters in the form of a single-story light timber frame house.

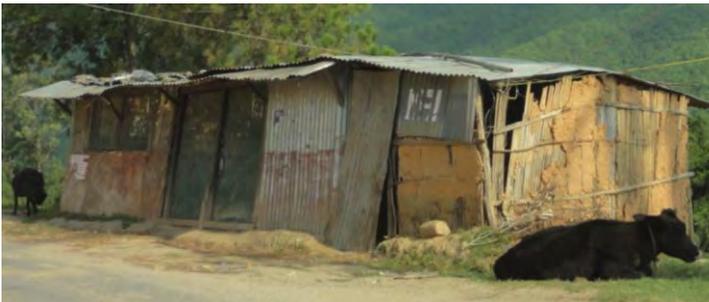
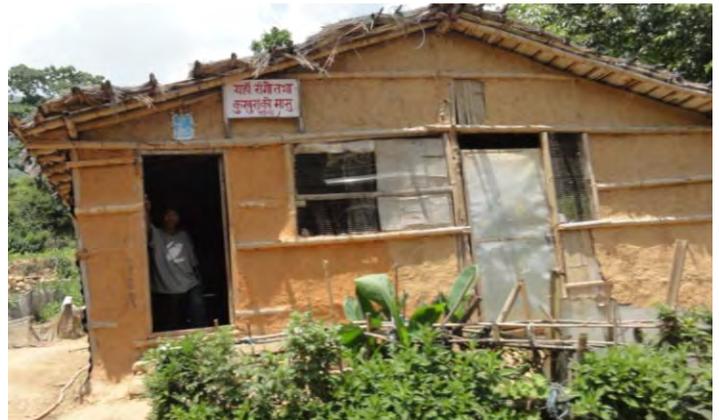
Figure 5-23. Load-bearing timber frame walls with bamboo/reed wattle and daub wall construction in Dolakha district (photos: Kishor Jaiswal).

While there are many variants of timber frame construction, three broad categories were impacted by the Gorkha Earthquake sequence and witnessed throughout the Kathmandu Valley and neighboring regions: (1) traditional heavy post-and-beam timber frame with infill masonry walls as shown in Figure 5-21, (2) post-and-beam timber frames made using light sheathing material (often CGI) for roof and walls as shown in Figure 5-22, and (3) Load-bearing timber frame walls with bamboo/reed (wattle and daub) as shown in Figure 5-23. The traditional heavy timber framing construction is widespread in the historical urban centers of Nepal whereas the simple post-and-beam light timber frame with CGI or other sheathing materials primarily occurs in the rural areas of Nepal.

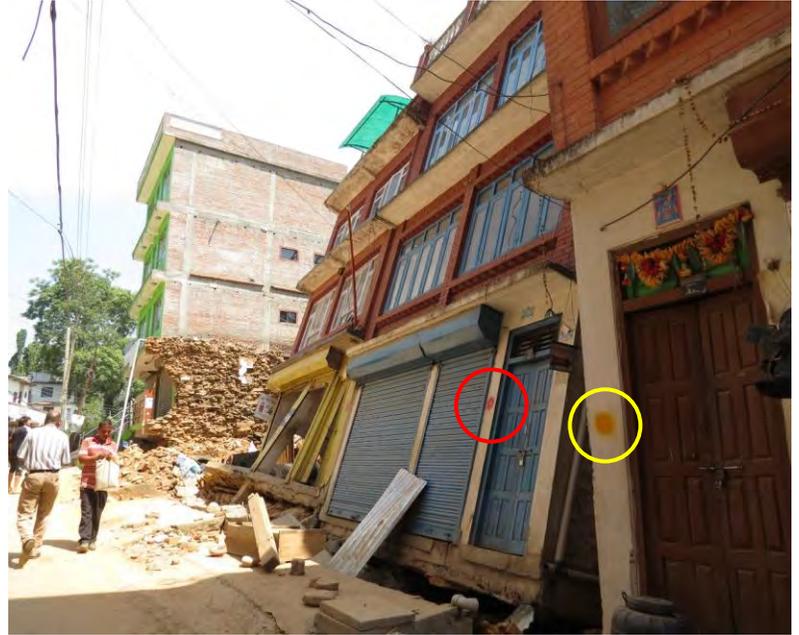
Figure 5-24. (a) Rear view of RC frame with masonry infill building in Chautara showing the down slope side (photo: Bret Lizundia, and (b) damaged buildings in Chautara showing spray-painted marks indicating postearthquake safety evaluation status (photo: Hemant Kaushik with annotations by Bret Lizundia).

Information was recorded for 152 buildings by a group of four EERI team members who reached consensus on each building. The evaluation began at Press Chowk Square at 27.7734°N, 85.71699°E and proceeded north to 27.77733°N, 85.71201°E to the informal United Nations settlement camp. Buildings on the up slope side of the street were typically on relatively flat site. Those on the down slope side had a relatively steep drop off to the rear of the building. Figure 5-24a shows the rear of a building on a steep down slope. Figure 5-24b shows the postearthquake safety evaluation marks for a pair of buildings.

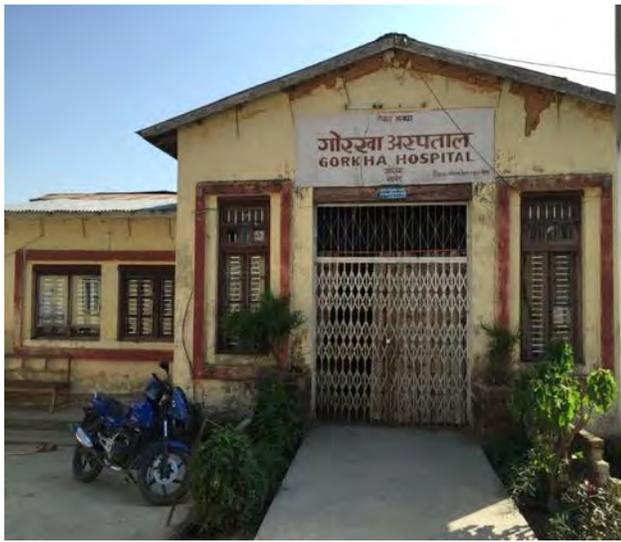
Figure 6-2. (a) Gorkha District Hospital Block 'H' was closed after the earthquake, (b) Gorkha District Hospital Block 'B' has a simple plan and did not suffer any structural damage, (c) patients crowded in the lobby at Kanti Children's Hospital six weeks after the earthquake, and (d) field hospitals and displaced medical equipment outside a red-tagged structure at Paropakar Maternity and Women's Hospital (photos: Judith Mitrani-Reiser).

impact closer to the epicenter of the main event. In the Gorkha District, we visited the district hospital (Figure 6-2a and b), Benighat Health Post, and one primary health center.

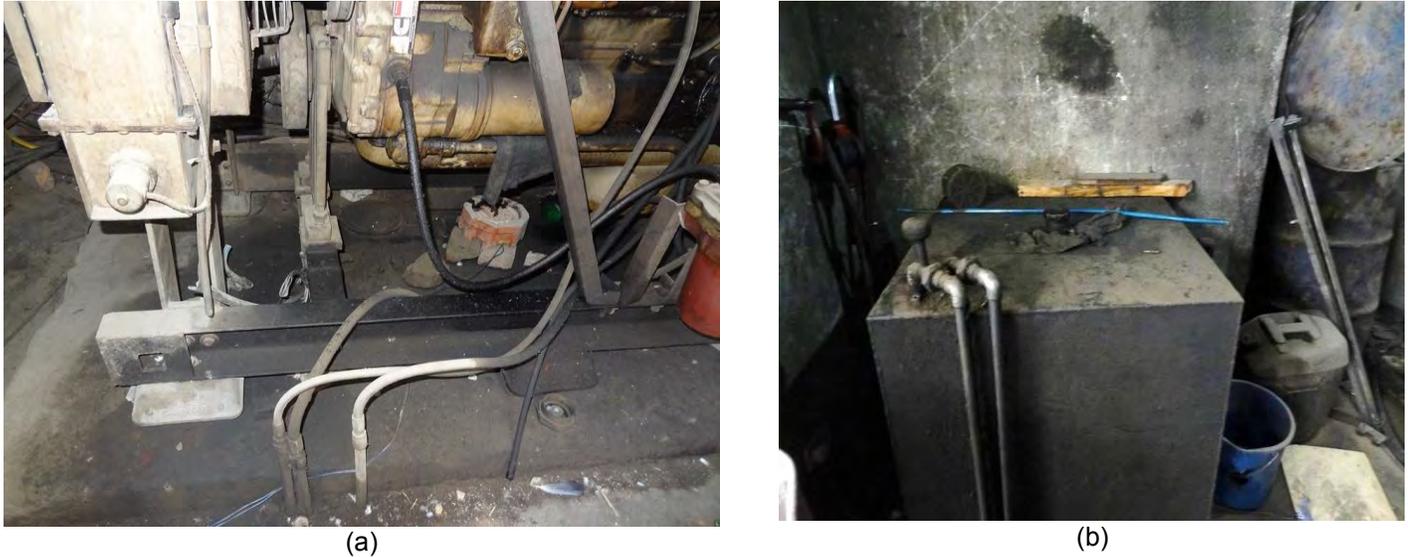
Figure 6-3. (a) Example of unanchored backup power generator at a healthcare facility; and (b) fuel storage for a backup generator that barely supplies six hours of power for the healthcare facility (photos: Hari Kumar).

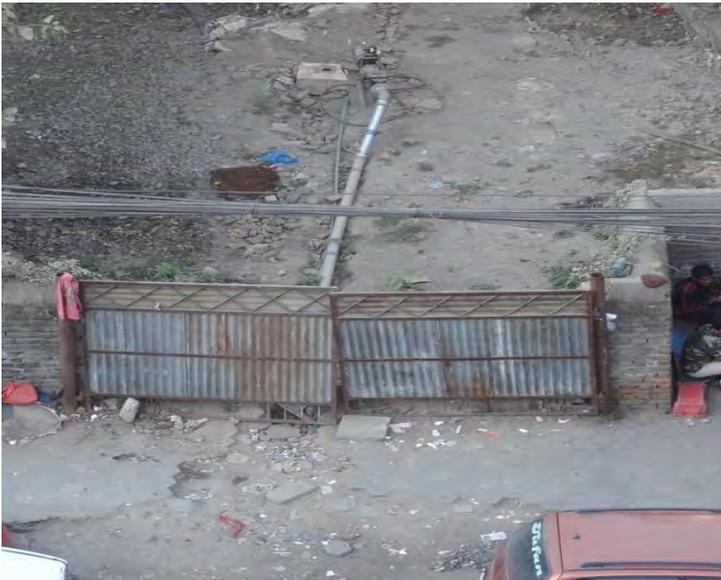
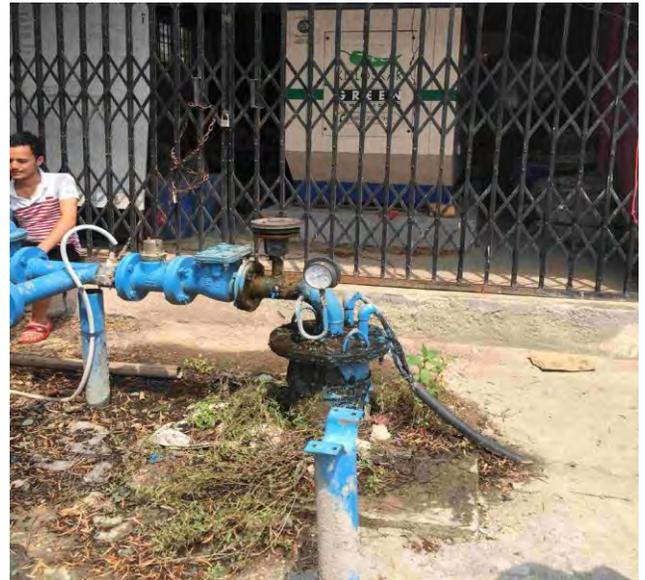
Figure 6-4. (a) A single water source, from a borehole, for an entire hospital campus (Bir); and (b) backup generators for water pumps at TUTH (photos: Judith Mitrani-Reiser and Hari Kumar).

The interviews made clear that there was little dependence on municipal water sources for daily operations in the healthcare facilities; only two facilities largely depended on municipal water supply. Most of the healthcare facilities had a single (e.g., Bir Hospital in Figure 6-4a) or multiple boreholes (TUTH), as well as water storage tanks (above and below ground) on site for daily consumption. Of all the facilities visited, one reported minor pipe damage (Kanti), and another (Paropakar) reported a contamination issue with the water from their borehole turning brown/black. A third facility (Nepal Medical College) largely dependent on municipal water lost this water source for four days, but they were able to manage with their own backup water storage tanks for the first 48 hours after the earthquake and with the additional water tankers brought in afterward. The team observed several seismic mitigation actions taken by the healthcare facilities on their water systems, including multiple boreholes per site, power generators dedicated specifically to pumps for water distribution (TUTH in Figure 6-4b), anchorage of water tanks (Kanti Hospital in Figure 6-28a), flexible joints of pipes (TUTH Figure 6-29a), and pre-existing agreements with private or public institutions to bring in water tankers if their backups failed. The amount of stored water on each campus and the level of mitigation actions taken (i.e., Figures 6-4b, 6-28a, and 6-29) were inconsistent. All of the facilities were also asked about any disruption to their communication system, including landlines, internal communication channels, and cellular connection. All of the healthcare facilities reported issues with all forms of communication in the first few hours after the earthquake due to overloaded networks.

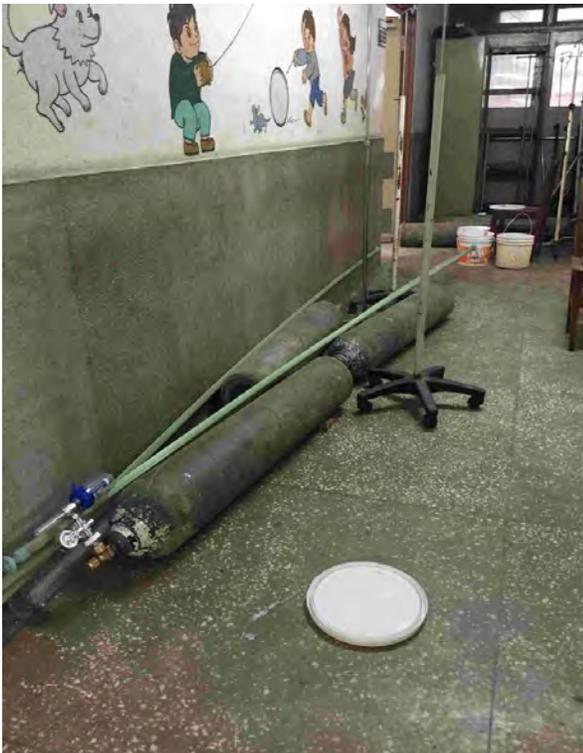
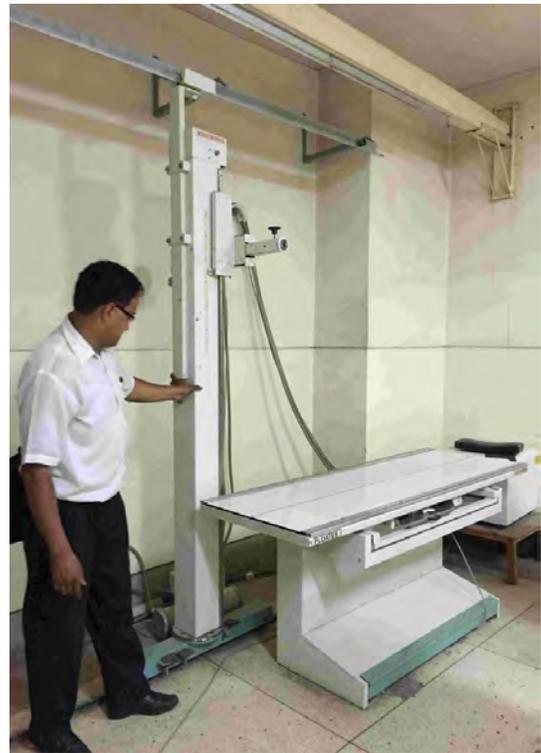
Figure 6-5. (a) Example of oxygen tanks fallen over at Kanti Children's Hospital, and (b) a damaged x-ray machine at Nepal medical College (photos: Hari Kumar).

Of all the visited facilities, several (Bir and Kanti) reported unbraced medical gas tanks falling over and scaring occupants (Figure 6-5a), and there were also few reports of damage to radiological machines (e.g., Figure 6-5b at Nepal Medical College) and autoclaves. The damage to equipment that was most disruptive to daily operations were the falling medical gas tanks, not because of any loss to the oxygen supply but because of the loud noises resulting from the tanks falling over and making occupants fearful of being indoors.

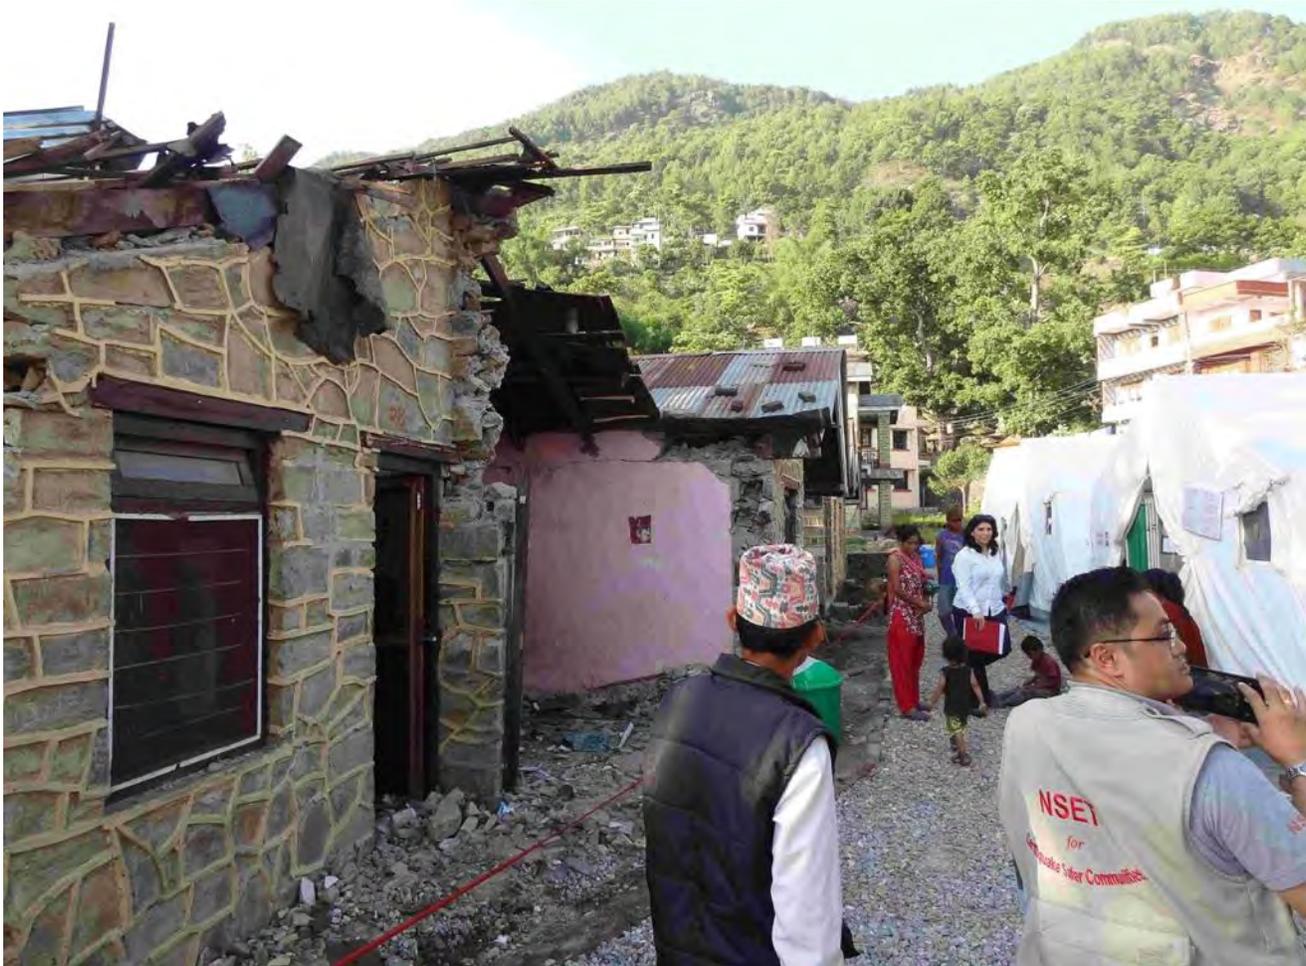
Figure 6-6. Example of damage to staff living quarters at Ghorka District Hospital (photo: Hari Kumar).

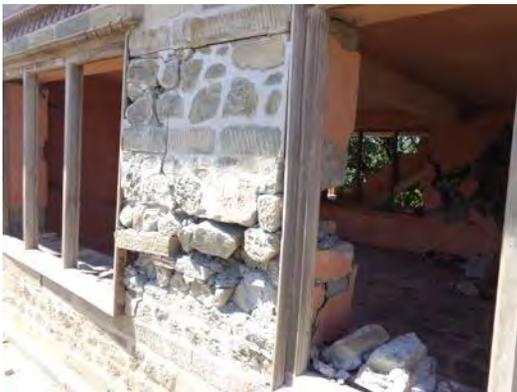
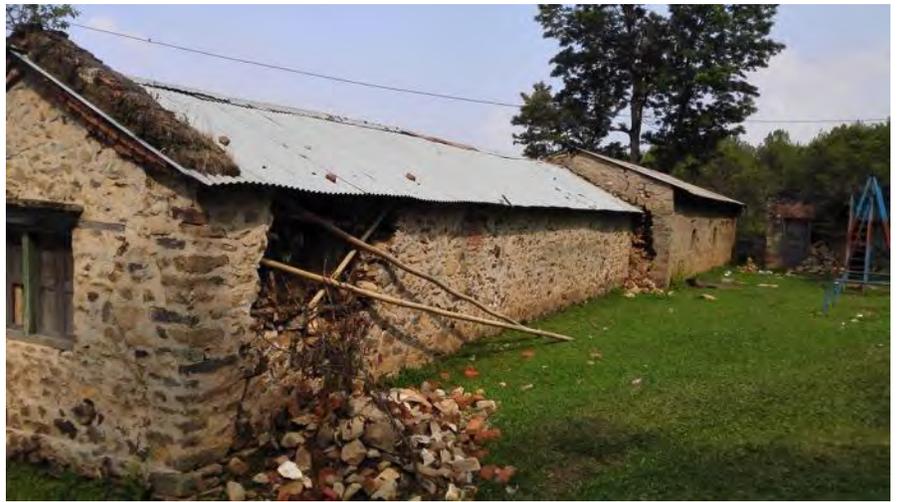
Figure 6-7. Examples of damaged school buildings with stone and cement mortar: (a) damaged school in Gorkha, and (b) school in Chundevi, Kathmandu assessed as Damage Grade 3 (photos: NSET, 2015).

Unreinforced masonry buildings are common with construction typically either stone or bricks in mud mortar or cement mortar. The majority of stone school buildings with cement mortar suffered heavy damage (DG 3 to DG 5). The main failure patterns seen were out-of-plane wall failure, tilting, in-plane diagonal cracking, collapse of gable walls at roof level, corner separation, and diagonal cracking around window or door openings. Examples of damage to these types of structures are shown in Figure 6-7. The main cause for these failures was poor construction quality, lack of seismic bands, lack of corner strengthening, and poor building maintenance.

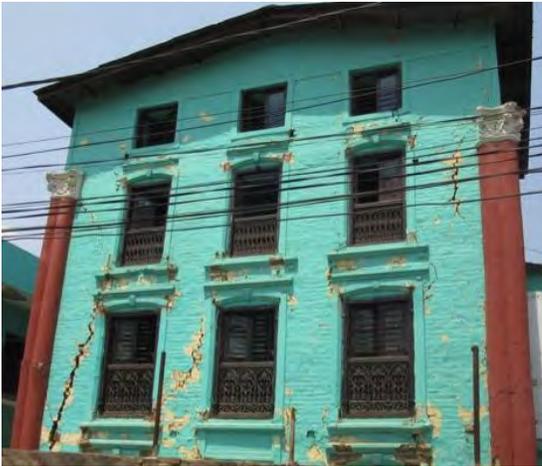
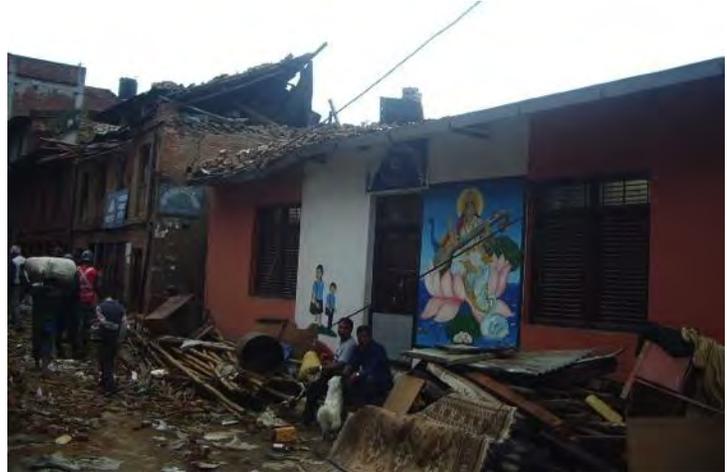
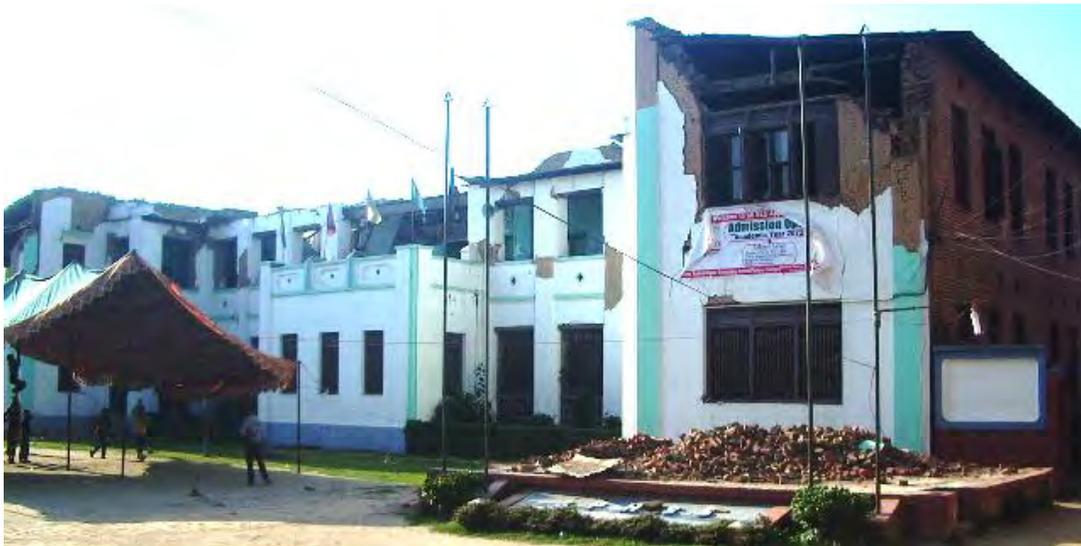
Figure 6-8. Examples of damaged school buildings with brick and mud mortar: (a) Rupak Memorial School in Sanepa assessed as Damage Grade 4, (b) adjacent building fell on Mahendra Lower Secondary School building in Bhaktapur assessed as Damage Grade 3, and (c) Padma Higher Secondary School in Bhaktapur assessed as Damage Grade 4 (photos: NSET, 2015).

Examples of schools with mud mortar are shown in Figures 6-8 and 6-9. Most of these buildings suffered full collapse or were so heavily damaged that they cannot be repaired. Almost 60% of school buildings made with stones and mud mortar collapsed.

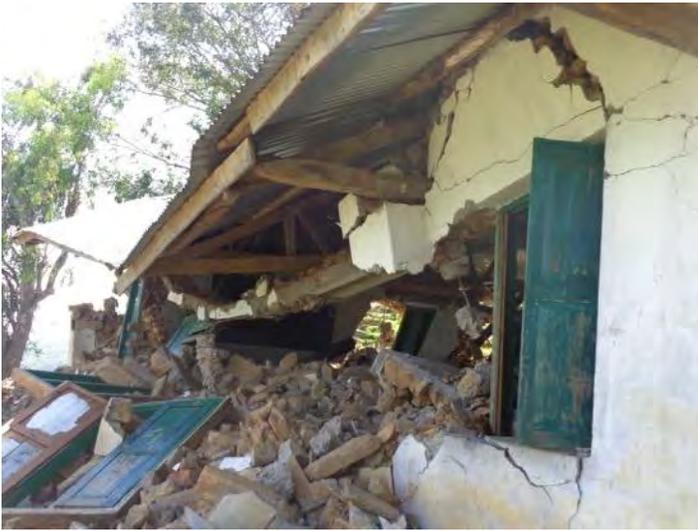
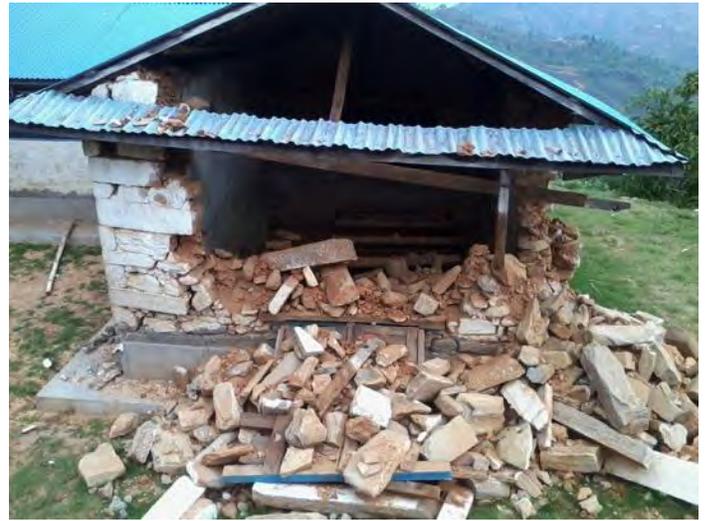
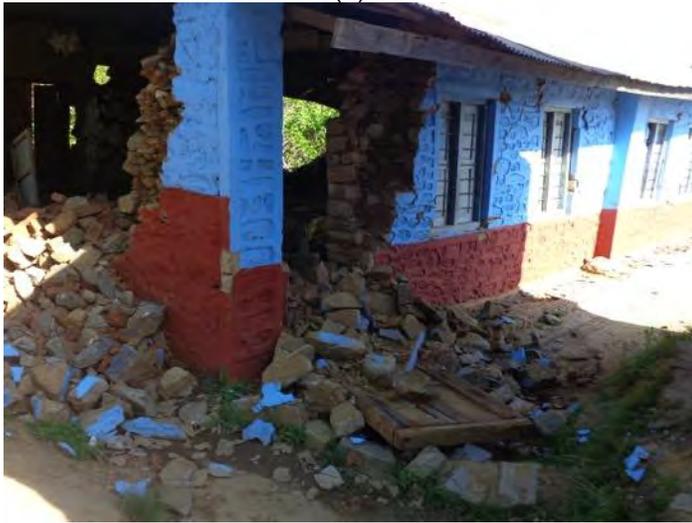
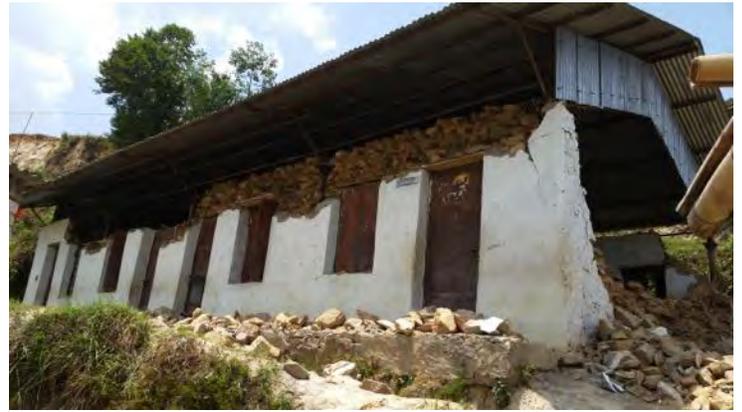
Figure 6-9. Examples of collapsed school buildings with stone and mud mortar: (a) Collapsed school with large opening, (b) failure of wall from corner in Gorkha district, (c) damaged school, and (d) Sarada School in Sindhupalchowk with weak stone masonry in mud mortar without any bands or through stones, assessed as Damage Grade 4 (photos: NSET, 2015).

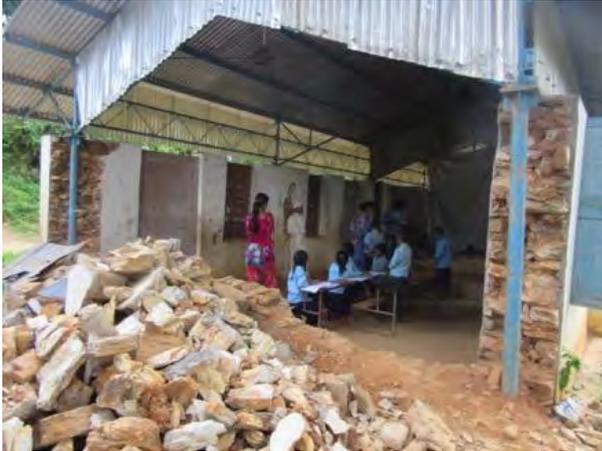
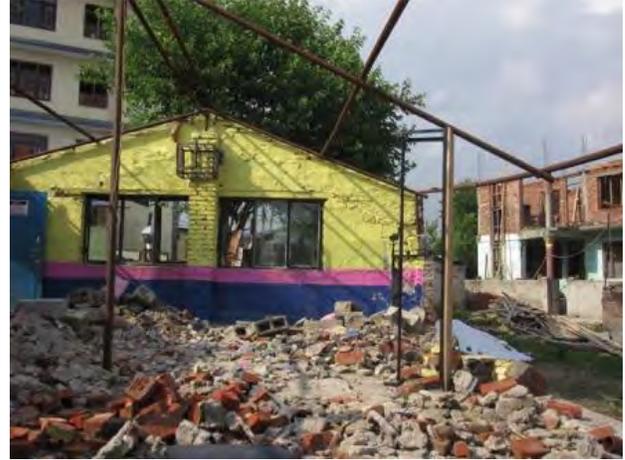
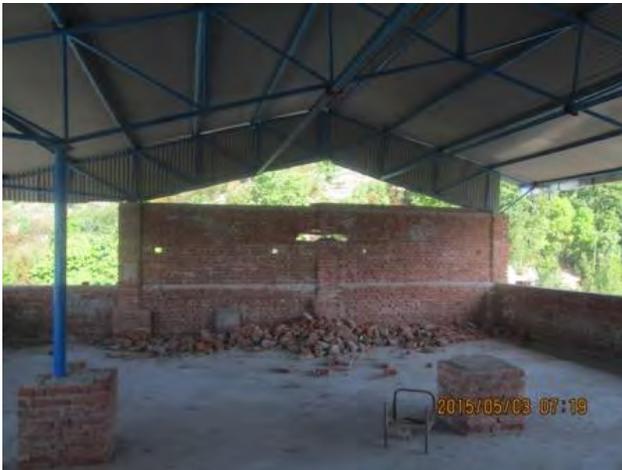
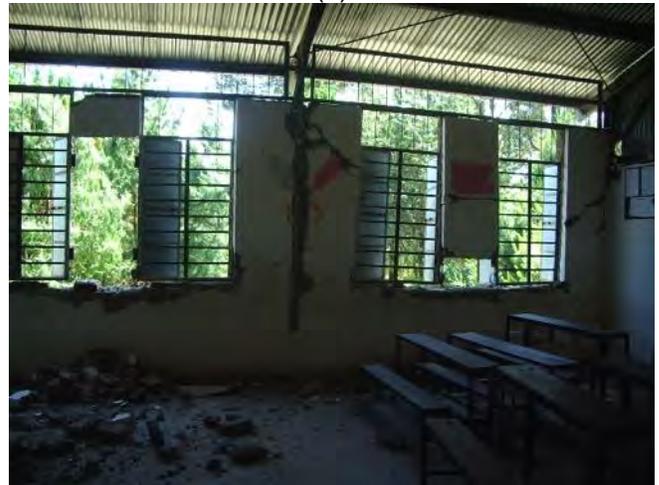
Figure 6-10. Examples of damaged school buildings with steel frames and masonry infill: (a) Ram Lower Secondary School in Sindhupalchok assessed as Damage Grade 4, (b) collapsed school building in Manohara municipality, Kathmandu assessed as Damage Grade 5, (c) school where wall survived due to horizontal band at sill and lintel level even after falling of bricks from the middle of the wall, assessed as Damage Grade 2, and (d) isolated wall piers not integrated with steel frame that were heavily damaged during earthquake shaking at Kalika Secondary School in Nagarkot, assessed as Damage Grade 3 (photos: NSET, 2015).

Most of the school buildings with steel frames and masonry infill walls were damaged due to failure of the infill walls. In most cases, no proper connection between the infill and steel structural elements existed; thus, while the frame was found intact, the masonry walls collapsed. Many of these buildings were affected by infill collapse, as shown in Figure 6-10.

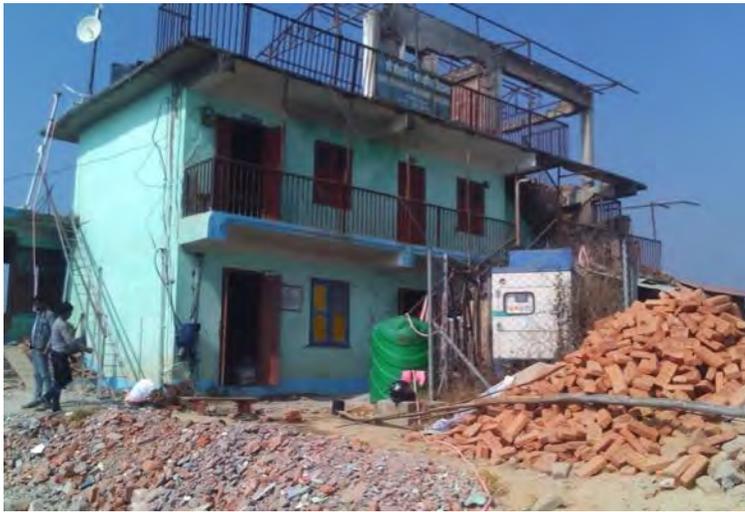
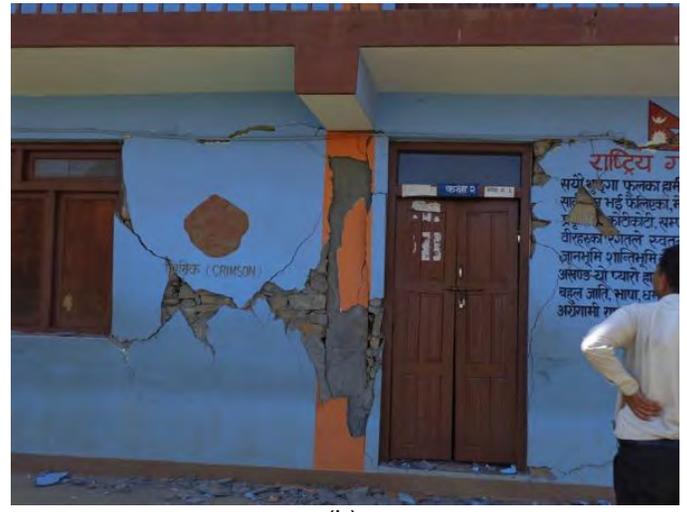
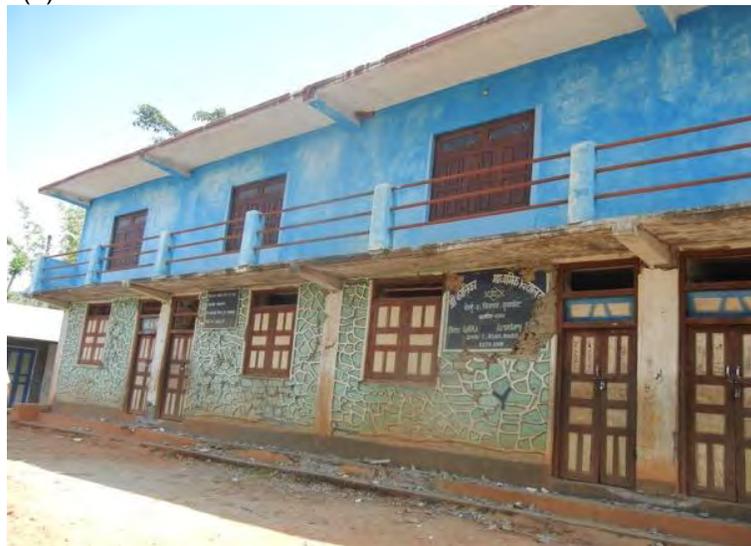
Figure 6-11. Examples of damaged school buildings with RC frames and masonry infill: (a) Okharpauwa Secondary School in Okharpauwa assessed as Damage Grade 3, (b) damaged school in Gorkha, and (c) damaged school in Nuwakot (photos: NSET, 2015).

The majority of the RC frame school buildings were found undamaged or only suffered minor damage, although there were exceptions where schools were heavily damaged (notably some high rise private school buildings suffered pancake collapse in Kathamandu). Examples of modestly damaged RC frame structures are shown in Figure 6-11. In cases where damaged occurred, it was most frequently found in the infill walls and beam column joints. Several reasons for these failures can be assumed, including inadequate design, construction that did not follow the building code, deficient structural elements, poor detailing, poor construction quality, and poor maintenance.

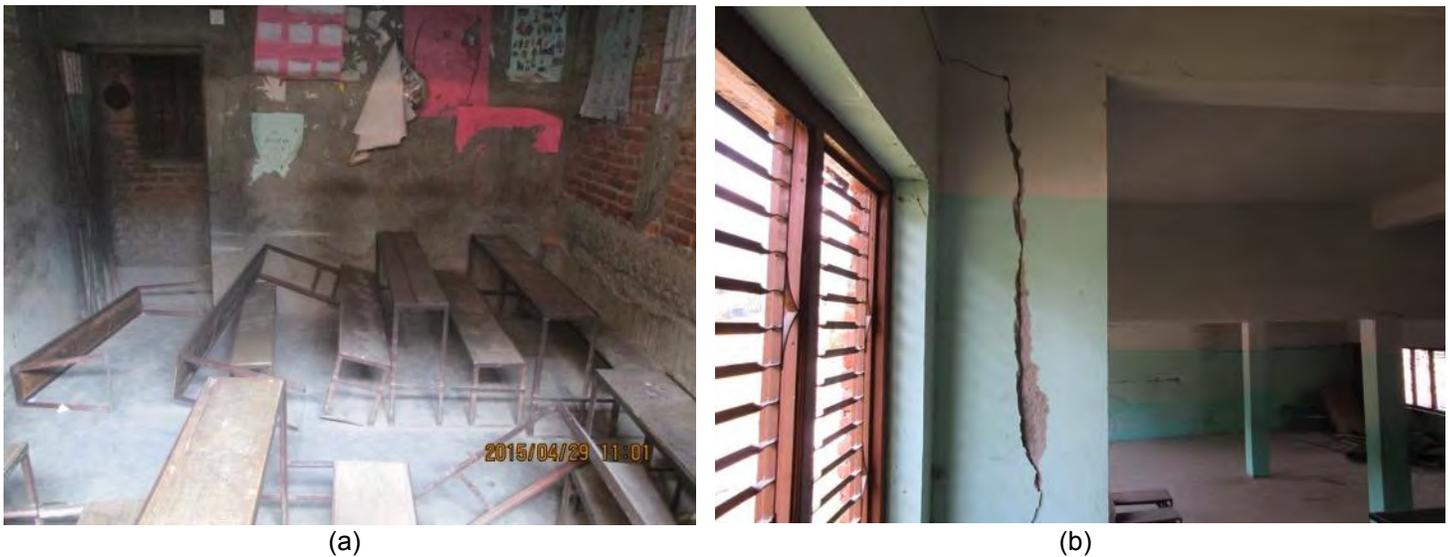
Figure 6-12. Examples of nonstructural school damage: (a) Fallen single desks and benches are scattered amongst standing desks in a classroom at Buddha Jyoti School in Kathmandu, assessed as Damage Grade 1, and (b) Spalling and cracking at column in Gokarna Higher Secondary School in Kathmandu, assessed as Damage Grade 1 (Photo: NSET, 2015).

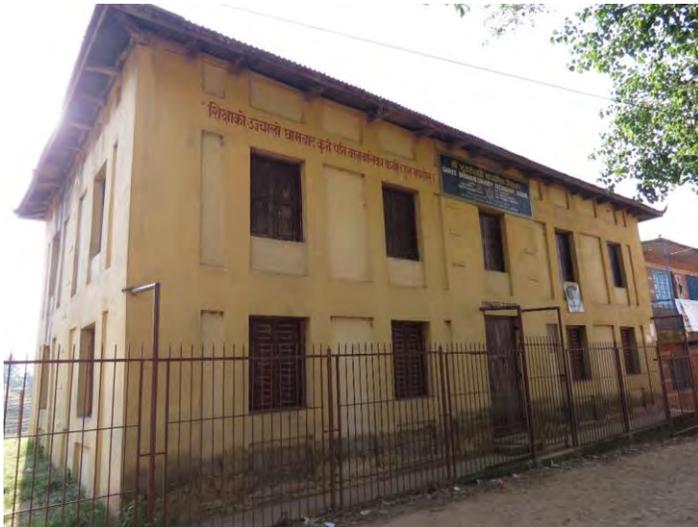
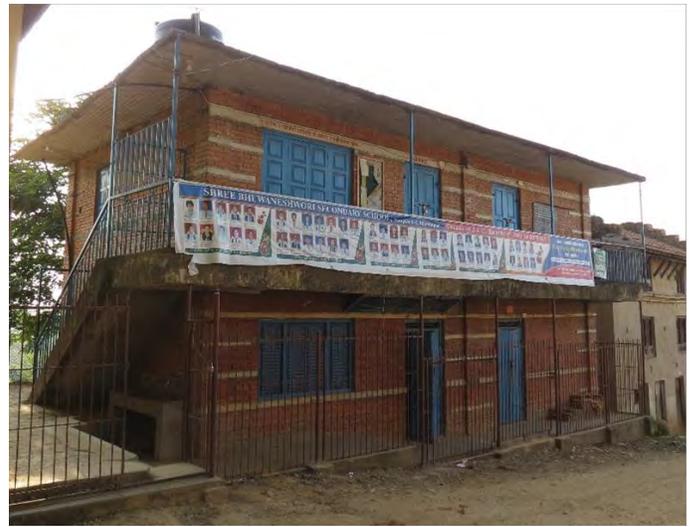
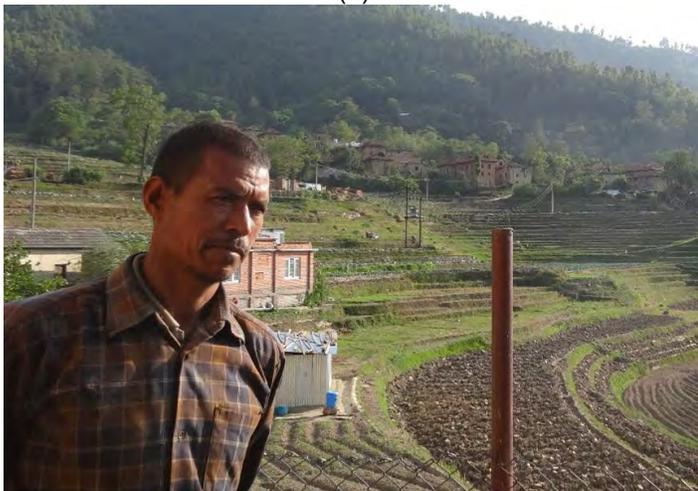
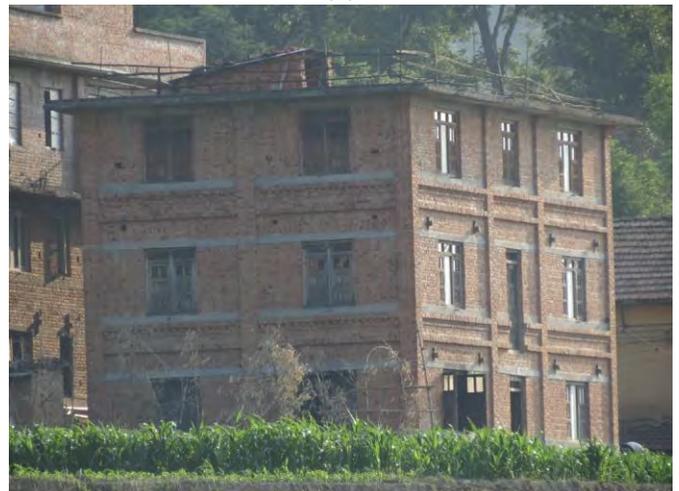
Figure 6-14. Success of NSET SESP in Nandikeshwor with retrofitted school buildings showing no damage (photos: Hemant Kaushik, unless noted otherwise): (a) First school retrofit in Nepal, (b) Adjacent new school built with improved earthquake resistance, (c) Head mason for each building (photo: Bret Lizundia), and (d) Mason’s home built with improved earthquake resistance.

The EERI reconnaissance team visited retrofitted schools in the village of Nandikeshwor, Bhaktapur and in Sankhu, Kathmandu. Nandikeshwor is a community with a large number of masons. It was selected as part of the pilot program, and masons were trained in seismic retrofitting techniques. Figure 6-14a shows the original URM brick bearing wall school, which was strengthened in 2000. It was the first school retrofitted in Nepal. Reinforced concrete bands were placed on the walls, and improvements were made in the diaphragms and diaphragm-to-wall ties. It had minimal damage in the earthquake and was green-tagged following the Department of Education’s postearthquake safety evaluation. When a new school was needed for a growing population in the village, though masonry construction was used, reinforced lintel bands and corner ties features were employed, based on what the masons had learned. The new school is shown in Figure 6-14b. It is next to the original retrofitted school, and it also had minimal damage in the earthquake. The head mason for both schools is shown in Figure 6-14c. He used his training and experience with improved seismic safety features in the construction of his own home, shown in Figure 6-14d. The mason now states that he incorporates these seismic features as often as possible in his construction practice, thus spreading the impact of school program throughout the community.

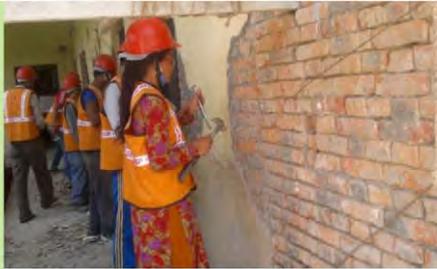
Photo: Tripadma H Secondary School, Lalitpur (NSET)

This is the first step of the retrofitting work. The plaster is removed from the surface of the wall where the reinforcement is to be erected. Joint mortar gap should be racked out up to 10mm. The surface must be cleaned with the wire brush. Joint racking can be done with the help of a pointed piece of 8 mm dia bar. The wall might be needed to be rebuilt if any evidence of structural abnormalities is observed.

- Strong Hammering to the wall may cause damage to the already decayed bricks/ masonry.
- Clean all the dust on the wall after removing the plaster and Joint racking with the wire brush.

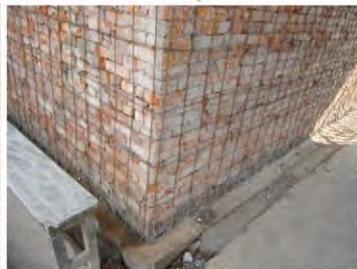
Photo: Saraswati Secondary School , Lalitpur (NSET)

Reinforcement placement during retrofit is one of the crucial part during a retrofitting work. Galvanized Wire mesh or Reinforcement bars of different size can be used for the Jacketing or Splint and Bandages. Reinforcement provides the ductility to the building and hence, provides the resistance against the lateral load during Earthquake. Vertical Bars from splints or Jacket continues to the top and ties the whole building. Ultimately, the rebar should be tied to each other at the roof.
