EERI Earthquake Reconnaissance Team Report: M7.8 Gorkha, Nepal Earthquake on April 25, 2015 and its Aftershocks

May 2016

A product of the EERI Learning From Earthquakes Program

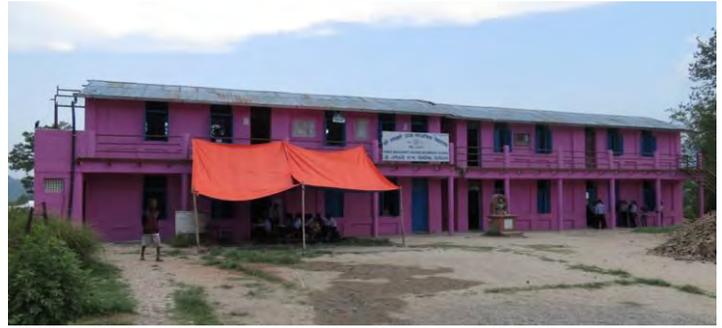
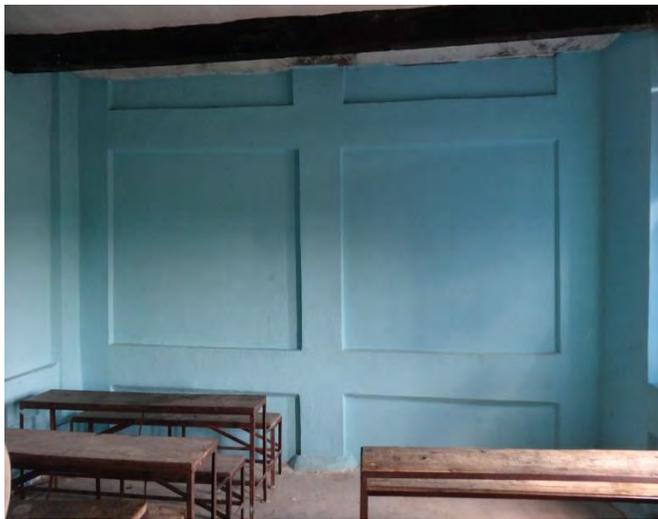
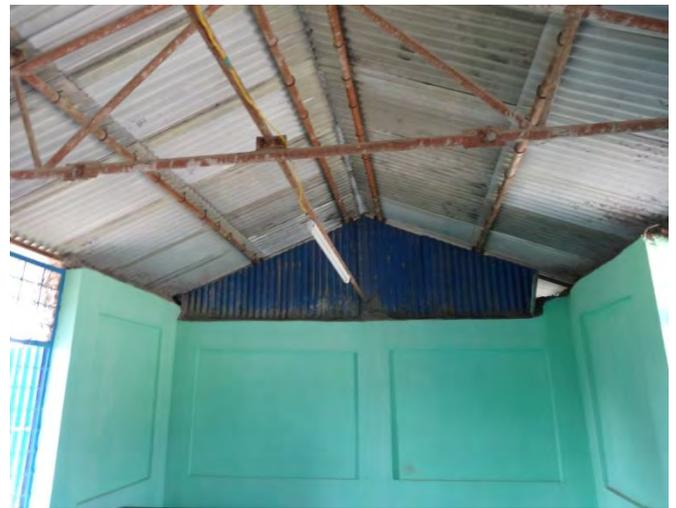
Figure 6-16. (a) Typical reinforcing for horizontal bands at lintels and vertical bands at jambs and corners (source: Shreshta, et al. (2012), (b) retrofitted school in Sankhu, Kathmandu (photo: Hemant Kaushik), (c) interior view of finished bands in classroom of retrofitted school in Sankhu (photo: Bret Lizundia), and (d) view of roof over strengthened walls in school in Sankhu (photo: Bret Lizundia).

Figure 6-16a shows a schematic example of the horizontal and vertical bands that were used. Figure 6-16b shows a retrofitted school in Sankhu, with the banding revealed on the inside face in a classroom shown in Figure 6-16c, and the lack of significant changes at the roof level in Figure 6-16d.

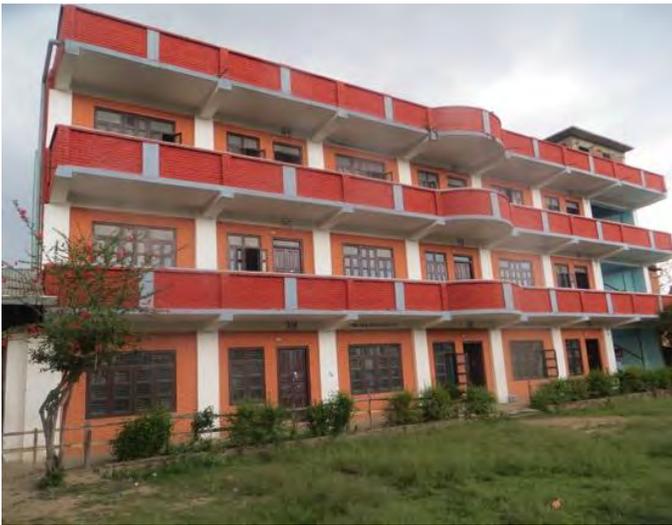
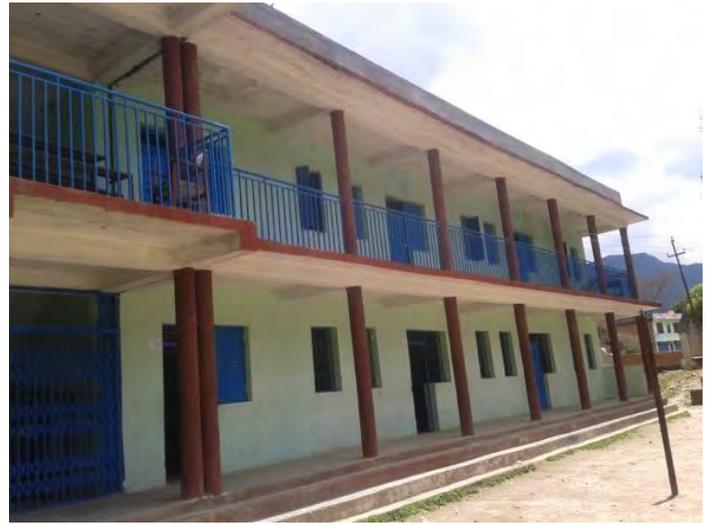
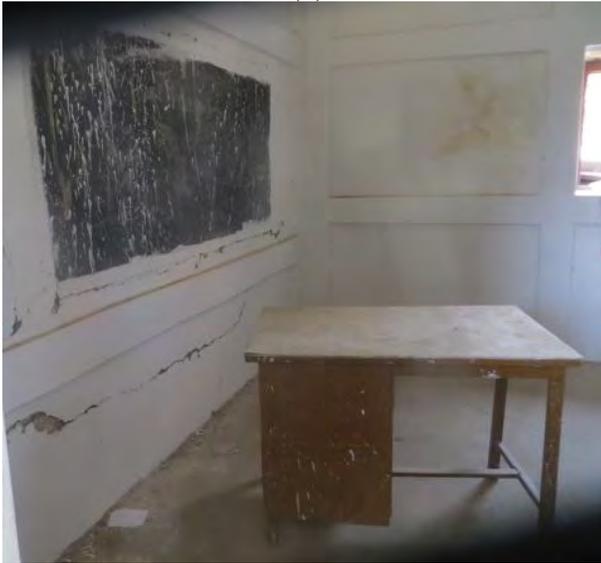
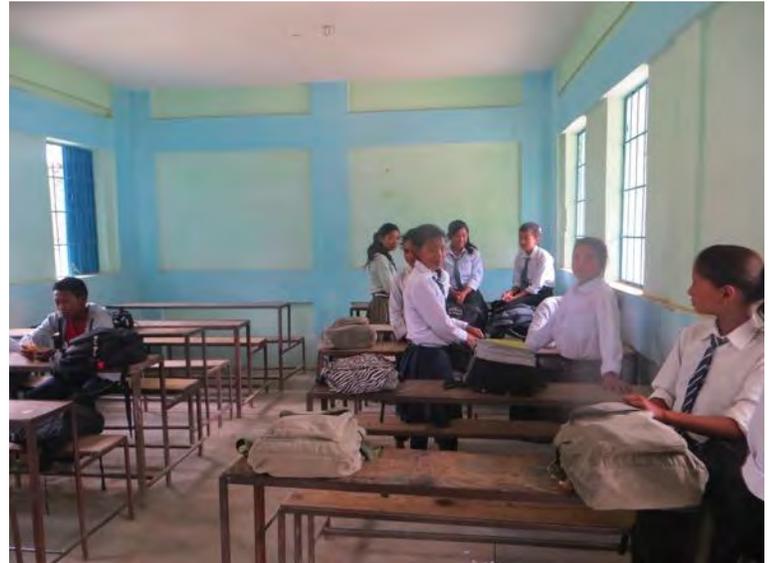
Figure 6-17. Examples of retrofitted school buildings with no damage or very minor damage: (a) Adarsha Ajad School in Bhaktapur without visible damage or cracking, (b) undamaged school in Chhampi, Lalitpur, (c) Gram Sewa School in Dharmasthali, Kathmandu with only minor damage, and (d) children occupying retrofitted school after earthquake (photos: NSET, 2015).

Examples of good performance are found in Figures 6-17, 6-18, and 6-19. In several locations, the retrofitted school buildings were used as emergency shelters by the people and also as emergency response coordination centers by response organizations (Figure 6-20).

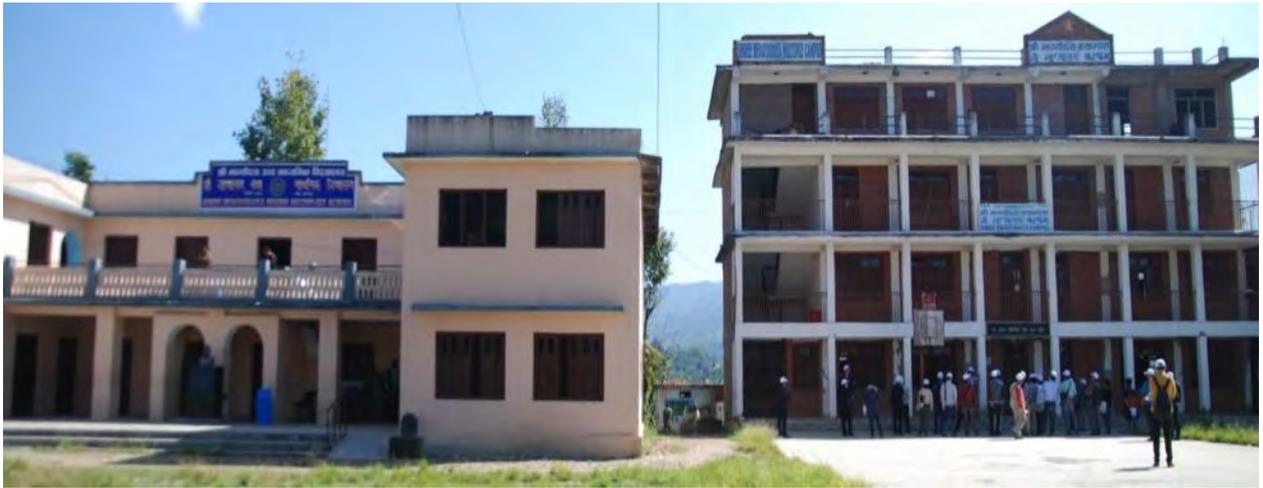
Figure 6-18. Two adjacent school buildings in Sankhu, Kathmandu. The unreinforced masonry building retrofitted with reinforced concrete jacketing (shown on the left) performed well with limited damage, while the reinforced concrete frame building with masonry infill wall (shown on the right) suffered damage to many columns and cracking in the infill walls (photo: NSET, 2015).

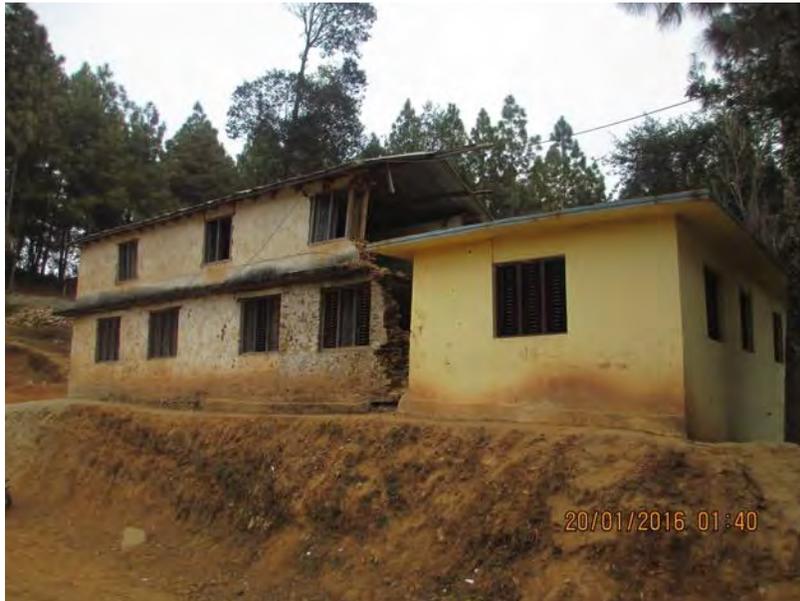
Figure 6-19. Partially collapsed non-retrofitted school building assessed as Damage Grade 4 (left) adjacent to an undamaged retrofitted school building (right) in Magargaun, Lalitpur (photo: NSET, 2015).

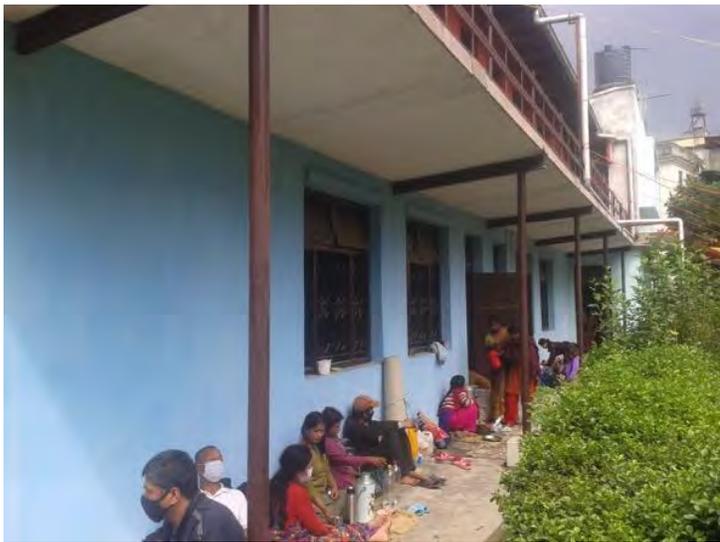
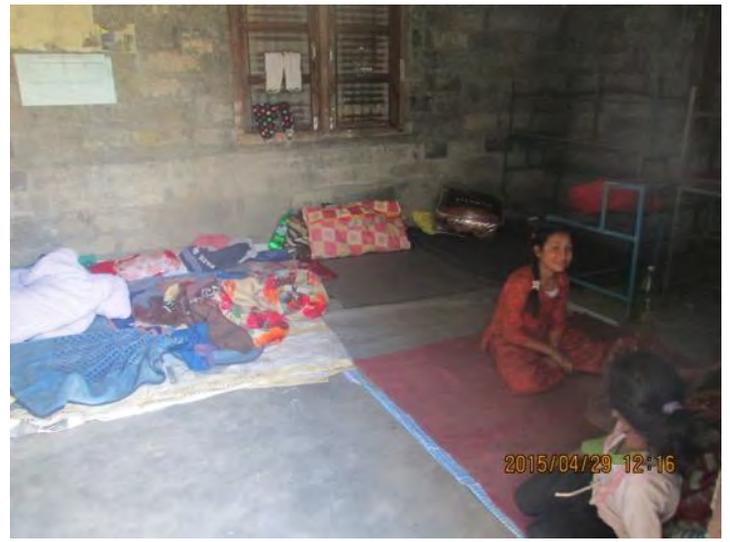
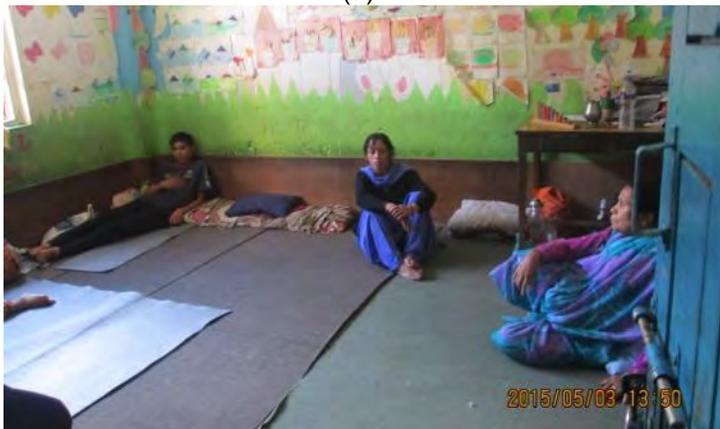
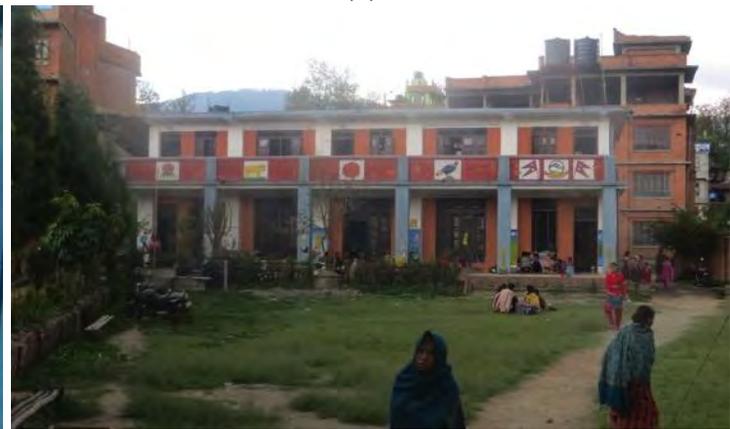
Figure 6-20. Examples of school buildings used as shelters: (a) Kanya Mandir School in Kathmandu that was retrofitted in 2014, (b) Baishnavi School in Kathmandu, (c) Bidhyodaya School in Kathmandu that was built with earthquake resistant techniques, and (d) Adarsha Ajad Higher Secondary School in Bhaktpur (photos: NSET, 2015).

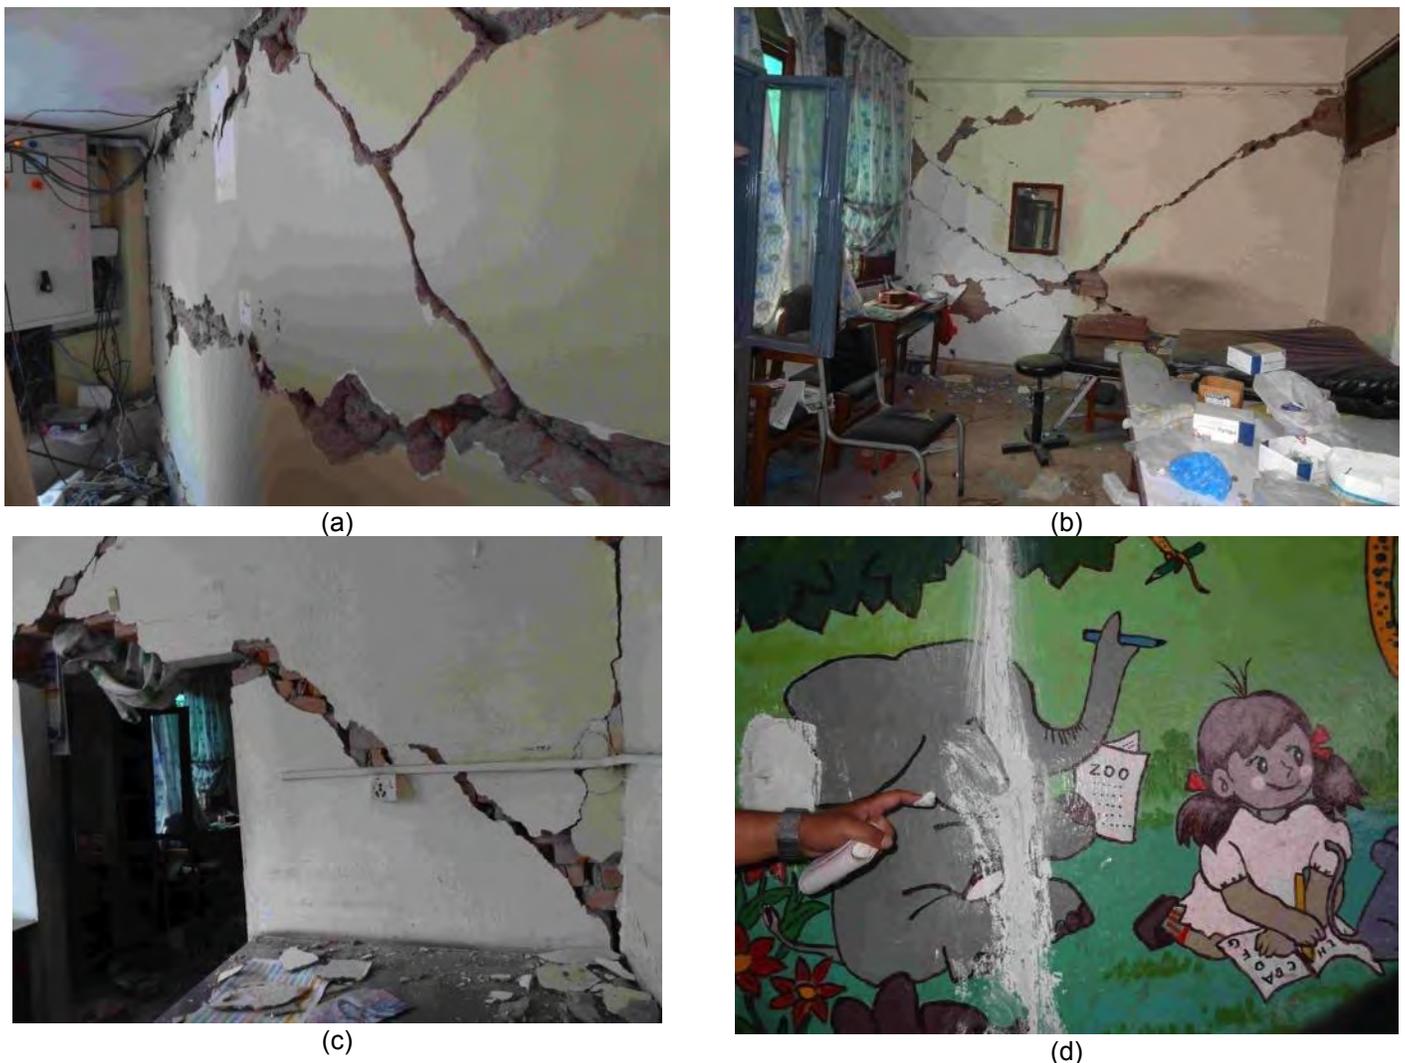
Figure 6-21. Examples of infill wall damage (a) in a hotel building near Gorkha (photo: Hari Kumar), (b & c) Paropakar Maternity and Women's Hospital in Kathmandu (photos: Hari Kumar), and (d) in Kanti Children's Hospital covered with wall putty. (photo: Judith Mitrani-Reiser).

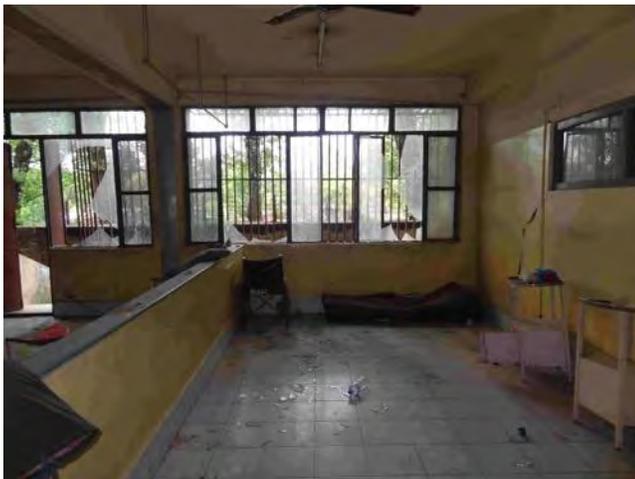
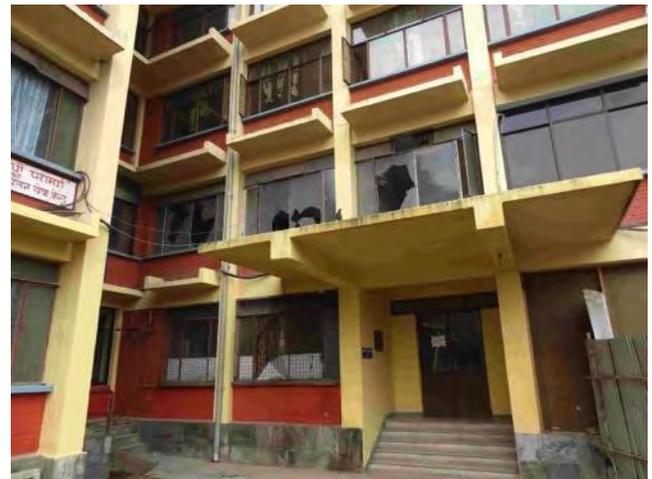
The EERI reconnaissance team observed damage to architectural finishes including external and internal cladding tiles and other adhered finishes, glazing, and suspended ceilings. Damage to glazing and interior building finishes posed a risk to the public as dislodged pieces fell on to the building periphery and also made several exits unusable (Figures 6-22 and 6-23). Damage to both plaster and tiled suspended ceilings disrupted functionality, especially in health facilities, department stores, and other similar large scale buildings (Figure 6-24). The NBC does not refer to plaster ceilings at all; however, Table 12.1 in the NBC 105:1994 sets provisions for suspended ceilings, although only for tiles weighing more than 2 kg each (Government of Nepal, 1994b).

Figure 6-22. Glazing damage in Paropakar Maternity and Women's Hospital, Kathmandu (a) in nurses station and (b) in VIP block (photos: Hari Kumar).

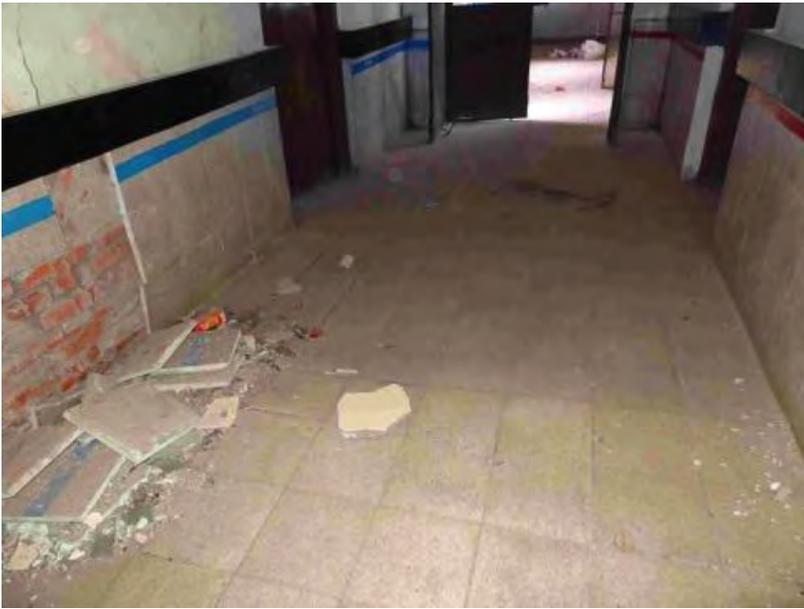
Figure 6-23. Spalling off of adhered tile finishes in two buildings in Kathmandu, both preventing easy egress from the buildings (photo a: Hari Kumar, and photo b: Judith Mitrani-Reiser).

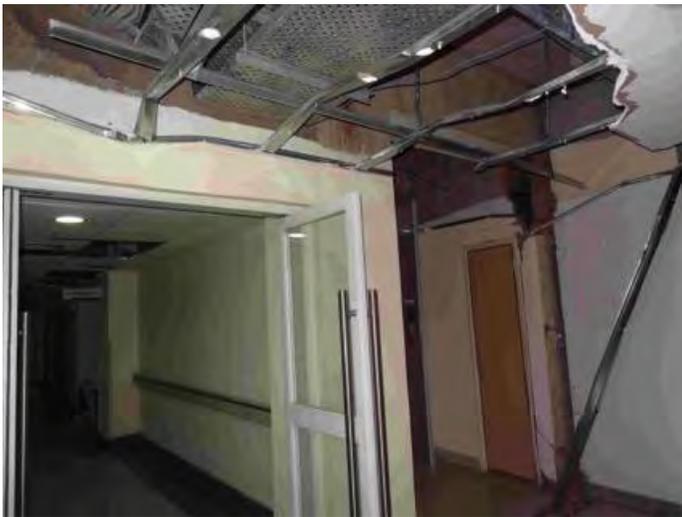
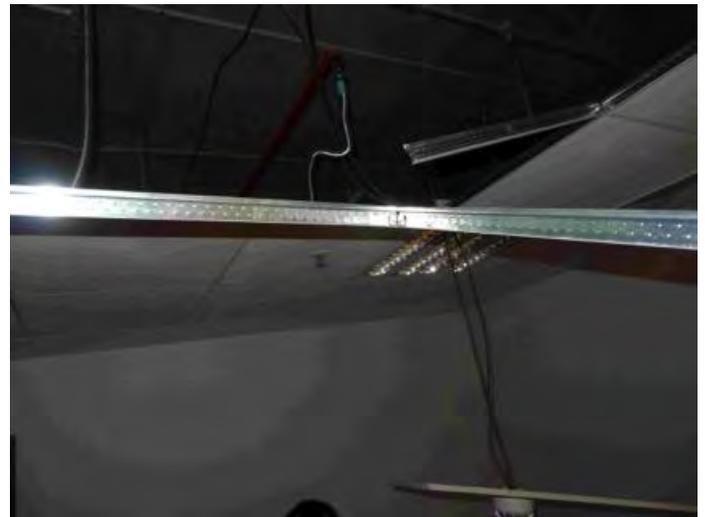
Figure 6-24. (a) Damage to plaster ceiling close to the walls in Grande Hospital, Kathmandu and (b) damage to acoustic ceiling tiles; however, photo b also shows good performance of flexible connections between the water branch line to the sprinkler heads (photos: Hari Kumar).

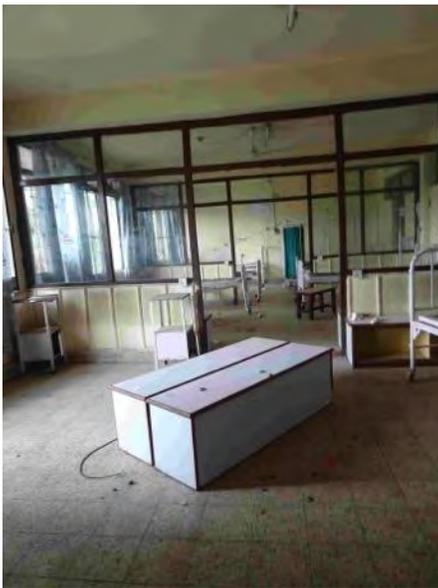
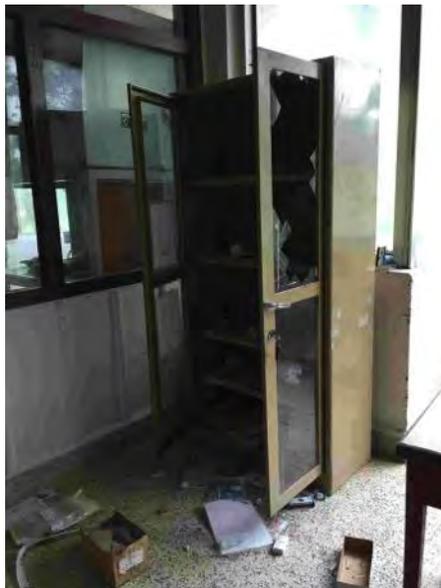
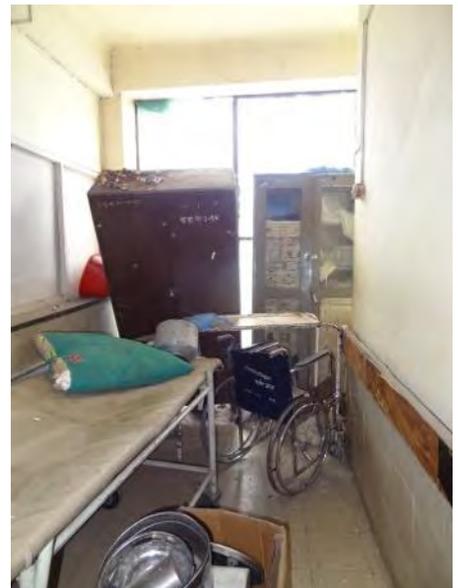
Building contents including cupboards, computers, and most furniture were dislodged and damaged in several locations visited by the EERI team (Figure 6-25); however, most undamaged displaced content had been restored at the time of the team's visit. Several hospitals reported loss of equipment in cases where this equipment had not been seismically anchored. Some schools reported loss of computers and science lab supplies, in cases where nonstructural mitigation measures had not been carried out prior to the earthquake.

Figure 6-25. Damage to storage cabinets and other furniture at various hospitals (photos: Hari Kumar).

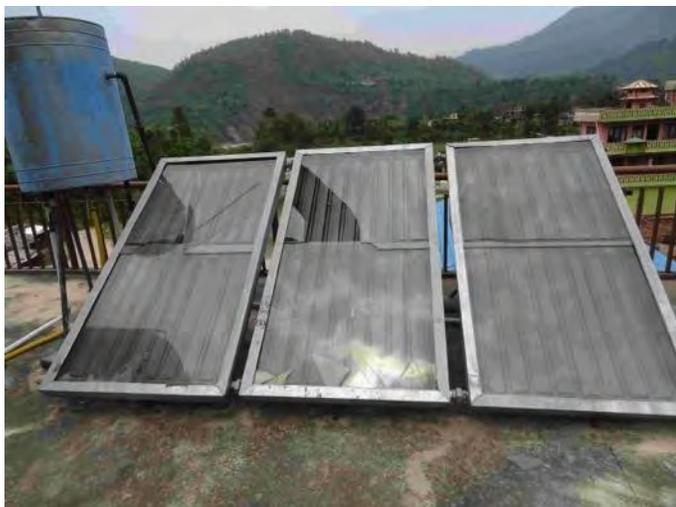
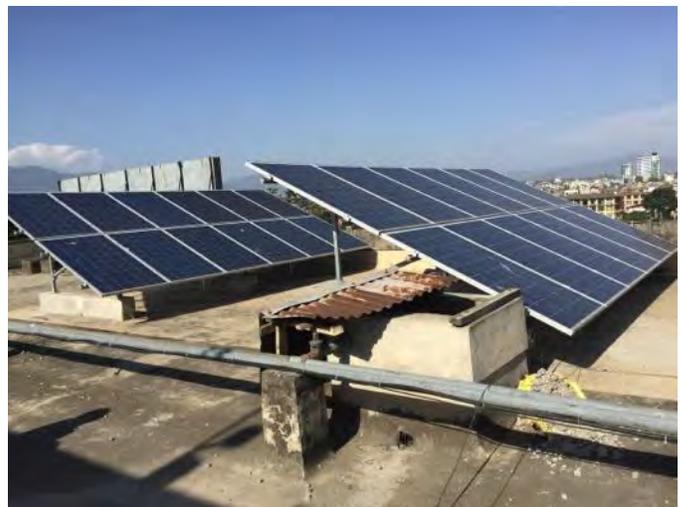
Figure 6-26 contrasts two sets of roof top solar panels. One unanchored panel array suffered damage and was not functional, while the other anchored array remained fully functional.

Figure 6-26. (a) Damaged and dysfunctional array of solar panels atop a building in Aanbu Khaireni, Tanahun District because the panel on the left had not been anchored (photo: Hari Kumar) and (b) well anchored array of solar panels at the Bir Hospital Kathmandu that remained functional (photo: Judith Mitrani-Reiser).

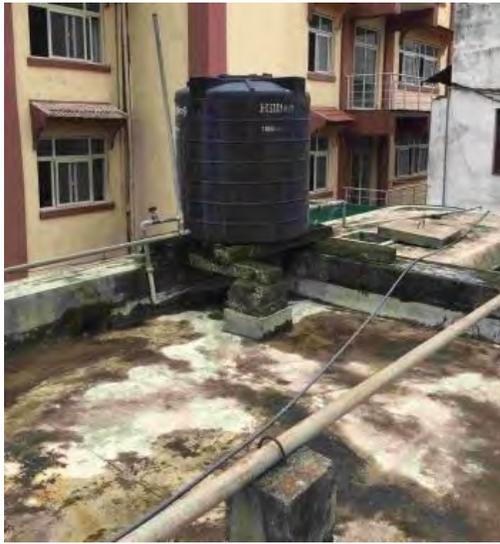
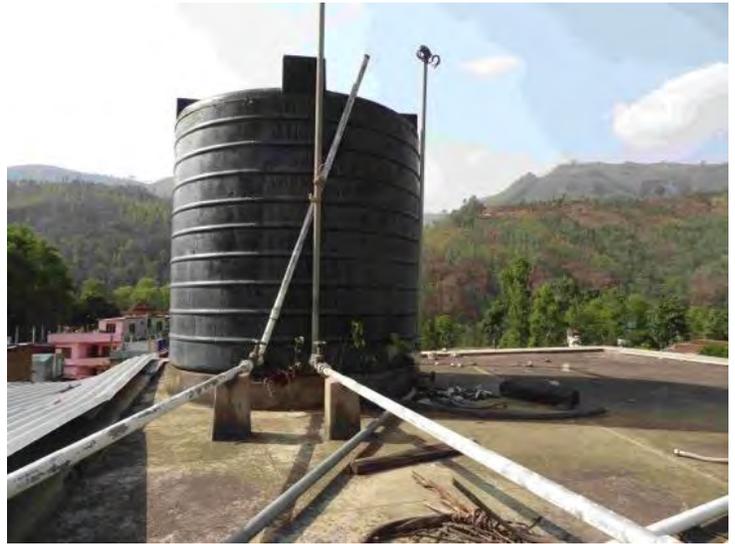
Plastic water tanks on rooftops were often observed to be unanchored and placed on minimal 'supports' without restraints or flexible connections as shown in Figure 6-27. While many of these support structures and tanks were found unaffected by the earthquake shaking, this may not be the case in future earthquakes. The Nepal Building Code should introduce guidance on provisions for anchoring of rooftop elements for earthquake safety.

Figure 6-27. Examples of plastic rooftop water tanks that are unanchored and placed on minimal 'supports' without restraints or flexible connections (photo a: Judith Mitrani-Reiser and photo b: Hari Kumar).

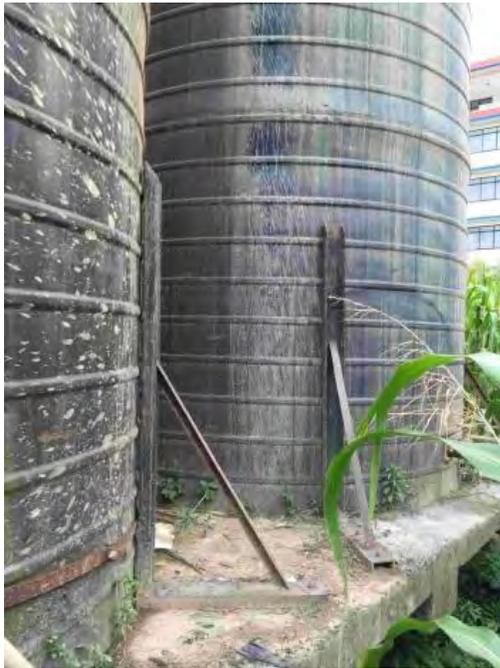
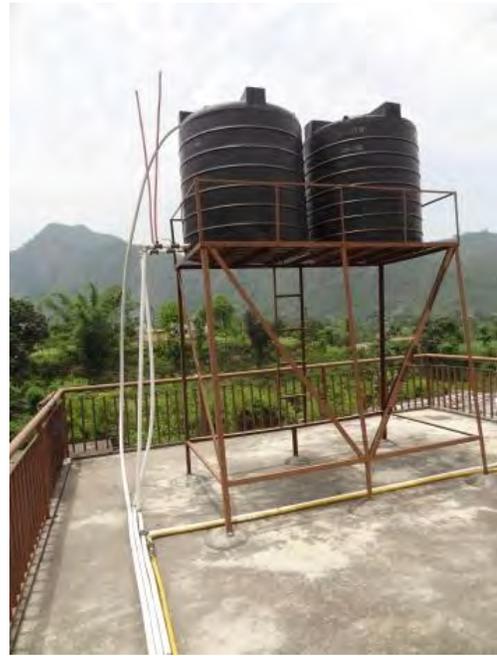
Figure 6-28. (a) Anchored tall water tanks provided at the Kanti Children's Hospital built with technical support from the Government of Japan performed well (photo: Judy Mitrani-Reiser) and (b) a raised water tank support structure with minimal anchorage details including plain cement concrete at base supports and side restraints that may not be strong enough to keep full tanks from sliding off (photo: Hari Kumar).

The dangers posed by nonstructural hazards have been understood in Nepal for over a decade, and several projects have addressed the issue in the recent years (NSET, 2012, GHI, 2013). The team observed the nonstructural mitigation and preparedness efforts at the Tribhuvan University Teaching Hospital which helped the hospital continue functioning better than most other hospitals in Kathmandu. Several other examples of good performance were observed at the Kanti Children's Hospital that was built with technical support from the Government of Japan. Figure 6-28a shows tall water tanks with superior anchorage detailing; however, this practice does not seem to have been replicated in tanks commissioned on the hospital premises since its initial construction. Figure 6-28b shows an example of a raised water tank support structure, similar to what is commonly seen across Nepal. In the case shown, the legs are poorly anchored with blocks of plain cement concrete and the side restraints may not be strong enough to keep full tanks from sliding off or tipping over. Even these limited mitigation measures, however, are an improvement over the previous practice of no anchorage at all. Figure 6-29 shows examples of flexible connections at both hospitals that also helped to prevent damage and leaks of water and fuel.

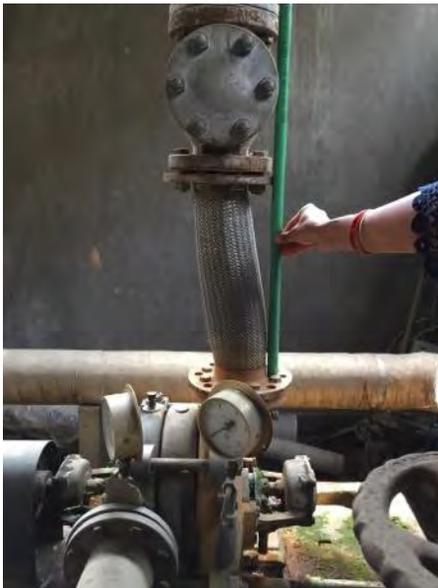
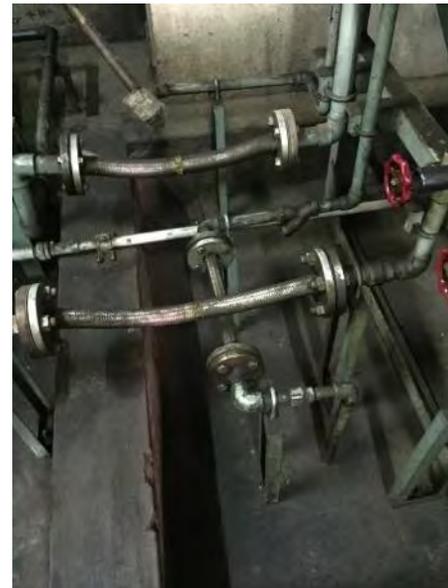
Figure 6-29. Flexible connectors seemed to have prevented the connections from breakage during the earthquake (a) in the water supply system at the Tribhuvan University Teaching Hospital (photo: Hari Kumar) and (b) in the generator fuel supply line at the Kanti Children's Hospital (photo: Judith Mitrani-Reiser).

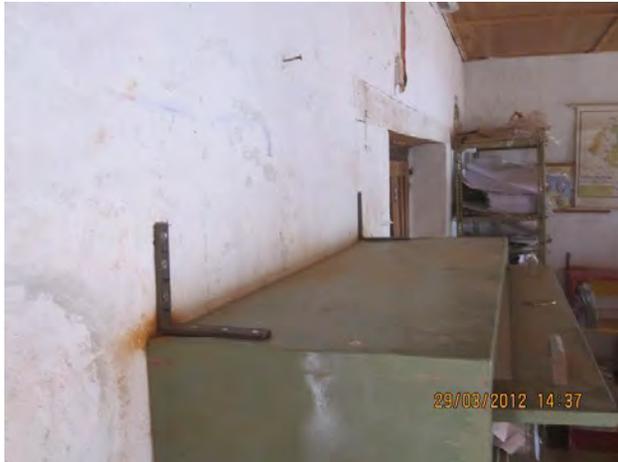
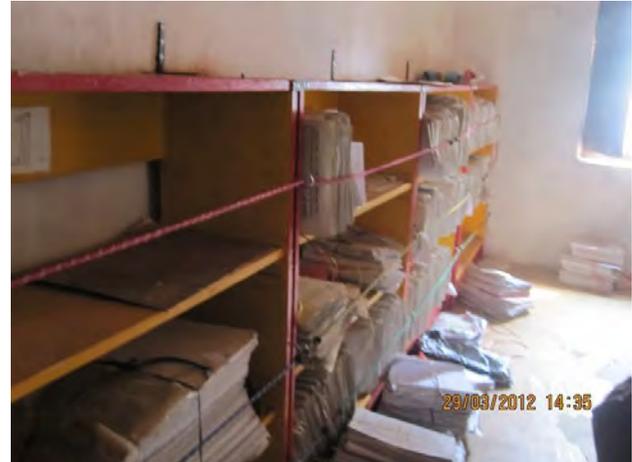
Several schools completed retrofitting projects prior to the earthquake to anchor contents such as cupboards in libraries and science labs (Paci-Green, et al., 2015). Figure 6-30 shows an example of the retrofitting techniques used in retrofit programs supported by NSET (2016).

Figure 6-30. Examples of anchorage details used for cupboards and bookshelves in schools retrofitted by NSET prior to the earthquake (photos: Surya Acharya).

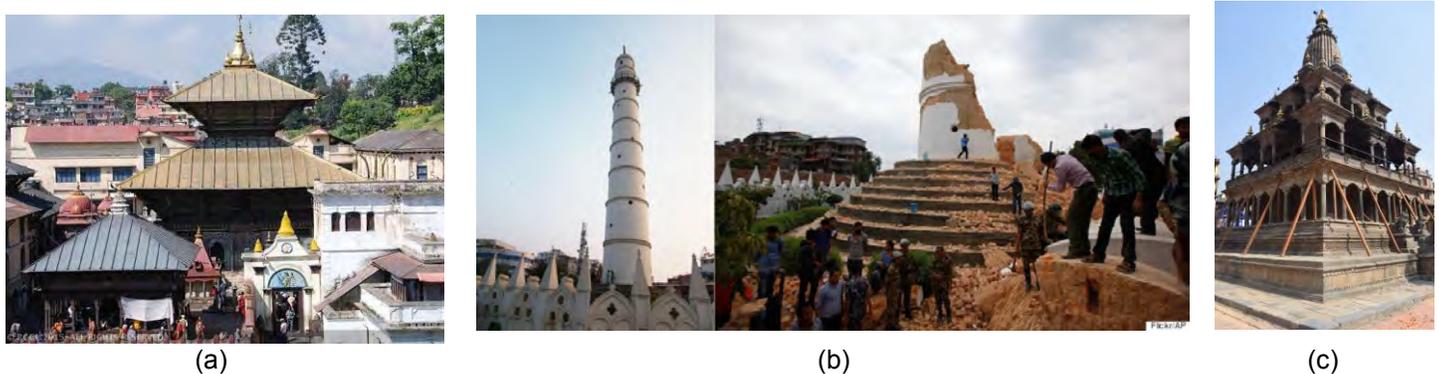
Based on construction characteristics, there are three basic typologies of cultural heritage structures in Nepal, as shown in Figure 7-3: brick masonry with timber, brick masonry without timber, and stone.

The first typology consists of temples with one to five diminishing tier symmetric structures made from brick masonry and timber structural elements (Figure 7-3a). The ground floor consists of a Sal wood (*Shorea Robusta*) timber framing system, which supports the wall above it (Figure 7-4). The timber columns on the base level stand on the base stone with a small pin inserted on the stone base. The top of the timber columns has a pin that extends into the beam above. The beam has a bracket, and it supports battens or joists upon which planks are laid. These in turn support the final floor finish. Additional lateral bracing is provided by linking the vertical and horizontal structural components to prevent relative sliding of the floor structure on the walls, thus creating a box behavior response. This connection is made using wedges or timber pegs that fix the wall plate along the perimeter through the joists that run both inside and outside the building.

Figure 7-3. Three typologies of heritage structures per construction material, (a) PashupatiNath Temple – brick masonry with timber structure (photo: Suraj Shrestha), (b) Bhimsen Tower – brick masonry (source: Kelly, 2015), and (c) Krishna Temple – stone (photo: Suraj Shrestha).

The second typology consists of brick masonry structures in lime or mud mortar. These are typical load bearing masonry structures with no timber frames that contain only nonstructural timbers, if any. Bhimsen Tower (also called as Dharahara) is a typical example of this type. It was a nine-story unreinforced brick masonry tower built in 1825 with a height of 203 feet. The main material used in the building construction is *Vajra*, which is a typical Nepali material made from “Surkhi” or brick dust, “Chuna” or lime, “Mas ko Dal” or black lentils, and “Chaku” or caramel. There is typically no iron reinforcement in this *Vajra* material, as was the case for the Bhimsen Tower. This tower was completely destroyed by April 25 main shock as shown in Figure 7-3b.

The third typology consists of temples made from stone. Krishna Temple of Patan Durbar Square is the famous stone temple of this type, which was built in 1723 (Figure 7-3c). It did not suffer any damage from the Gorkha Earthquake or

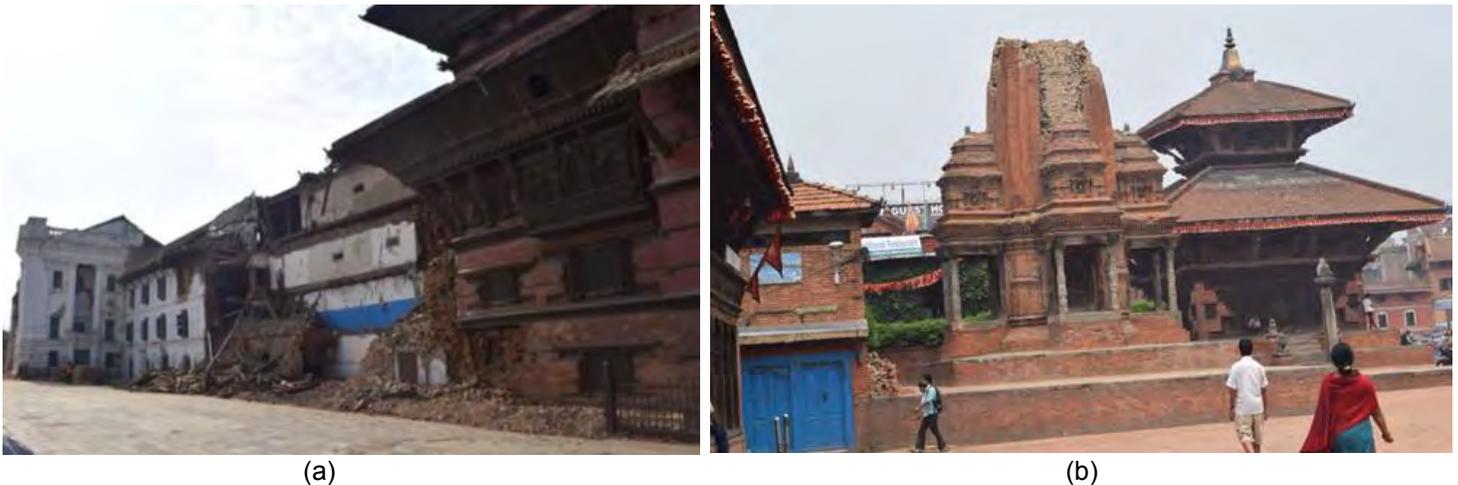
Figure 7-6. Examples of damage to cultural heritage sites: (a) Kathmandu Durbar Square, and (b) Bhaktapur Durbar Square (photos: Suraj Shrestha).

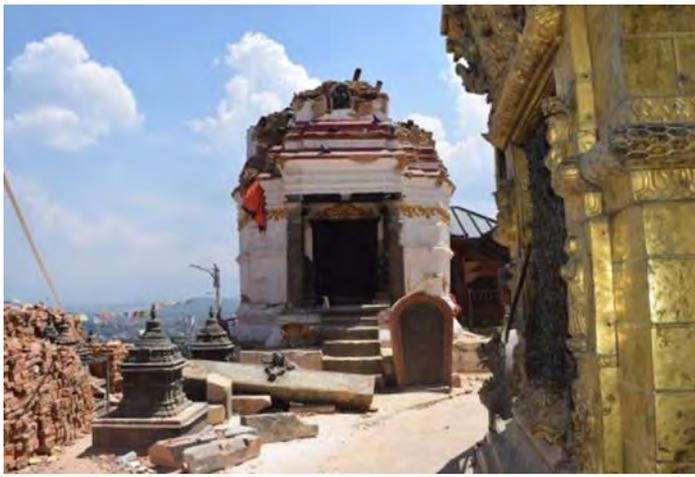
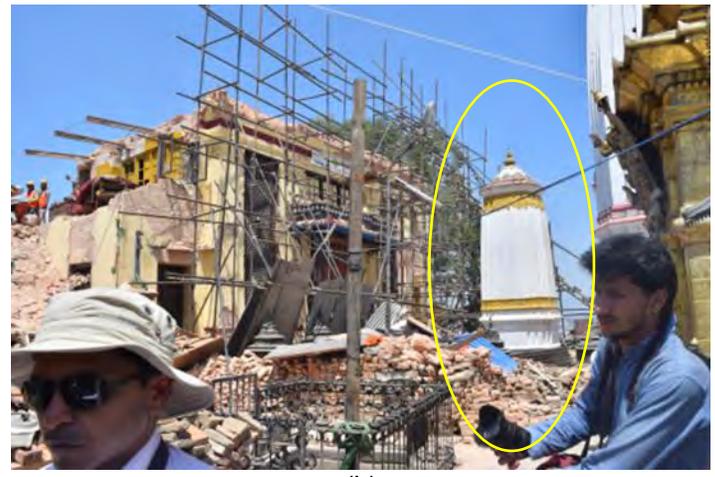
The performance of monuments in the earthquake varies greatly from monument to monument and from place to place. Despite similar construction materials and architectural features, some monuments collapsed at one location while others at a different location survived. In some other cases, nearly identical monuments on the same site suffered vastly different levels of damage (Figure 7-7). For example, in Patan Durbar Square, many temples remained standing, but a few temples like Char Narayan and Sankhar Narayan completely collapsed. In Kathmandu Durbar Square, the Kasthamandap, Maju Dega, Narayan Vishnu, Trailokya Mohan, and Chasin Dega Temples were heavily damaged.

Figure 7-7. Examples of varying degrees of damage to similarly constructed temples at Swayambhu: (a) Anantapur Temple with a collapsed superstructure, and (b) Pratappur Temple with an undamaged superstructure and some limited plinth damage (photos and annotations: Suraj Shrestha).

Pratappur Temple of Swayambhu suffered minor damage to its plinth. Maintenance of the superstructure of this temple was done after being damaged partly by fire in 2003 and by lightning in 2011. However, the similar, adjacent temple Anantapur had not received any recent maintenance and experienced superstructure collapse (Figures 7-7 and 7-8a).

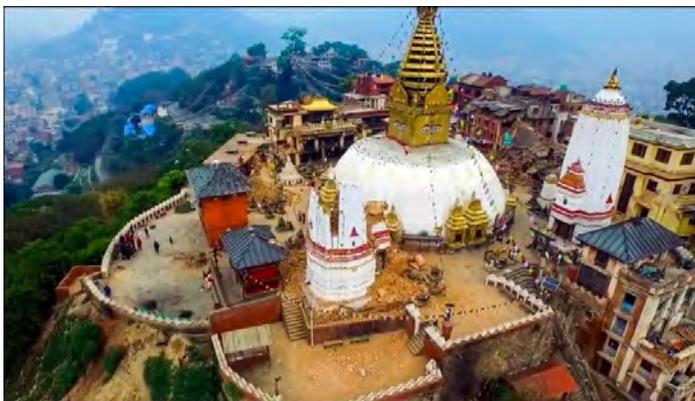
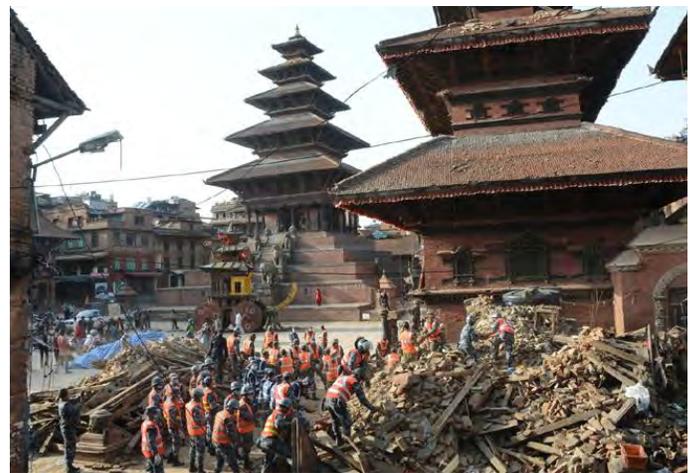
Topographic effects that weaken or amplify the earthquake shaking at certain sites may also be a reason why some structures fell and some survived. The effects of hilltop amplification were seen clearly in Swayambhu which lies atop the crest of a hill (Figure 7-8a).

The underlying geological conditions below temples—including the depth of the water table, thickness and type of sediments, and proximity of bedrock to the surface—may also be major contributing factors; however, limited studies have been conducted on geological conditions for most temples. Most of the temples of Taumadhi Square in Bhaktapur including Nyatapola suffered much less damage not only in this earthquake (Figure 7-8b) but in previous earthquakes as well, which may be due to the nature of the soil. Detailed study is needed to verify this possible conclusion.

Figure 7-8. (a) Hilltop amplification may have exacerbated damage in Swayambhu (source: Albinger, 2015), and (b) Taumadhi Square of Bhaktapur suffered less damage in many historic earthquakes, which may be due to its underlying soil characteristics (source: Rauniar, 2015).

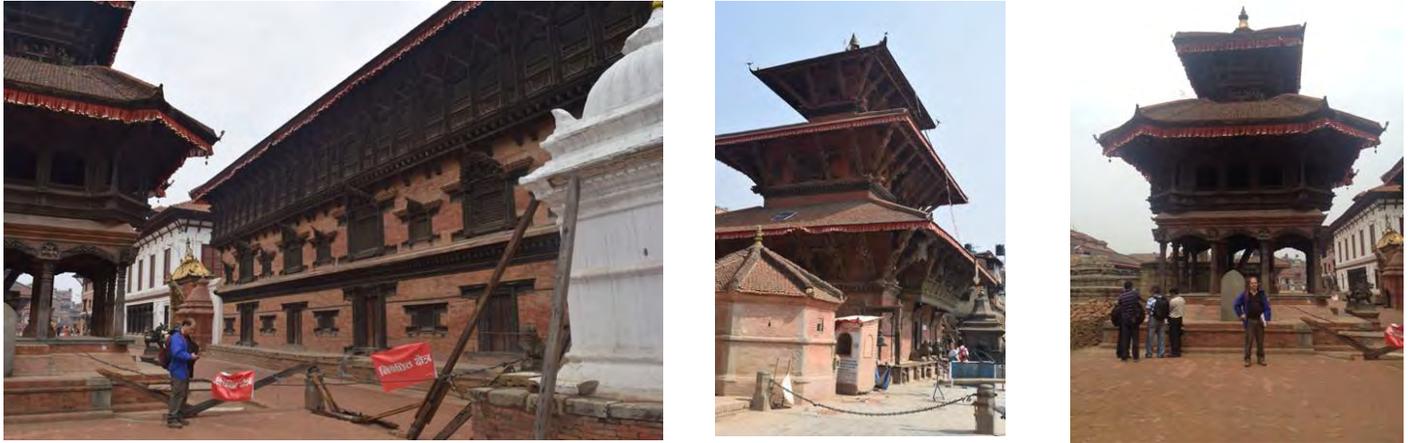
Figure 7-9. Restored monuments performed well: (a) 55 Window Palace of Bhaktapur Durbar Square, and (b) Bhimsen Temple of Patan Durbar Square, and (c) Chyasilin Mandap of Bhaktapur Durbar Square (photos: Suraj Shrestha).

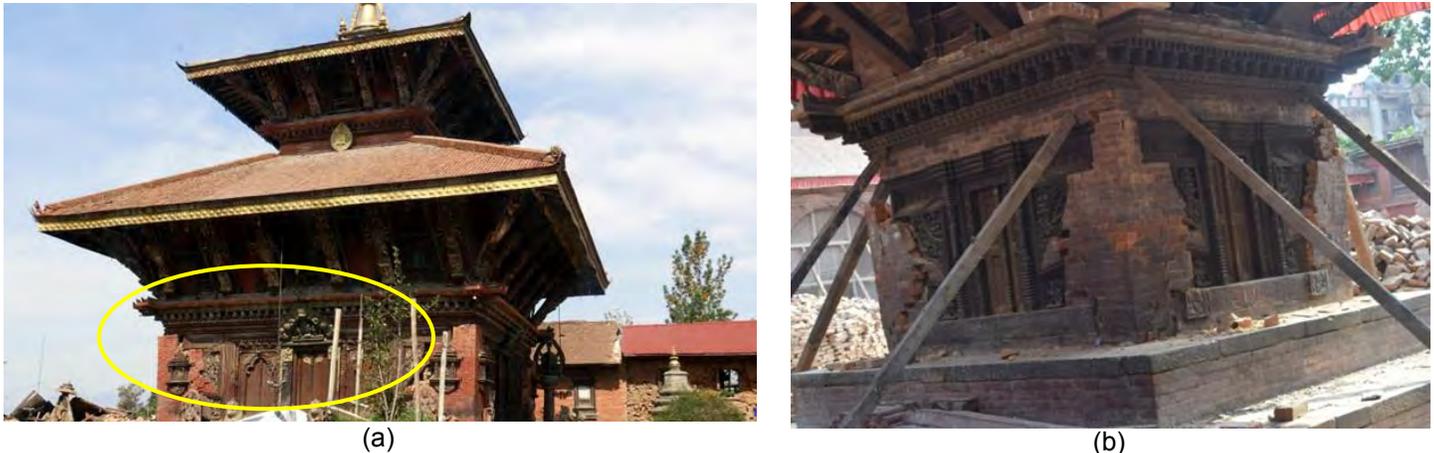
Figure 7-10. Temples supported by timber structures with brick masonry infill performed better than pure masonry structures: (a) Changu Narayan Temple, and (b) a temple in Kathmandu Durbar Square (photos and annotations: Suraj Shrestha).

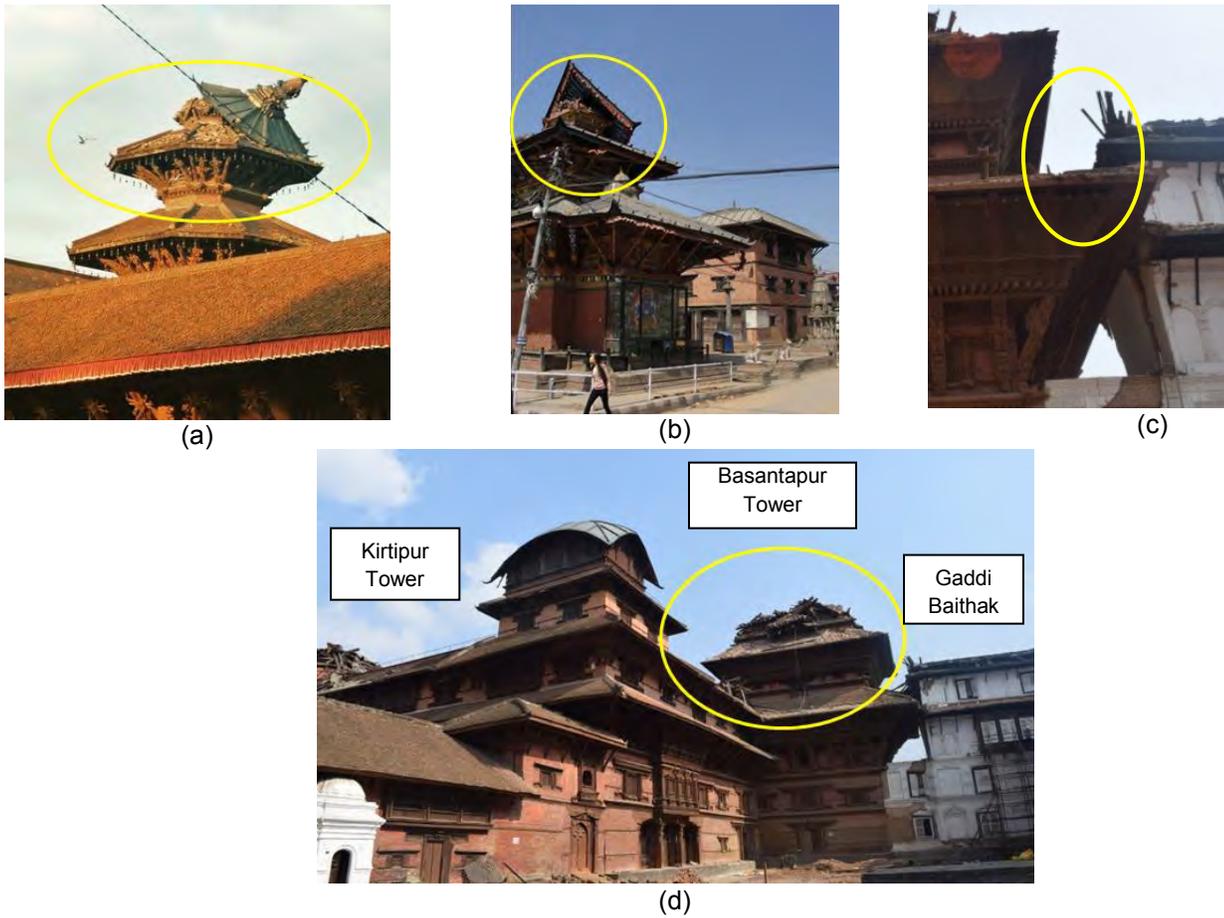
Figure 7-11. Examples of the collapsed upper stories of multi-tiered temples: (a) Taleju Temple in Patan Durbar Square (source: Shrestha, 2015a), (b) Jayabageshwori Temple in Gaushala, Kathmandu, (c) close view of pounding effect between nine-story Basantapur Tower of Kathmandu Durbar Square and Gaddi Baithak, and (d) the nine-story Basantapur Tower of Kathmandu Durbar Square (shown in center) lost two top stories (photos and annotations: Suraj Shrestha).

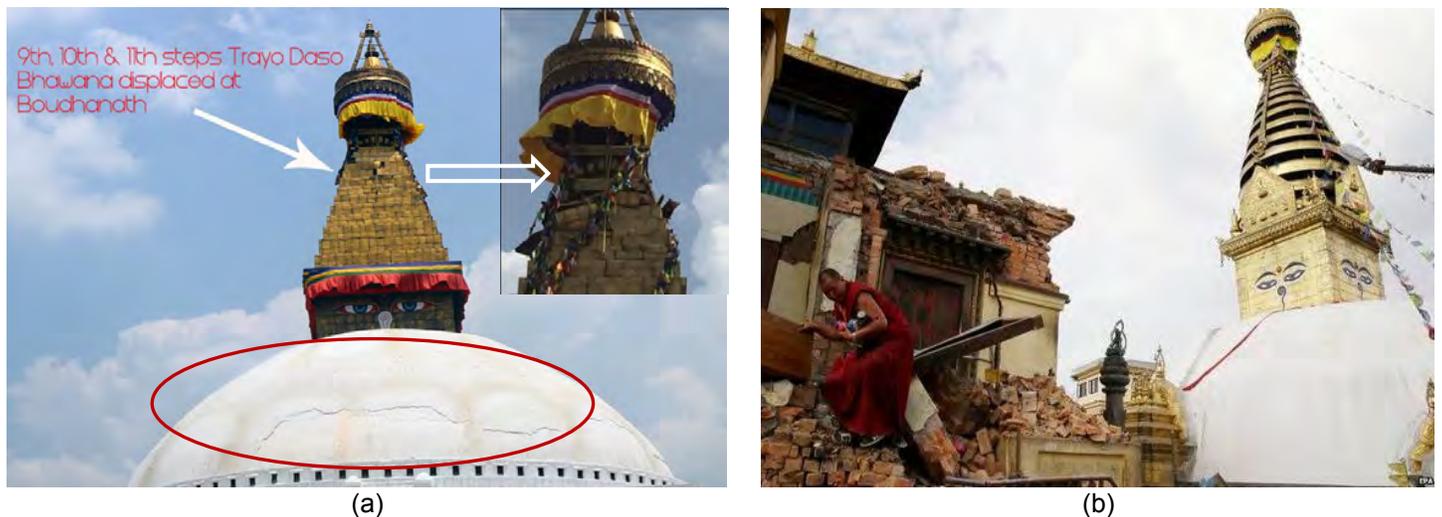
Figure 7-12. Most Stupas performed well: (a) Boudhanath Stupa (source: Explore Himalaya, 2015, Bodhivastu, 2015), and (b) Swayambhu Stupa (source: BBC, 2015).

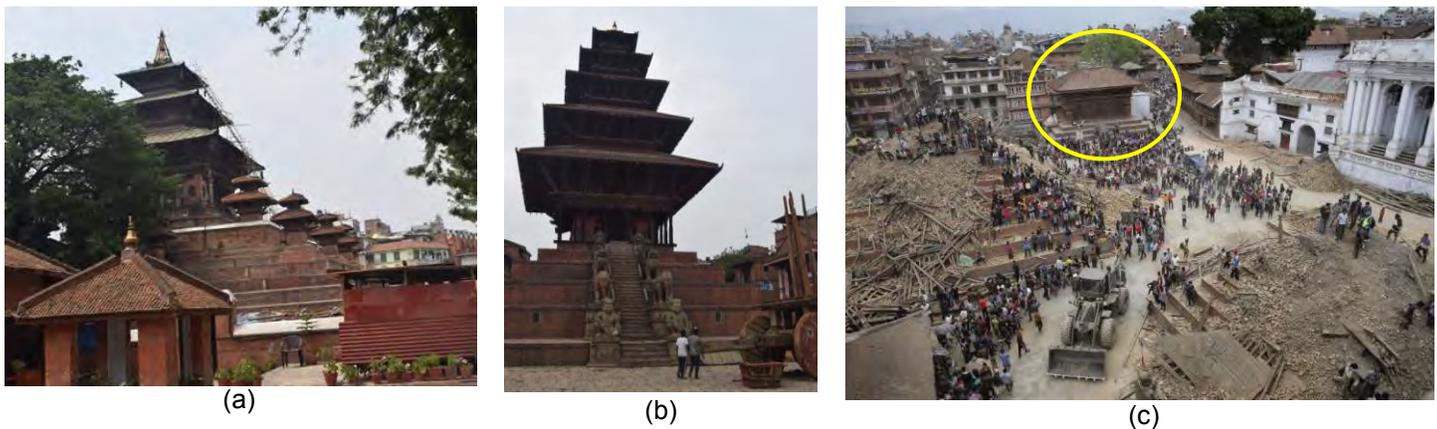
Figure 7-13. Most of the temples with a wide plinth base performed well though a few collapsed: (a) Taleju Bhawani Temple of Kathmandu Durbar Square (photo: Suraj Shrestha), (b) Nyatapola in Bhaktapur built in 1702 survived Great Earthquakes of 1833, 1934 and 2015 (photos: Suraj Shrestha), and (c) Maju Dega of Kathmandu, a tall multi-tiered temple with a wide base, collapsed (in foreground) while other low rise masonry structures on site performed well as indicated by the circled building in the rear center of the photo (source: Shrestha, 2015c).
