EERI Earthquake Reconnaissance Team Report: M7.8 Gorkha, Nepal Earthquake on April 25, 2015 and its Aftershocks

May 2016

A product of the EERI Learning From Earthquakes Program

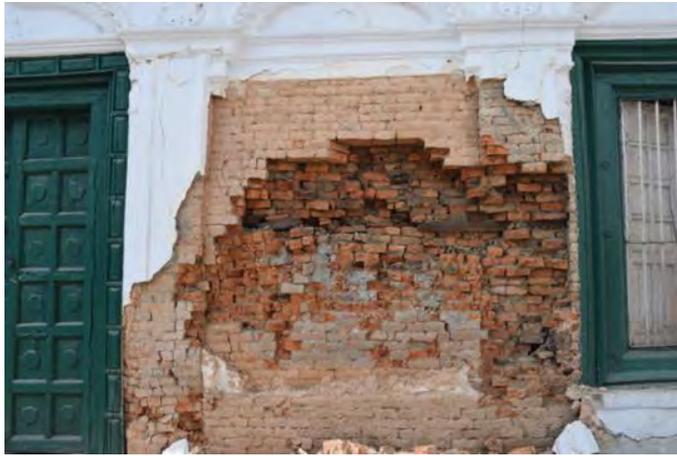
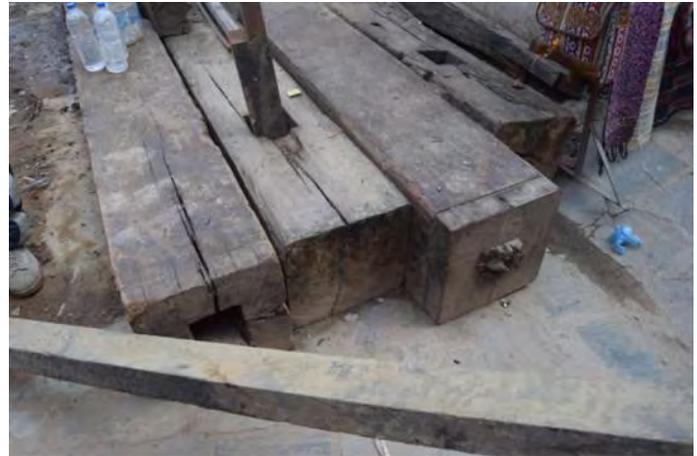
Another main reason for failure of heritage structures is the quality of materials and construction. Some of the brick quality, especially in the neo-classical building of Gaddi Baithak in Kathmandu Durbar Square, was poor compared to other heritage buildings. This resulted in failure to the outer layer of the walls (Figure 7-14a).

Poor maintenance and deterioration was also repeatedly reported as the main cause of failure. This deterioration was often exemplified by rotten wood members (Figure 7-14b). Loose capitals, deterioration of the timber column dowel

connecting the column to the stone base, or loose connections between timber columns and beams have also been reported to be the cause of damage in some cases.

Figure 7-14. (a) Poor quality of bricks in a neoclassical heritage structure in Kathmandu Durbar Square, and (b) rotted timber taken out from a collapsed temple in Kathmandu Durbar Square (photos: Suraj Shrestha).

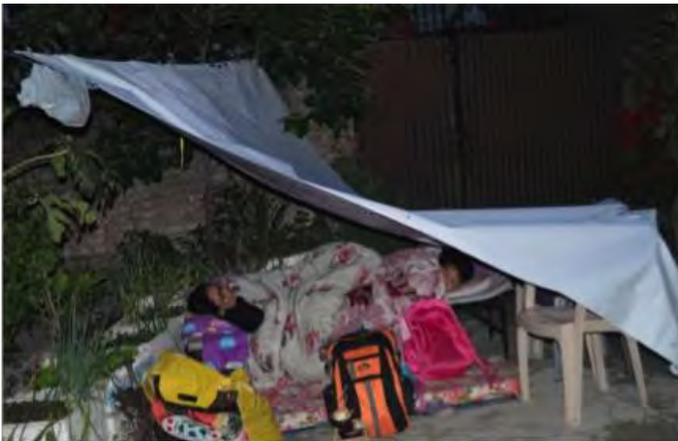
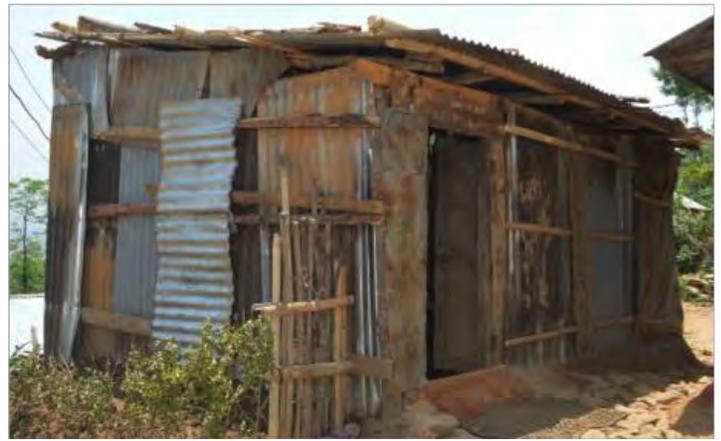
Figure 8-9. (a) Emergency shelter next to damaged building in Bagdol, Lalitpur, and (b) Emergency shelter using salvaged materials in Chalnakhel, Kathmandu (photos: Ganesh Kumar Jimée).

The United Nations shelter cluster system (also described in Chapter 9, Section 9.6) was activated to coordinate shelter related activities in affected districts through the District Disaster Relief Committee (DDRC). The Government of Nepal provided 5,000 Nepalese Rupees (NPR) per totally collapsed building and 3,000 NPR per partially damaged building (MOHA, 2015) as immediate support. The Government also instituted a 'One Door Policy' to distribute all relief materials through Government authorities, but it was not effective. Many organizations, individual donors, and volunteer groups independently provided shelter materials and supported displaced people who needed to construct emergency shelters. Very few people stayed in the formal group shelters. It was observed that most of the affected people constructed emergency shelters near their damaged buildings and property using salvaged materials (Figure 8-9b). The major problem in these shelters was of lack of water, food, and sanitation.

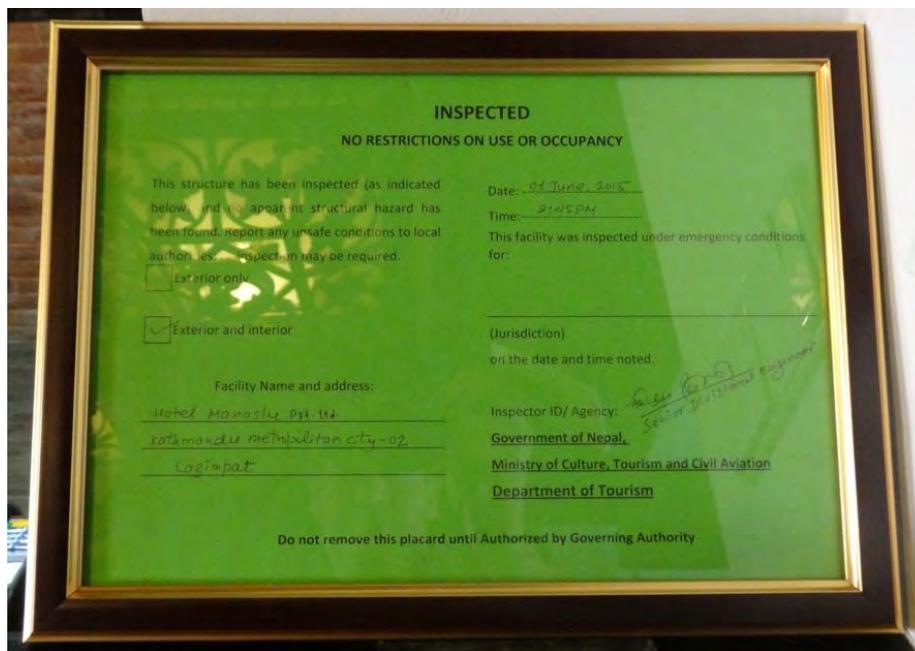
Figure 8-10. Placard at hotel front desk in Kathmandu (photo: Bret Lizundia).

Various types of placards were observed. At the check-in desk of the hotel where the EERI team stayed while they were in Kathmandu, the building had minimal damage, and there was a framed copy of a placard the hotel had received. It is shown in Figure 8-10. The inspecting agency was identified as the Department of Tourism. The level of technical expertise used by the Department of Tourism and the extent of structures they tagged are not known, but relatively few buildings are assumed to have been tagged by this agency.

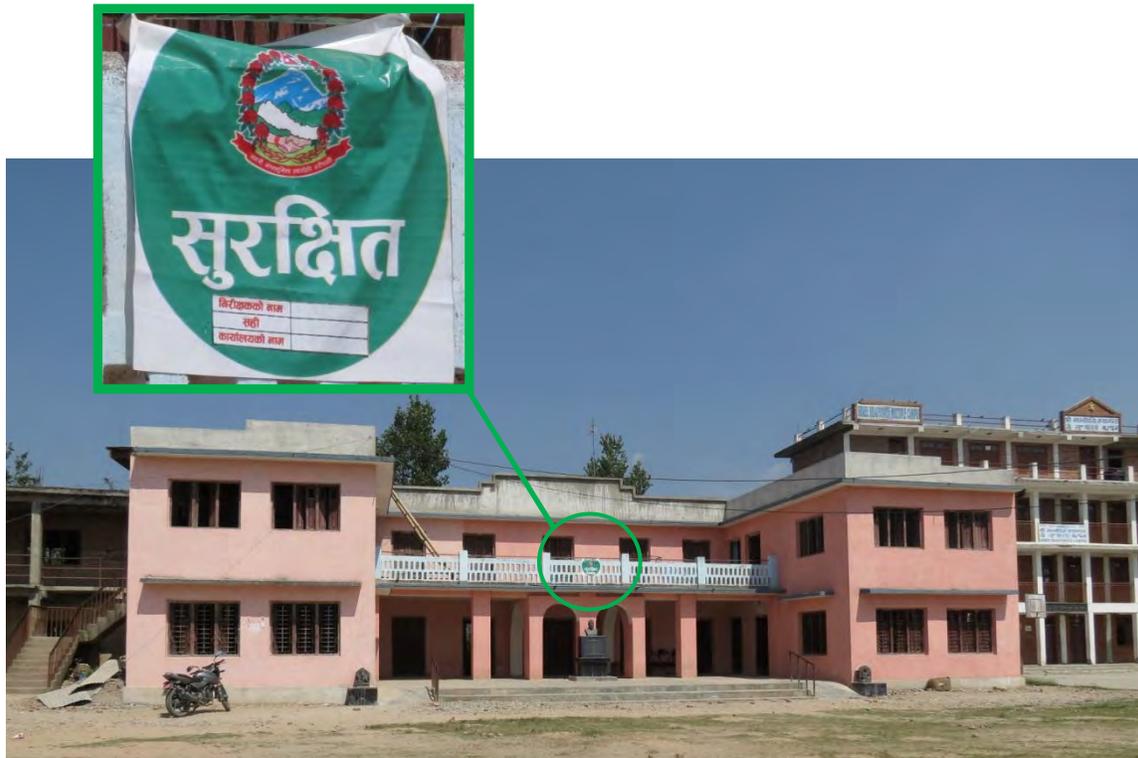
Figure 8-12. School building with a green tag by the Department of Education in Sankhu (photo: Hemant Kaushik, annotations: Bret Lizundia).

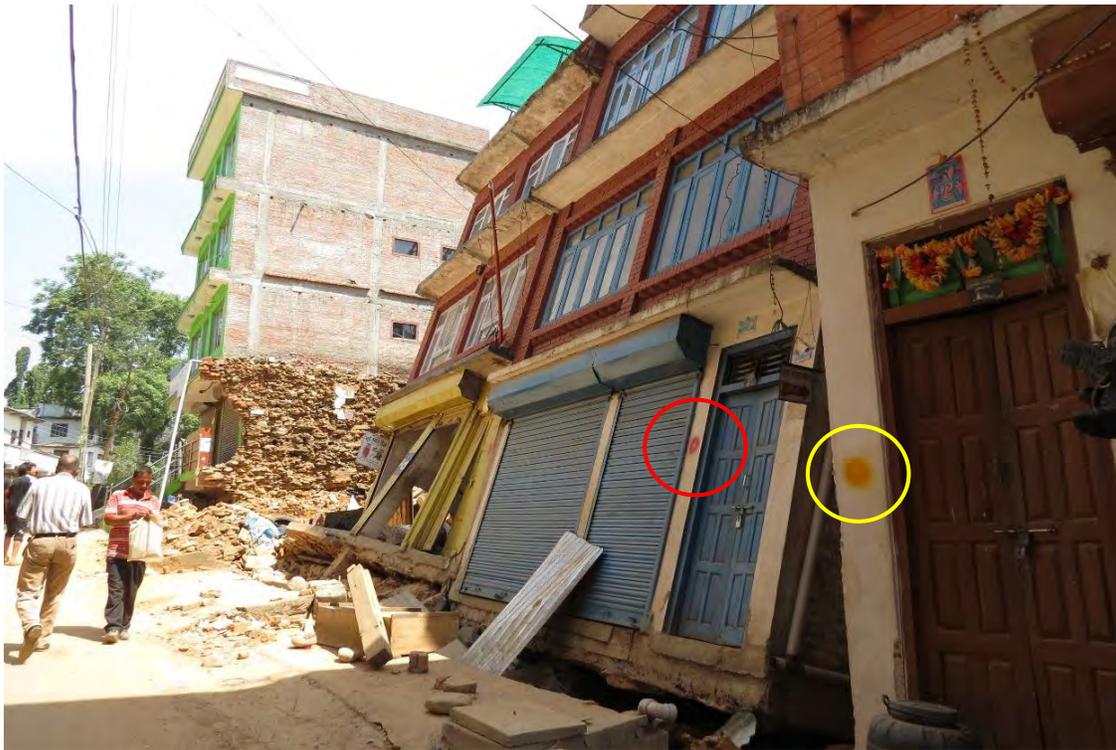
Figure 8-13. Spray painted postearthquake safety evaluation results of buildings on the main street in Chautara, Sindhupalchowk (photo: Hemant Kaushik, annotations: Bret Lizundia).

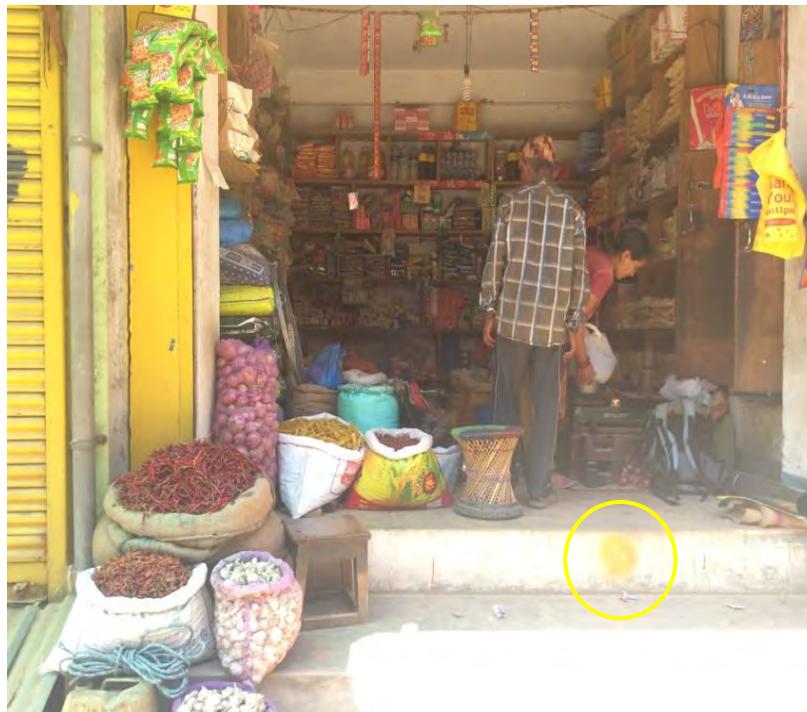
Figure 8-15. Occupied yellow-tagged store in Chautara, Sindhupalchowk (photo: Jan Kupec, annotations: Bret Lizundia).

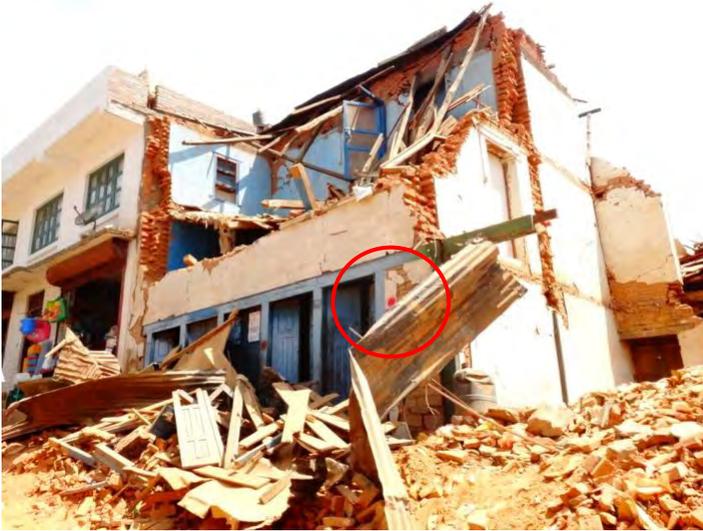
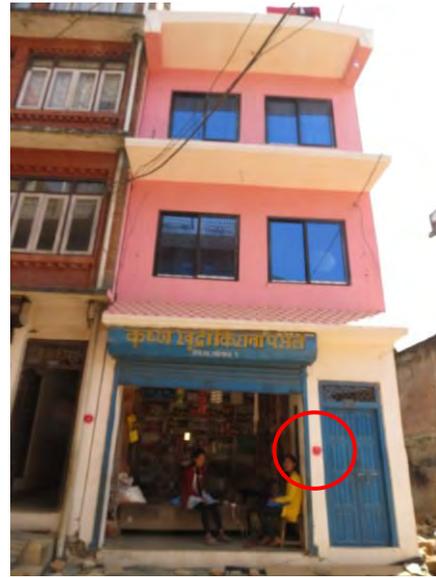
Figure 8-16. (a) Vacated red-tagged structure in Chautara, Sindhupalchowk (photo: Bret Lizundia), and (b) Occupied red-tagged structure in Chautara, Sindhupalchowk (photo: Hemant Kaushik).

The language and intent for red-tagged UNSAFE structures is similar in the NSET/DUDBC guidelines and in ATC-20-1. Such structures are not to be occupied. Figure 8-16a shows a heavily damaged building in Chautara that was posted with a red spray painted dot. It was vacated. However, we did see some with red dots that were still occupied. Figure 8-16b shows an example. Enforcement of tagging status was not observed in Chautara or typically in other areas of the country. An exception was a heavily damaged apartment complex in Dhapasi, a suburb of Kathmandu. These reinforced concrete frame buildings with masonry infill at the top of a hill are shown in Figure 8-17a and had been tagged UNSAFE and vacated. Security guards enforced the closure. The tag posted at the closed gate is shown in Figure 8-17b.

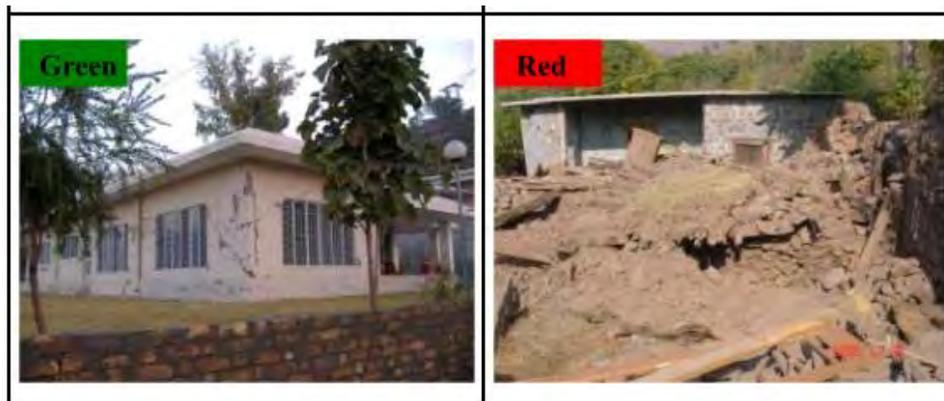
Figure 8-19. Rapid Evaluation Safety Assessment Form guidance photos (source: NSET/DUDBC, 2009).

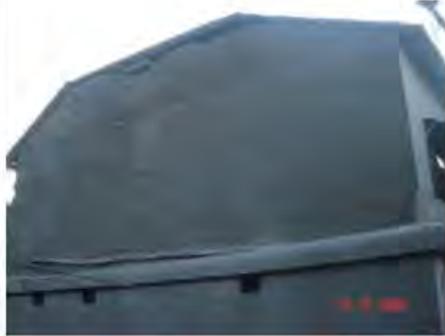
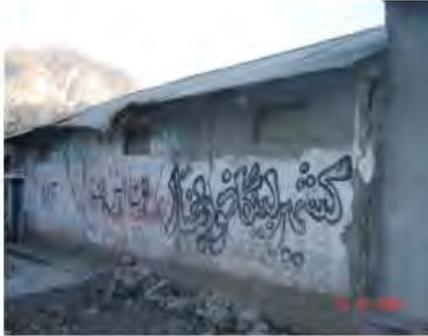
<p>Thin cracks in many walls, falling of plaster in last bits over large area, damage to non-structural parts like chimney, projecting cornices; The load carrying capacity s not reduced appreciably.</p>	<p>Architecture repairs needed, Seismic strengthening advised.</p>

The NSET/DUDBC Detailed Evaluation differs from that in ATC-20-1. The Detailed Evaluation does not have placard status. There are five “Damage Grades” and retrofit/demolition recommendations. Images are used to illustrate the damage grades. Damage Grade 1 is the equivalent of a green tag. Damage Grades 4 and 5 are for partially or totally collapsed structures that would be red-tagged. Damage Grades 2 and 3 cover the wide spectrum between Damage Grade 1 and Damage Grade 4. Figure 8-20 shows an excerpt of the definitions from Damage Grades 2 and 3. Evaluators told the EERI team that more detail and more examples for the Damage Grade 2 and 3 categories would be helpful.

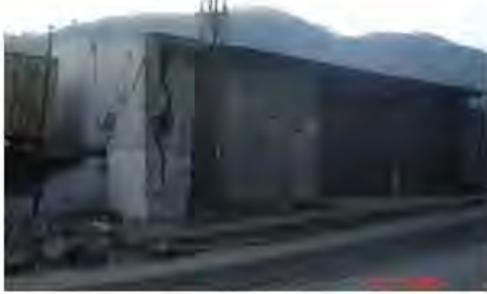
Damage Grade 3

<p>Large and extensive cracks in most walls, roof tiles detach, tilting or falling of chimneys, failure of individual non-structural elements such as partition/ gable walls. Load carrying capacity of structure is partially reduced.</p>	<p>Cracks in wall need grouting, architectural repairs required, Seismic strengthening advised</p>

Figure 8-20. Detailed Evaluation Damage Grade definitions (source: NSET/DUDBC, 2009).

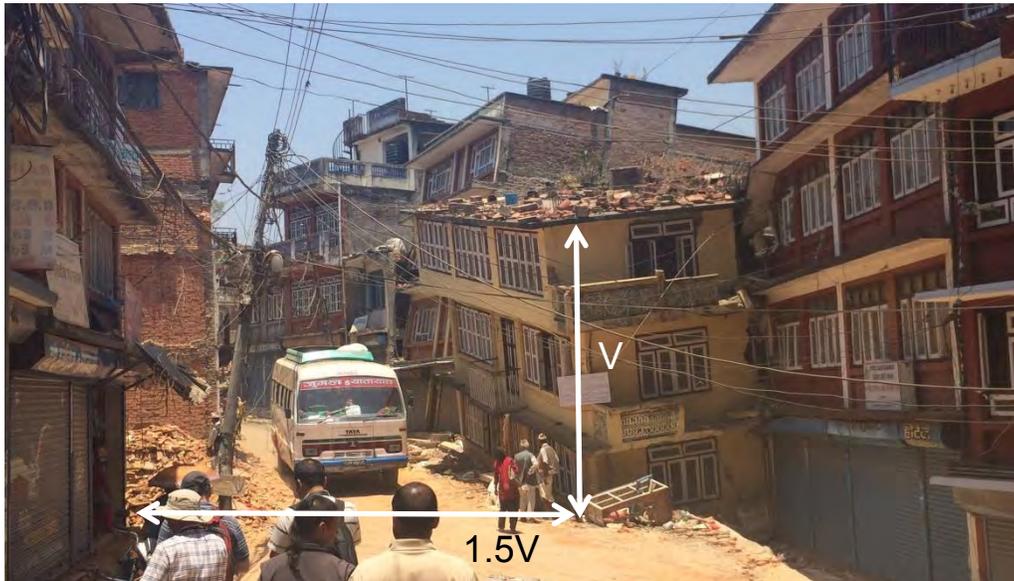
Figure 8-21. Leaning building with ground story collapse next to main street in Chautara, Sindulpalchowk (photo: Jan Kupec, annotations: Bret Lizundia).

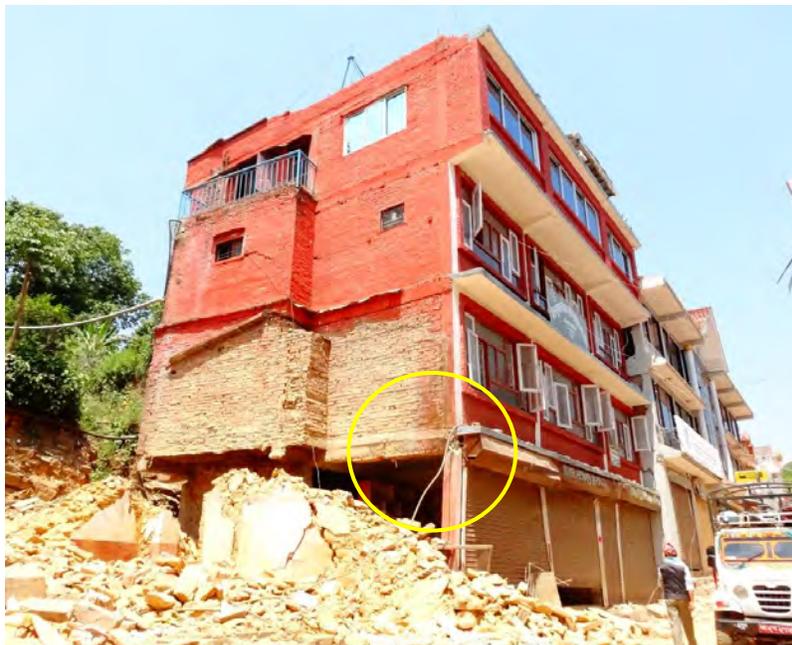
Figure 8-22. Damaged reinforced concrete frame with masonry infill in Chautara (photo: Bret Lizundia).

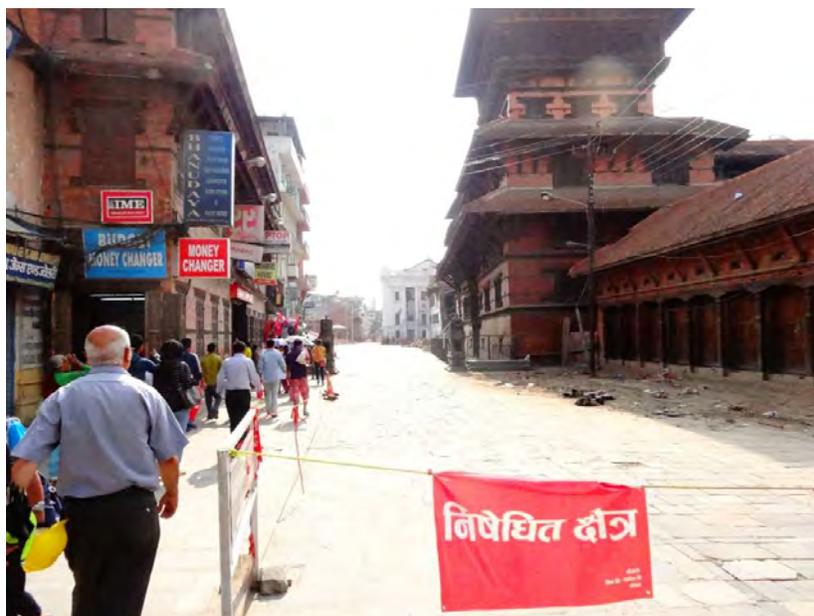
Figure 8-23. Light “barricade” guardrail installed in street surrounding damaged heritage structures in Kathmandu's Durbar Square (photo Bret Lizundia).

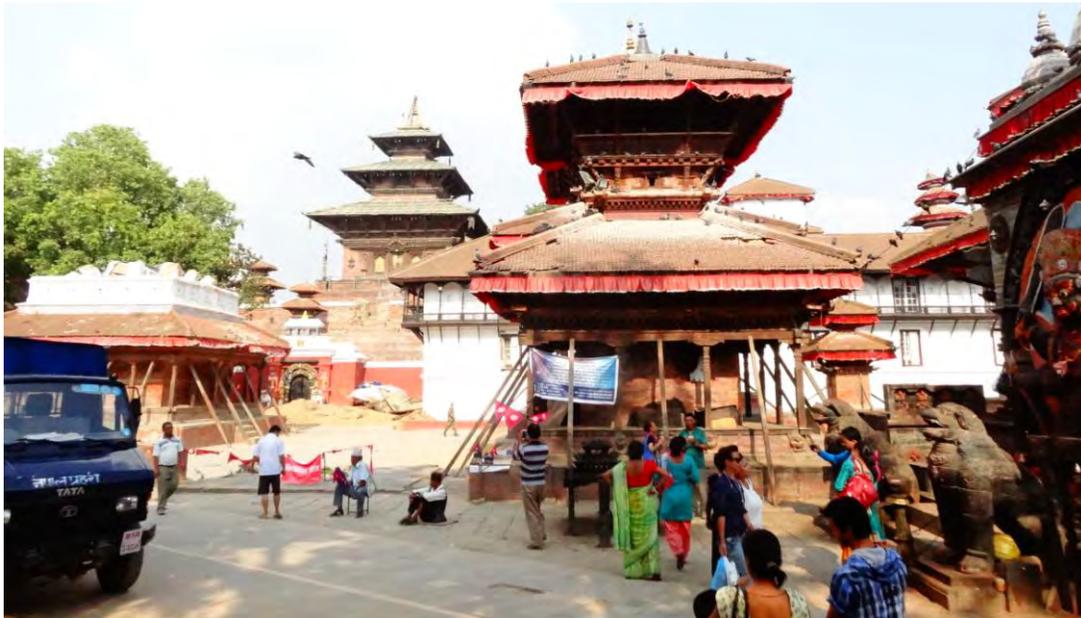
Figure 8-24. Shoring of bottom tier of temple in Kathmandu Durbar Square (photo: Bret Lizundia).

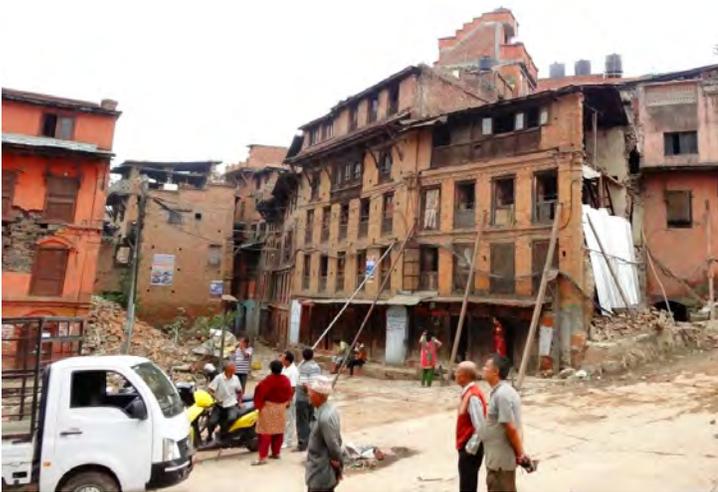
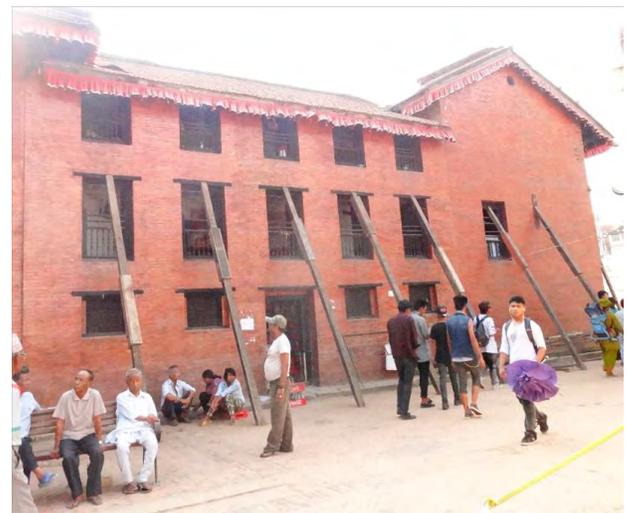
Figure 8-25. (a) Heavily damaged brick masonry bearing wall structure with light shoring in Bhaktapur (photo: Bret Lizundia), and (b) shoring of a lightly damaged masonry building adjacent to the street across from Kathmandu Durbar Square (photo: Bret Lizundia).

By the time of the EERI visit, shoring had been installed at many structures including both temples and buildings. Typically, wooden posts of about 100 mm by 100 mm were used. Figure 8-24 shows a shoring at the lower tier of two temples in Kathmandu's Durbar Square. Figure 8-25a shows a heavily damaged masonry structure in Bhaktapur with a lost façade on one side and a leaning façade on the other side. Figure 8-25b shows bracing of a lightly damaged masonry façade adjacent to Kathmandu's Durbar Square. Figure 8-26a shows a similar approach next to Patan's Durbar Square. Note the long length of the shoring braces; they are already sagging under self weight in a few cases. The capacity of the long braces to resist buckling under compression will be limited. Capacity, though, is likely further limited by the connection of the shoring post to the ground, which is often just a simple peg such as shown in the lower photo of Figure 8-26a. By inspection, such braces will have only a fraction of the capacity needed to resist loading in a damaging aftershock.

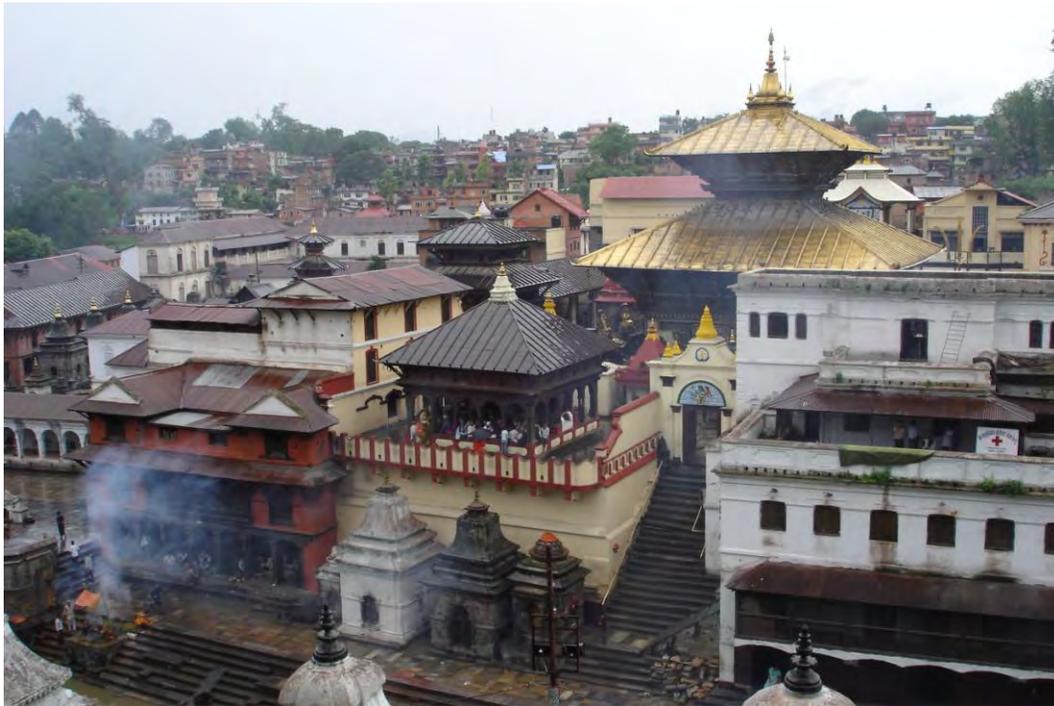
Figure 9-2. Pashupatinath Temple in Kathmandu is dedicated to Lord Shiva. It survived the earthquake with relatively minor damage while other historical structures of seemingly similar design were destroyed (source: Zvacek, 2015).

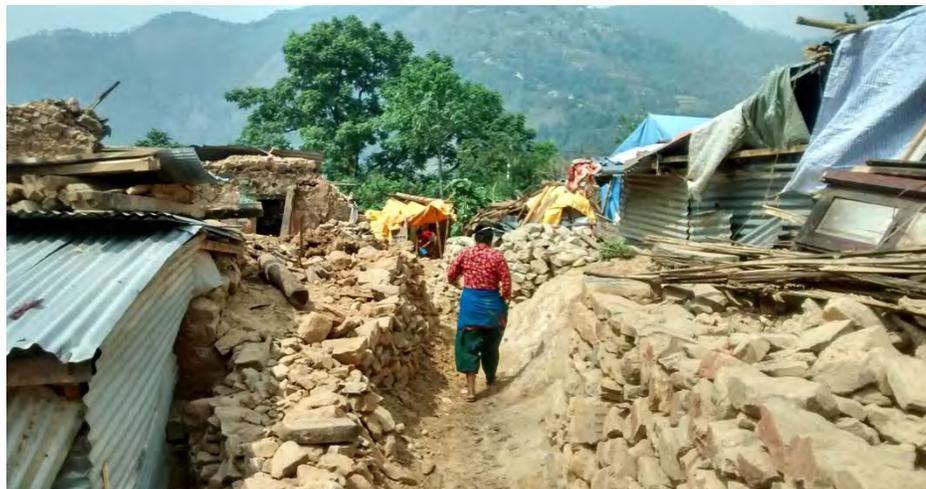
Figure 9-3. Woman walking along a path between destroyed residential structures, Bhimdunga VDC, Nagarjun Municipality, Kathmandu Valley. Temporary structures were erected in this community weeks after the earthquake, despite the risk of landslides (photo: Courtney Welton-Mitchell).

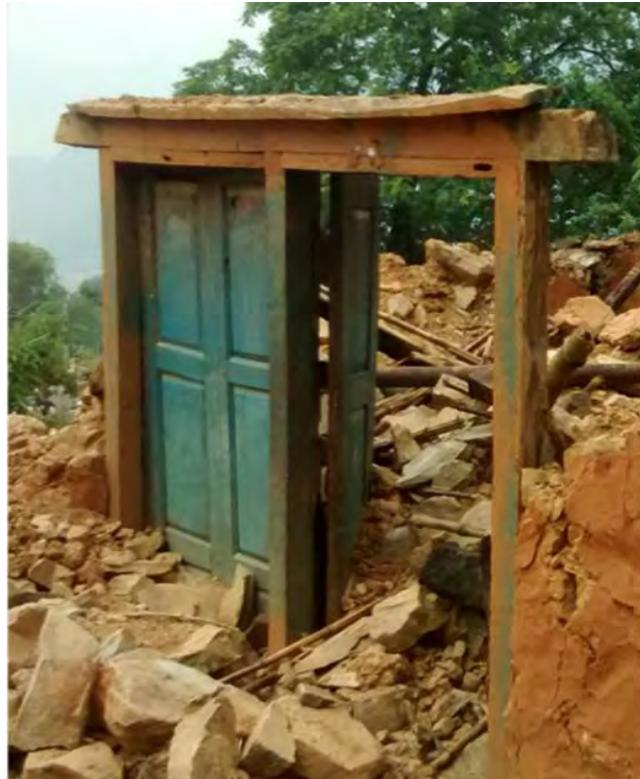
Figure 9-4. Destroyed home, Bhimdunga, just outside of Kathmandu (photo: Courtney Welton-Mitchell).
