ZIMBABWE - Chimanimani Area

Tropical Cyclone - Impact map

Observed the 20/03/2019

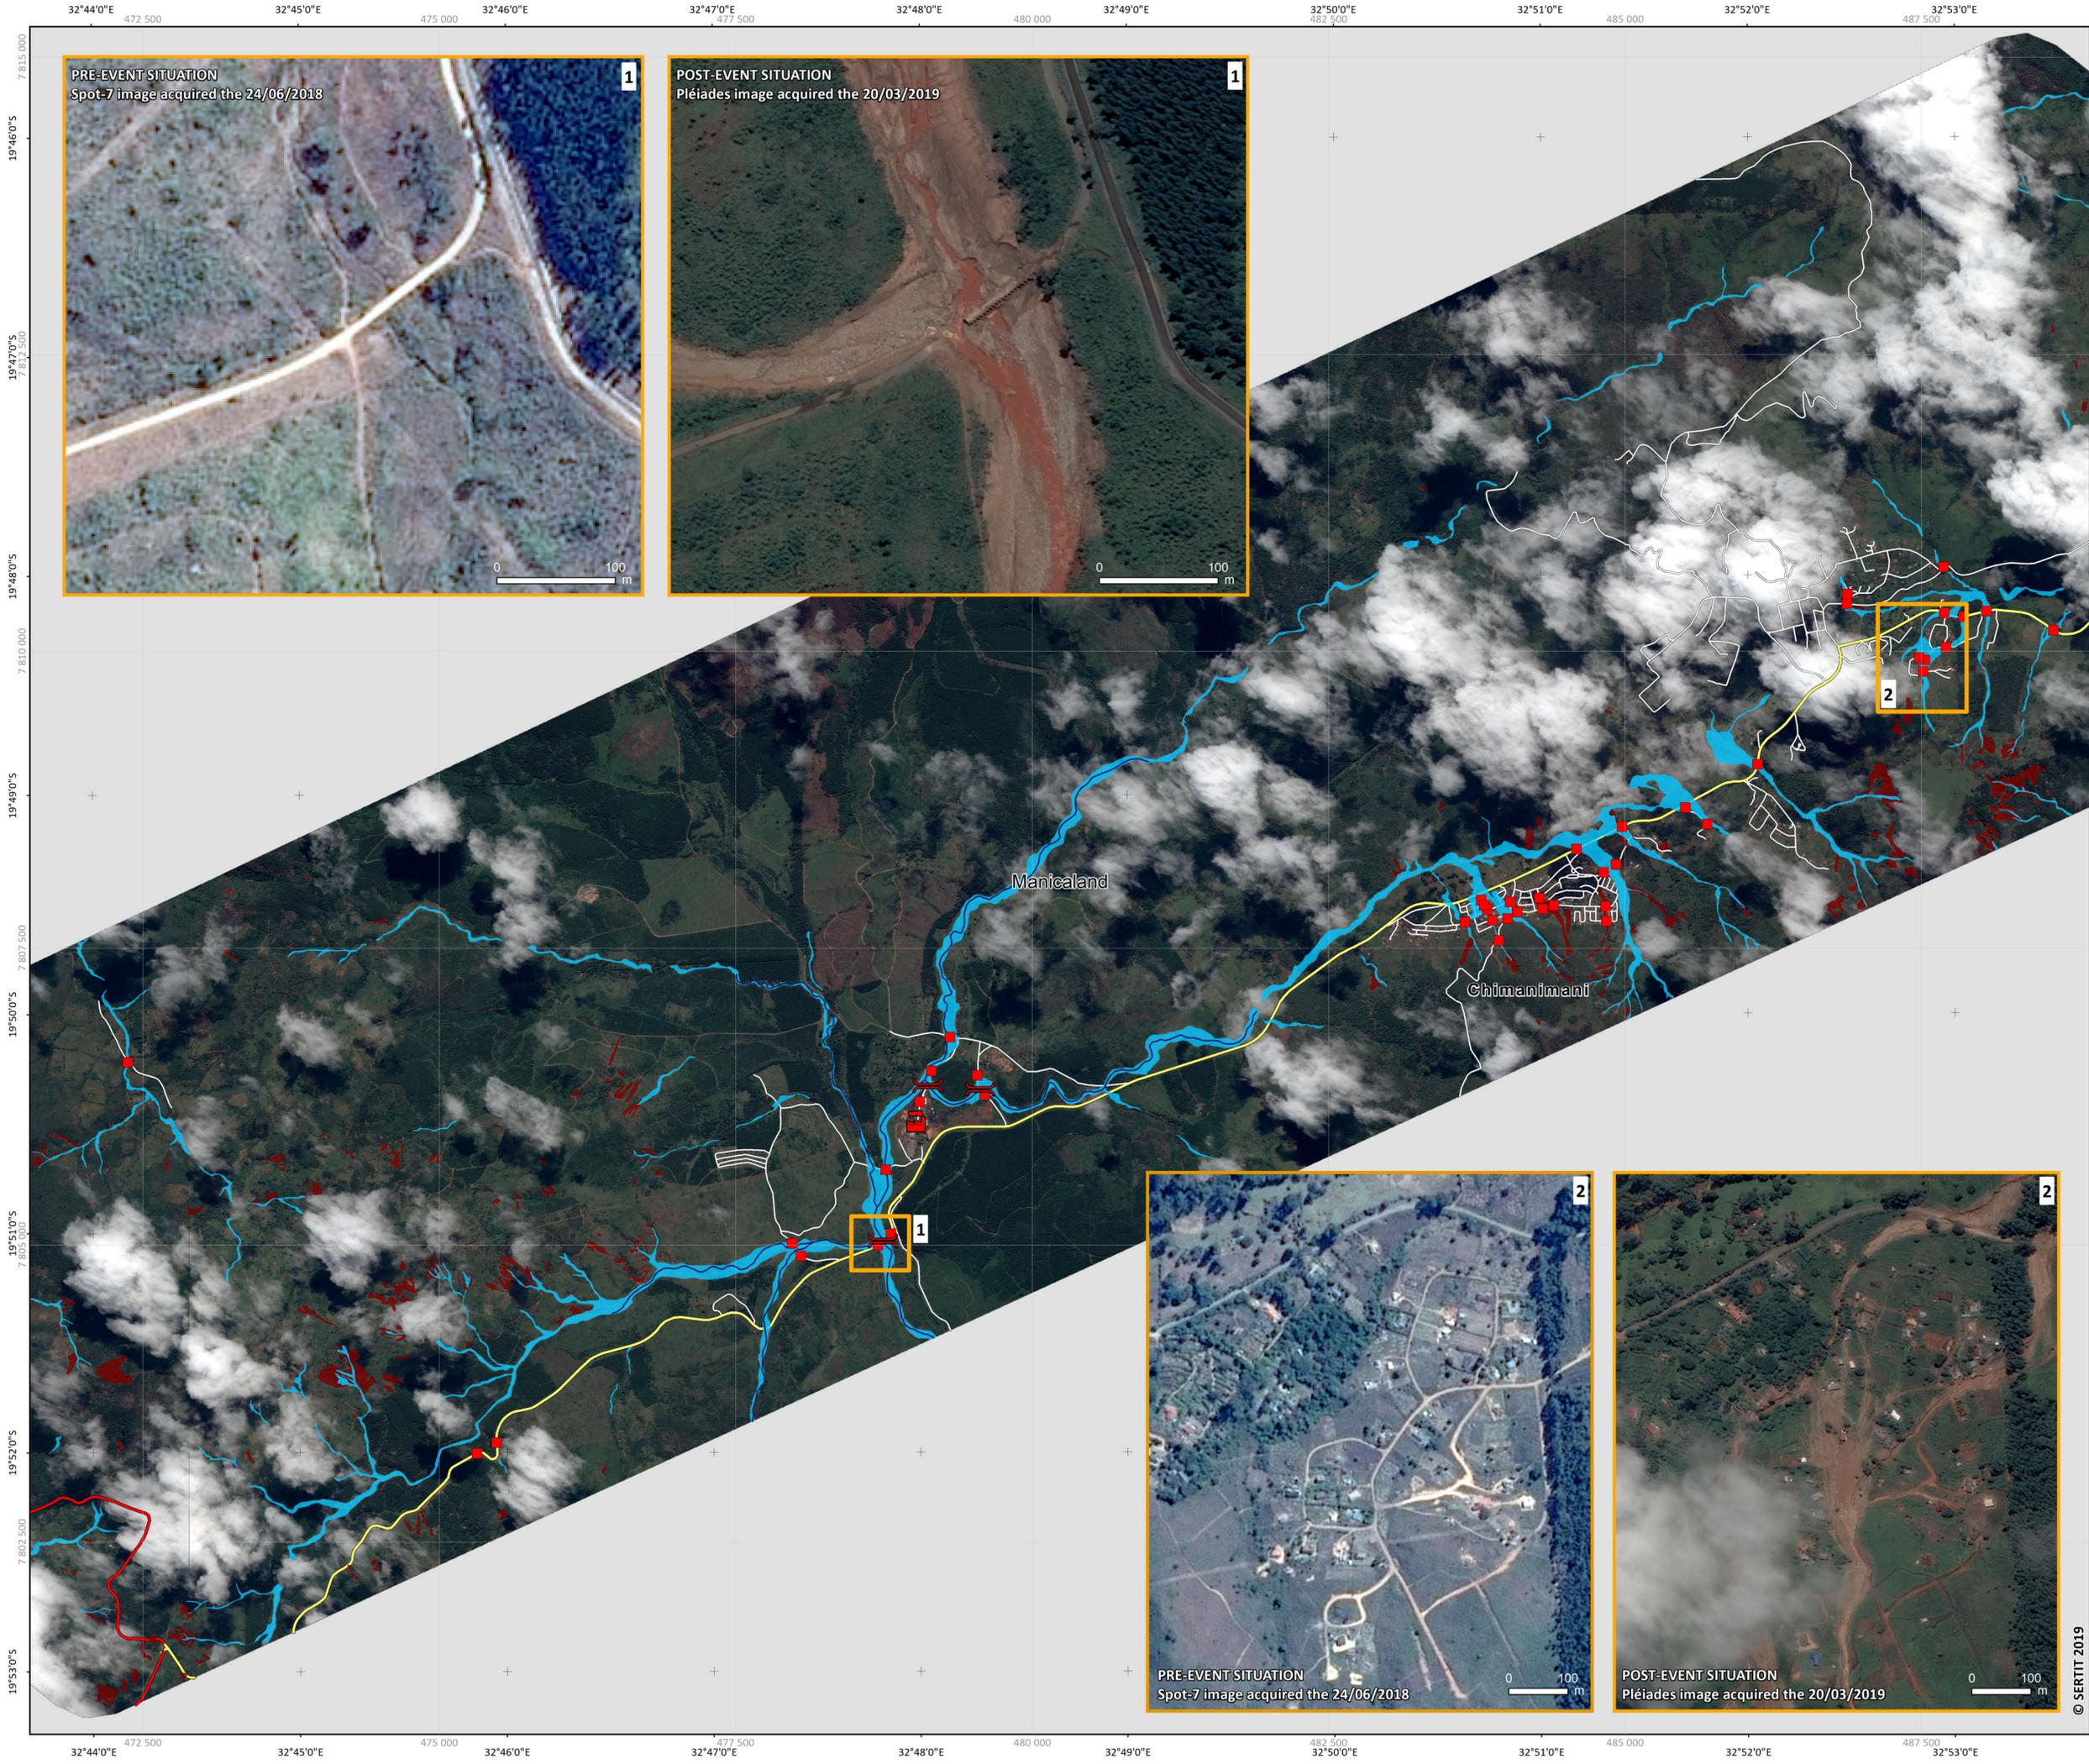
Crisis information	Roads
Road block	Primary
Bridge - Damaged	Secondary
Industry - Affected	Local road
Flood traces	Hydrology
Landslides	River

Tropical Cyclone Idai passed over eastern Zimbabwe on the 14 March 2019 killing at least 80 people with hundreds more missing. The death toll is expected to rise as authorities continue rescue efforts. This map presents the damage assessment in the Chimanimani area.
