## Situation Report Municipality of Munai, Lanao del Norte

**Emergency:** TS Tembin/Vinta  
**Date:** January 2, 2018  
**Prepared by:** Mirriam J. Solleza- WASH Cluster Coordinator- Iligan City

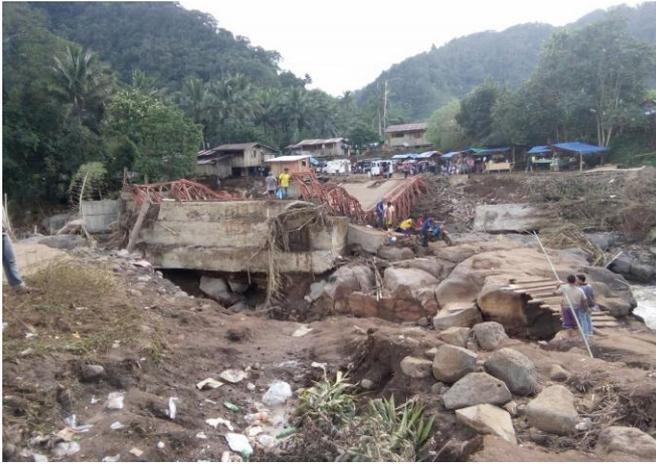
Main Bridge connecting the 5 barangay's highly hit by TS Vinta in the Municipality of Munai

Main bridge connecting the 4 upland hardly hit barangay's are totally damaged and roads to Bacayawan, Lininding, Pendulunan is not accessible while Matampay, Old Poblacion is accessible from Punong-Matampay old.

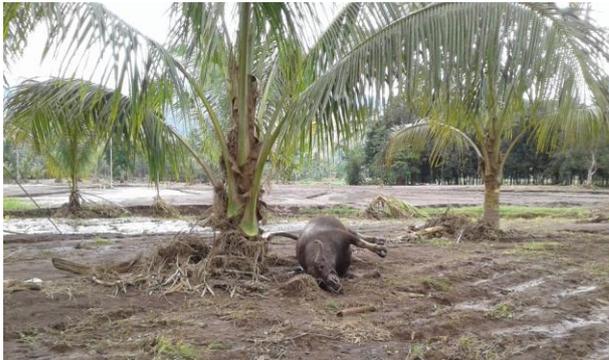
Remains of dead animal already on decomposing stage as the major health risk for the community of Brgy. Old Poblacion

The Municipal Health Officer shared that there were cases of diarrhea and skin diseases during the medical mission but it was not being reported by the health worker so there is a need to intensify the disease surveillance report mechanism. The decaying dead animals is starting to become a major treat to the health of the community if not properly handled.

- Debris clearing and provision of tools such as shovel, rake, wheel borrow, dust pan and broom stick
- Need for MHPSS intervention

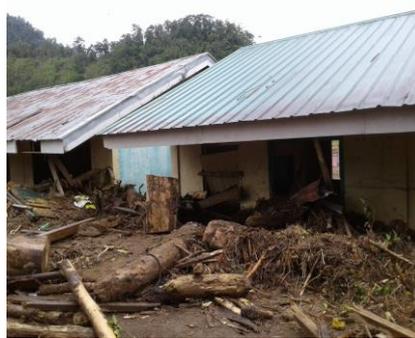
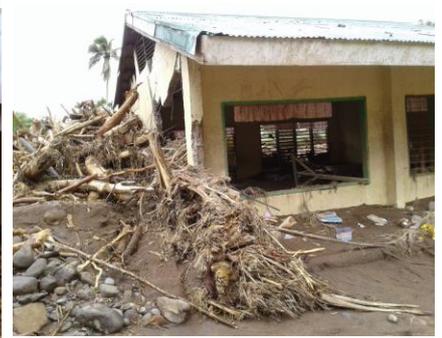
Some of the schools in Lininding-7 rooms, Old Poblacion- 4 rooms , and Pendulunan-9 rooms, are totally damaged while N. Cadulawan-1 room is partially damaged.

Photos of the schools in Brgy. Lininding and Old Poblacion

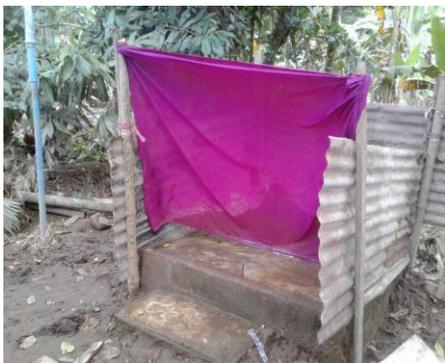
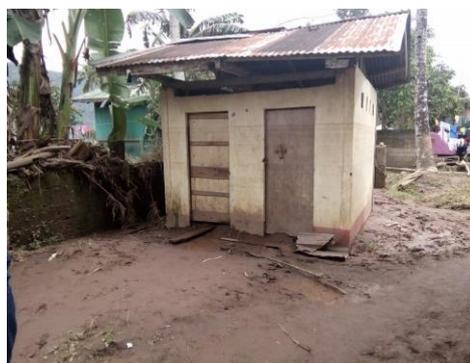
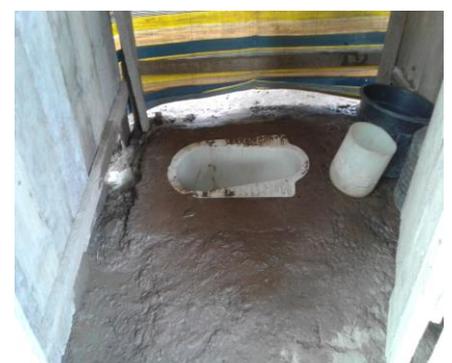
In the community the access to functioning sanitary facilities is limited because majority of the latrines were totally damaged by the flood. Sanitary Inspector shared that the number of families in need of sanitation materials will be identified after the conduct of the assessment, specifically in the hardly hit barangays. On the other hand, number of families is in need of hygiene kits and also, there were no adequate personal hygiene supplies available such as soap, sanitary cloth/napkins in the area and mothers expressed that they highly appreciate if any organization can provide them. There were WASH related diseases encountered during the medical mission such as diarrhea mostly are children and skin diseases both adult and children that links to contaminated water and open defecation.

Damaged Communal latrines in Brgy. Old Poblacion

- provision of semi-permanent or permanent latrines
- Immediate repair of the hand pumps and water lines
- Water quality monitoring/test
- Monitoring of mortality and morbidity

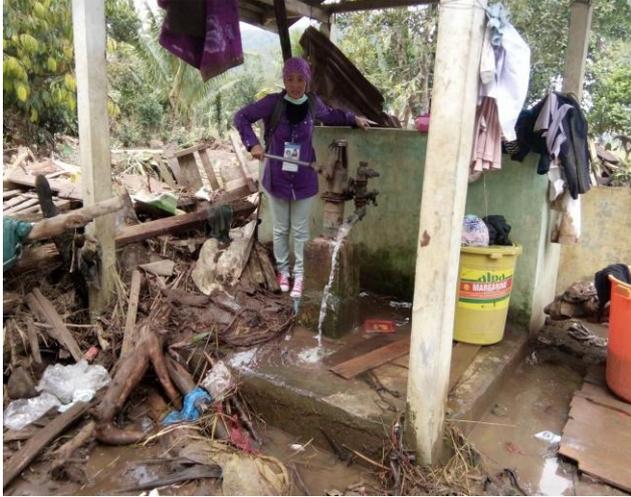
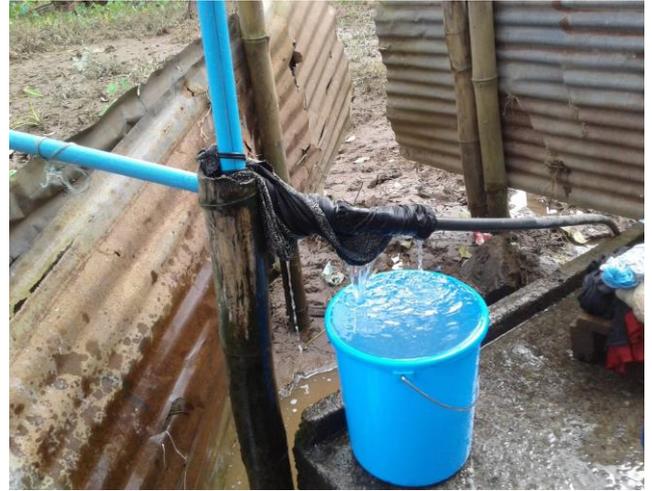
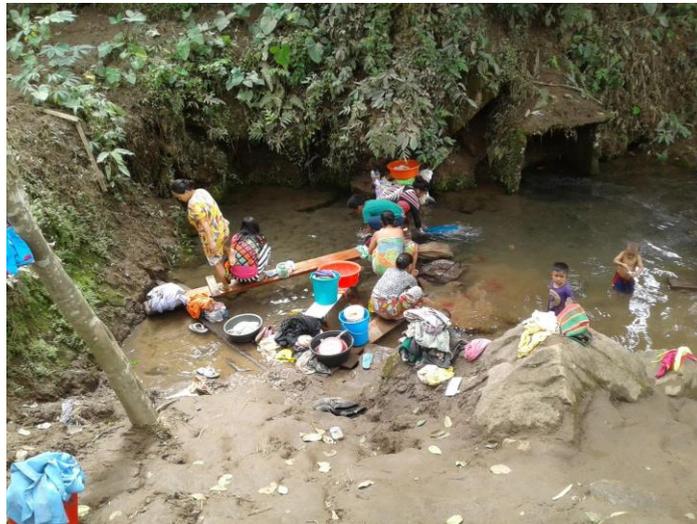
According to Sanitary Inspector, there is available water but not sure on the potability and majority of the distribution pipes are totally damaged including the reservoir. The families’ primary water source for drinking water and for cooking is from the unprotected open spring, and deep-well but majority are damage. There is an immerging issue on the need of water container and hyposol for the water treatment.

There is a possibility of water contamination at the spring and the deep-well. The families use boiling as their means of treating water/disinfecting water for drinking. The Rural Health Unit (RHU) is requesting WASH Cluster to provide number of jerry cans for storing water in the household level and bucket for carrying from water point to household and hyposol/aquatabs. The community is also requesting for laundry basin for washing their clothes.

Brgy. Old Poblacion water source for drinking and domestic use
