Tacloban north. Environmental situation and recommendations regarding the dumpsite Santo Niño.

Åsa Granath, Environmental Advisor, UN OCHA granath@un.org

Thorsten Kallnischkies (thorsten.kallnischkies@undp.org) UNDP Disaster Waste Management Team

March 2014

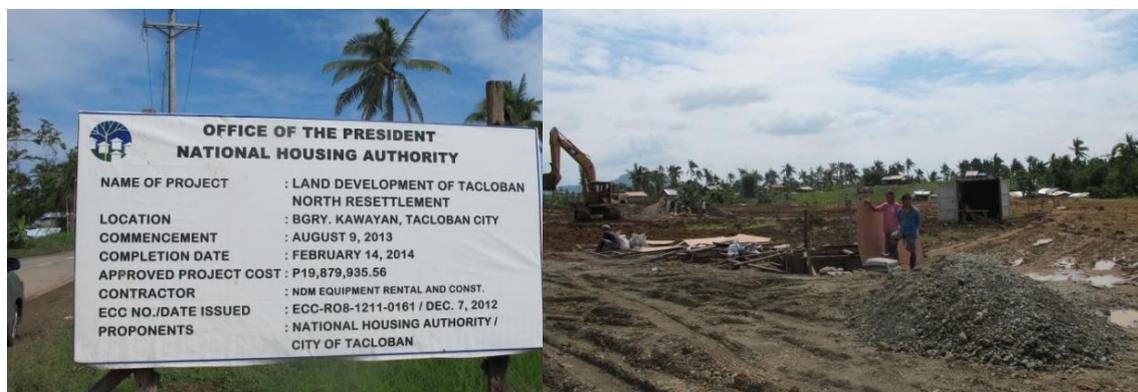
Tacloban north resettlement, February 2014. There is ongoing excavation work in the area.

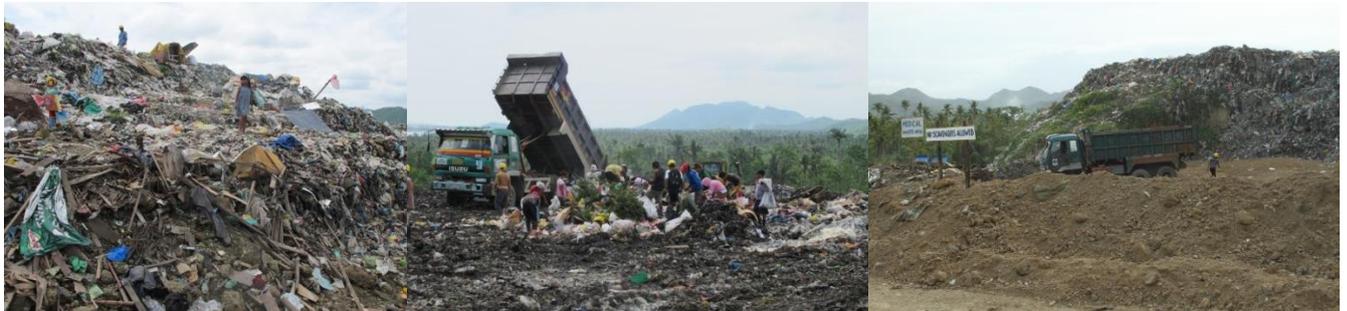
The Tacloban Municipal dumpsite Santo Niño is located approximately 14 km north of Tacloban City on the eastern side of the highway to Babatngon. The dumpsite is installed without bottom lining which means that leachate will infiltrate directly into the ground and reach the groundwater. There is no installed system to collect leachate and the leachate drains directly to an open waterbody downstream. The dumpsite is not fenced and has free access for unauthorised people. There is ongoing work to improve the dumpsite. The dumpsite receives municipal waste from Tacloban city and is also used for debris waste generated by Yolanda.

Santo Niño. There is ongoing dumping of waste on the site. Right. Cell for health care waste.

To close the dumpsite a pre-closure assessment, closure plan, aftercare plan and monitoring plan shall be prepared. Closure procedures should be done in accordance with DENR Administrative Order

09/2006 *General Guidelines in the closure and Rehabilitation of Open Dumpsites and Controlled Dump Facilities* (Section 37 of RA 9003). According to Section 6.1 a Pre-Closure Assessment is to be carried out, including (amongst others)

- Evaluation of potential or existing impacts on the ecological and human environment
- Determination of potential contaminants and formulation of appropriate mitigating and remedial measures
